**CEOCOR 2007
MALAGA (SPAIN) 8 - 10 May 2007**

Paper A06

a.c. corrosion – Some results of the activities

L. Di Biase – R. Cigna – O. Fumei - ISPRONA S.r.L

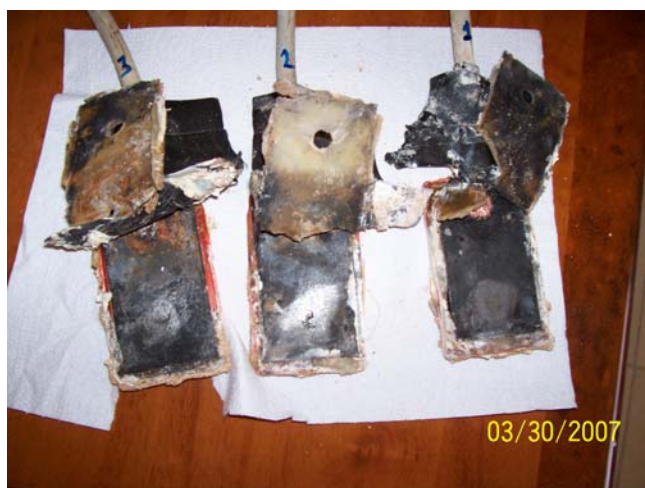
In March, 2007, the three a.c. Corrosion Coupons existing in the Section 3 have been excavated:

All three coupons have been found with a slight a.c. corrosion, as expected. Further, detailed examination are in course in our laboratories.

From the excavation of the first series of three coupons, a certain initial corrosion can be observed, as expected.

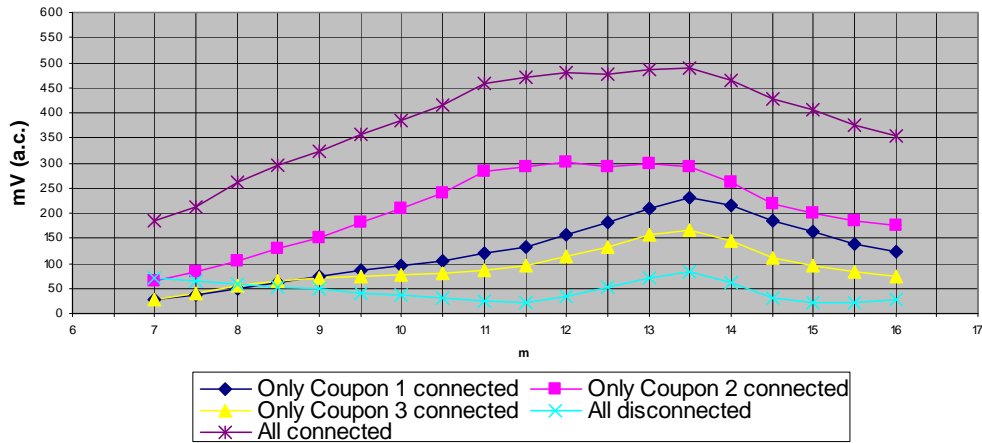
a.c. gradients measured over the Corrosion Coupons

Some a.c. and d.c. Gradient Measurements had been performed over these coupons :

The presence of coating faults absorbing high current densities (either a.c. or d.c.) can easily be localised on a real pipeline. By a careful examination of the ratio between a.c. and d.c. gradients, some hint on the risk of a.c. corrosion seems possible.

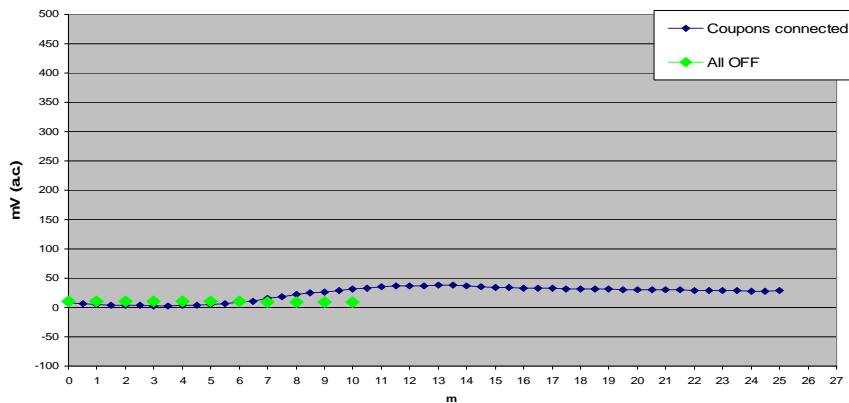
**a.c. gradients measured over the Corrosion Coupons
(a.c. Discharge Device connected)**

These graphs demonstrate that the Discharge Device can decrease the a.c. current on the pipe down to NON CORROSION conditions.
