**a.c. corrosion experiences in ENERGINET.DK**

*P. Cohn – ENERGINET - Denmark*

Investigation for AC-corrosion on a Danish transmission pipeline  
interfered by HVAC lines

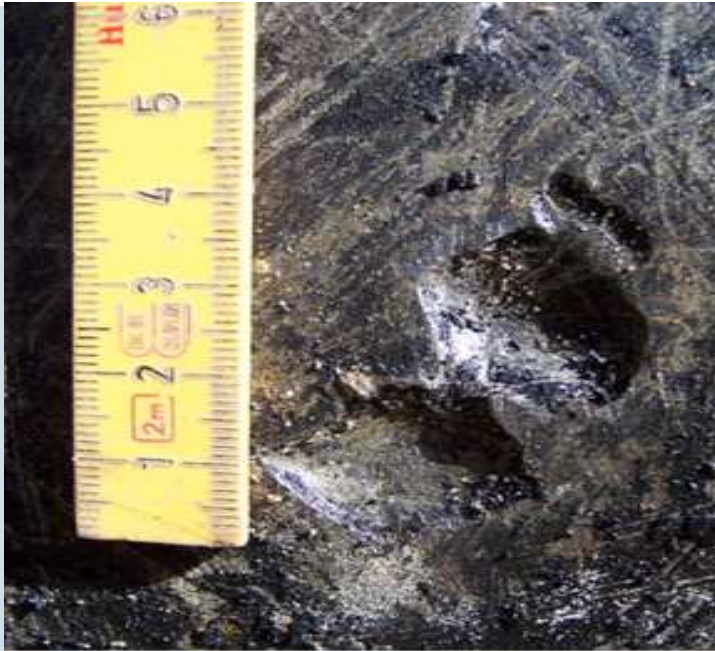
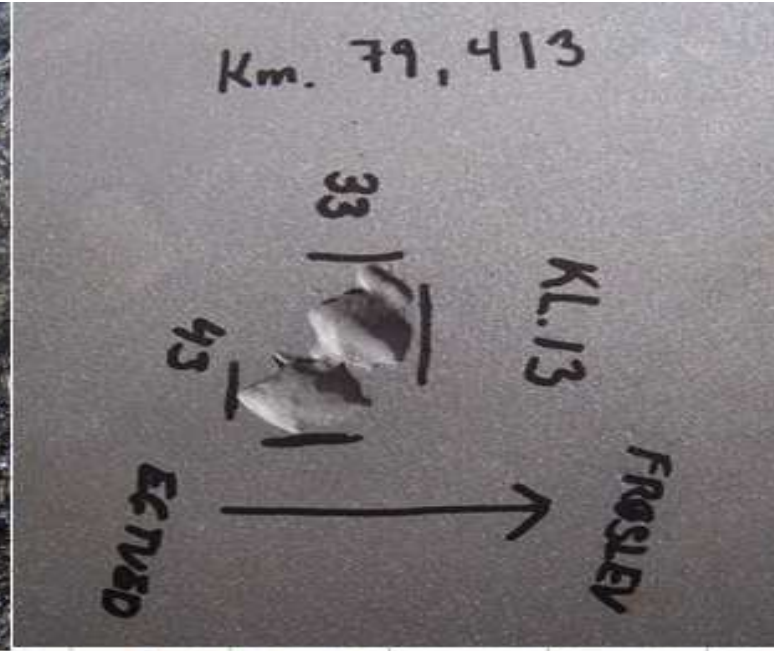
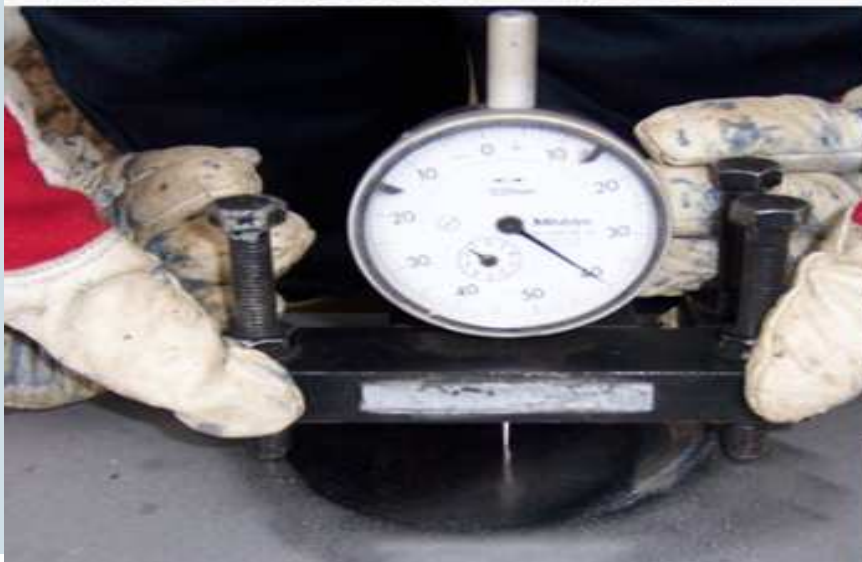
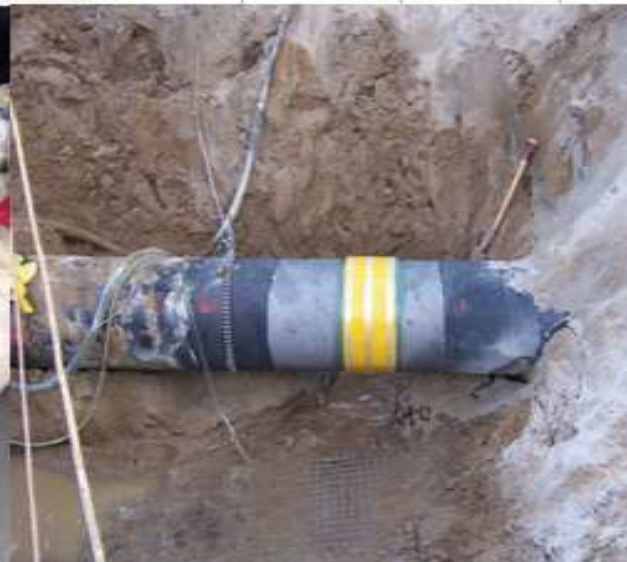
# Metal loss detected by ILI – Milling defect – no coating defect – clock spring

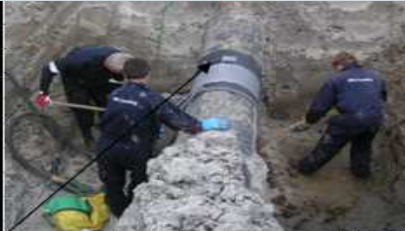
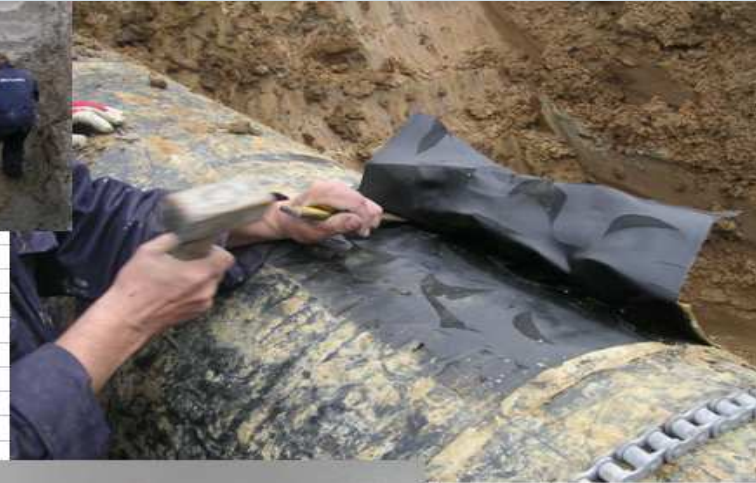
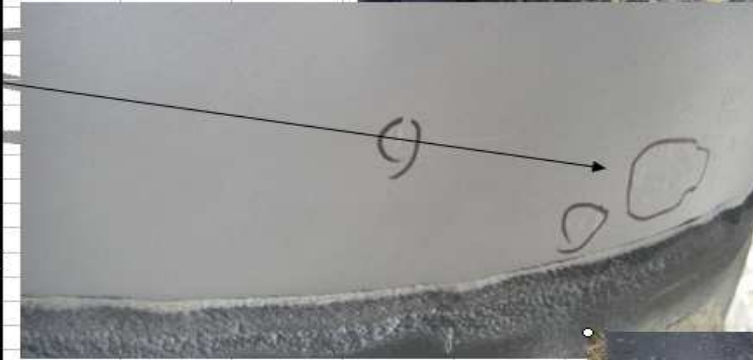
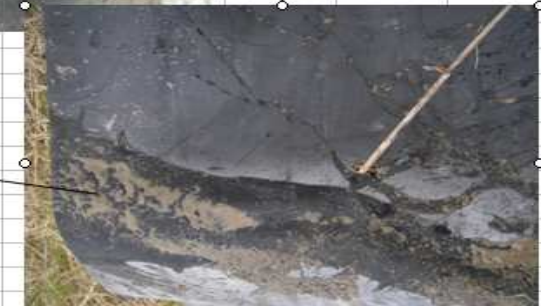
# Metal loss – detected by ILI – no coating defect – “mechanical defect” – polished before fieldcoating

Strækning:	F-E	Ch:	77.016,61
Frilægningsdato:	05-09-2007	Initialer:	pco/kej
Årsag:	Pll pigrun -notat	137527/07	
PSP	35-0202-01-03		
<b>Lokation :</b>			
Factory coating :	2-lags PE	Vedhæftning	100%
Fieldcoating	asfalt bitumen m	Krympemuffe	
Overlap (cm)			5,00
Vedhæftning til rør			100%
Gennemslag ved 25kV			ja
Korrosionsfri			ja
fugt/vand under fieldcoating			0%
<b>EVT Skadesdybde ( beskrives separat)</b>			
<b>Bemærkning</b>			
Recoating	rengøring	sandblæst	
	primer	denso	
	tape	denso AS40Plus	
	entreprenør	Pihl Coating	
Pigging data:		svejsesøm	836
Skadesdata:			
I (mm)	23	b (mm)	29
d (mm)	0,9	KI :	05:05
afstand fra svejsesøm (cm)			13,6
Måleværdi "3-M"			0
Frilægningsdata ( målt på skade)		svejsesøm	661
Skadesdata:			
I (mm)	20	b (mm)	30
d (mm)	0,9	KI :	05:05
Position (afstand fra svejsesøm)			13
<b>Bemærkning: Ingen coatingskade over mekanisk skade</b>			
Mekanisk skade - fra anlæg			
Lap kl 0 ca 100*100 mm i kant af fieldcoating - 100% ok

coatingskade kl 6 ca 6 cm opstrøms svejsesøm uden korrosion			
forårsaget af sten-fundet ved frilægning			
Billedreference :	Q:\6 Diverse Fotos\20070905 - F-E frilægning

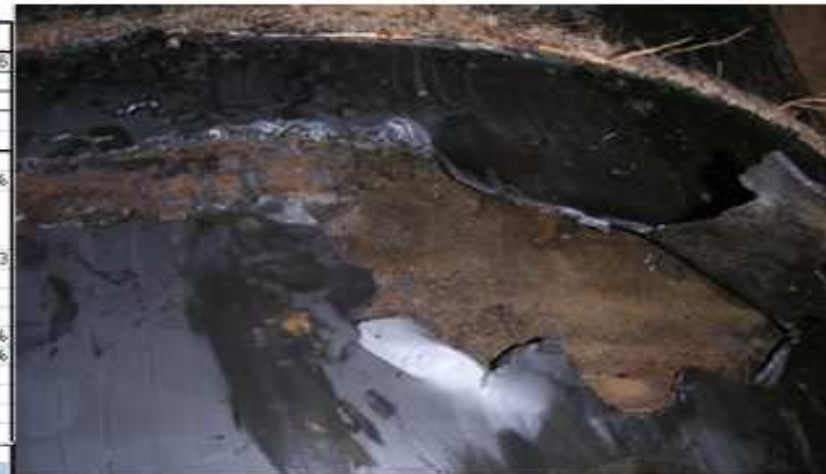
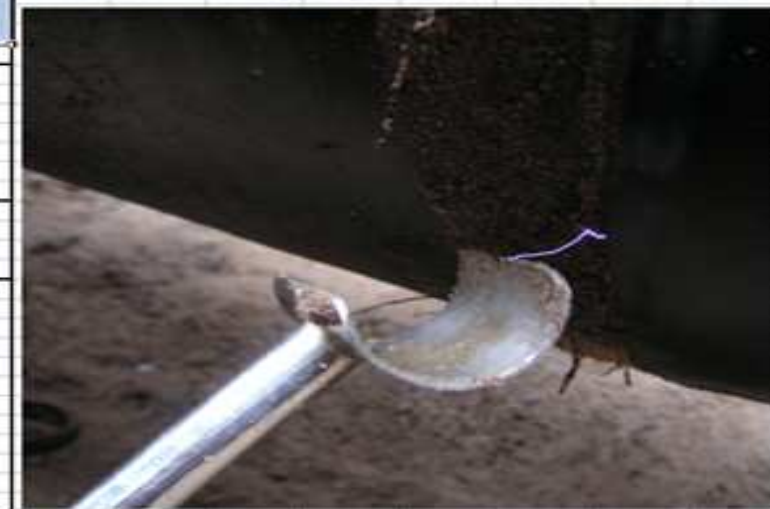
# Coating defect detected by ACVD – No metal loss detected by ILI - corrosion – lack of workmanship

Inspektion af "Fieldcoated svejsesøm"		
Strækning:	Freslev - Eghed	Chc 1,936
Fri lægningsdato:	26-10-2006	Initialet: J0J
Årsag:	Fundet ved ICB-måling	
PSP:	35-0202-01-03	
Lokation:		
Factory coating:	Vedhæftning til rør	2-lags PE 100%
Fieldcoating	Type	asfalt på ståloverflade til niveau med PE derefter Reychem krympemuffe med få cm overlæg
	svejsesøm (no)	
	Overlap (cm)	0 til 3 cm 123
	Bredde af fieldcoating	
	Gennemslag ved 25kV	ja
	Vedhæftning til rør	50%
	Vedhæftning til Factorycoating	0%
	Korrosionsfri	overfladerust
EVT Skadesdybde (beskrives separat)		
Fri for fugt/vand under fieldcoating	delvis	
Bemærkning		
Recoating	rengøring	sandblest
	primer	denso
	tape	denso AS40Plus
	entrepriser	Pihl Coating
lap	dimension (cm)	
	position ca 2m nedenstrøms svejsesøm	
	Gennemslag ved 25kV	ja
	Vedhæftning	
	Korrosionsfri	
Fri for fugt/vand under fieldcoating		
Bemærkning		
Recoating	rengøring	
	primer	
	tape	
	entrepriser	
(Rating)

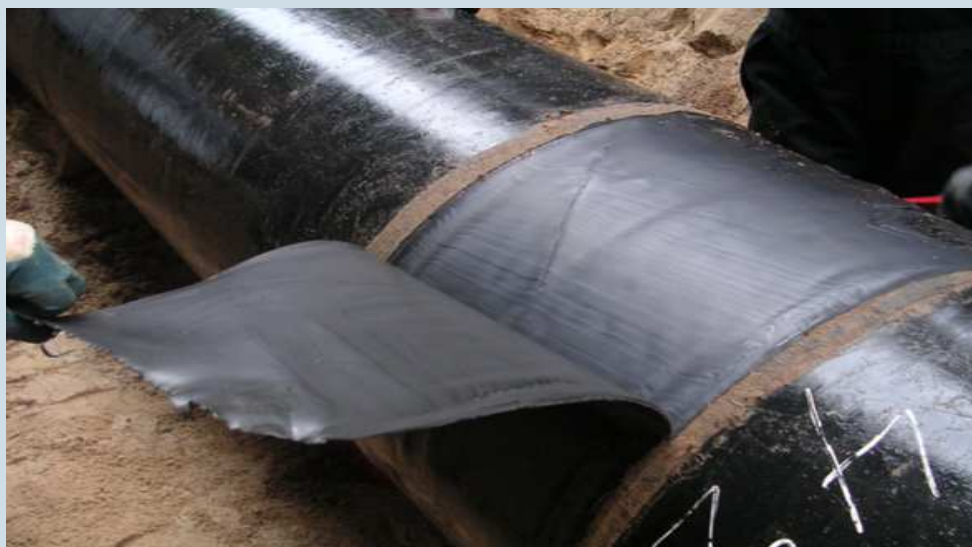
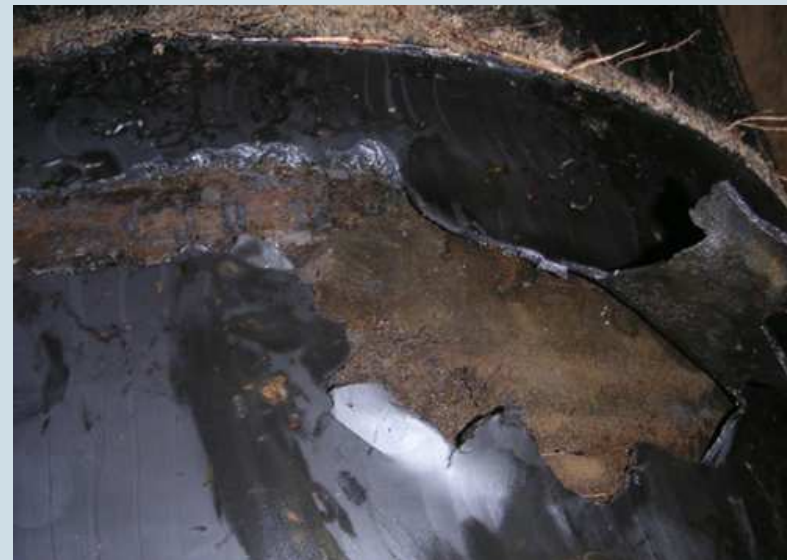
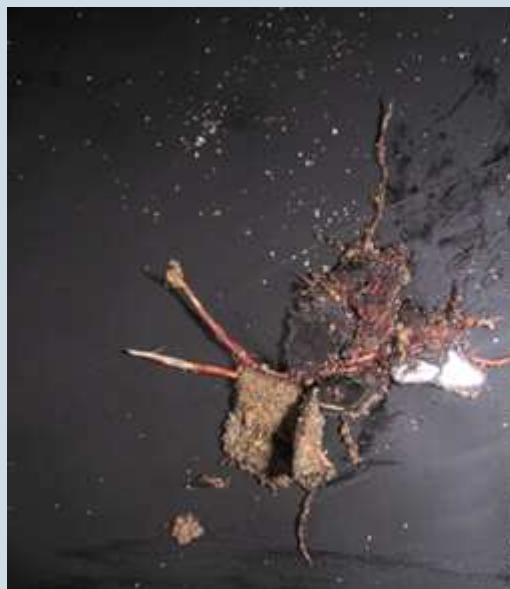
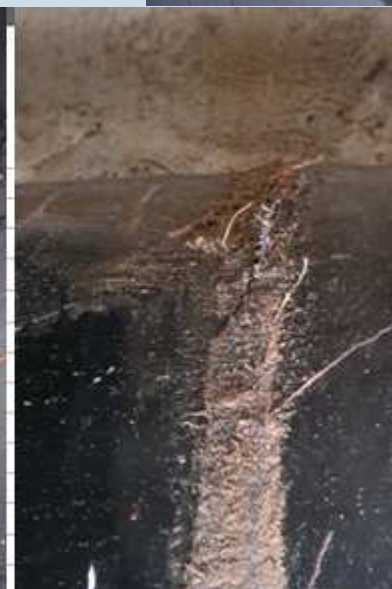
# Raychem sleeve – with asphalt and tree roots
