**CONTRIBUTION TO THE UNDERSTANDING OF THE BEHAVIOR  
OF VARIOUS CONSTRUCTION AND LINING MATERIALS IN  
DRINKING WATER TANKS: A WATER SUPPLIER'S  
EXPERIENCE.**

**Brigitte Schmidt**  
Master of Science  
**eauservice** Lausanne  
Rue de Genève 36,  
Case Postale 7416,  
CH-1002 Lausanne  
Switzerland

**Dr. Jean-Gabriel Hammerschlag**  
Product engineer  
Holcim (Switzerland) Ltd  
Product Management & Innovation  
CH-1312 Eclépens  
Switzerland

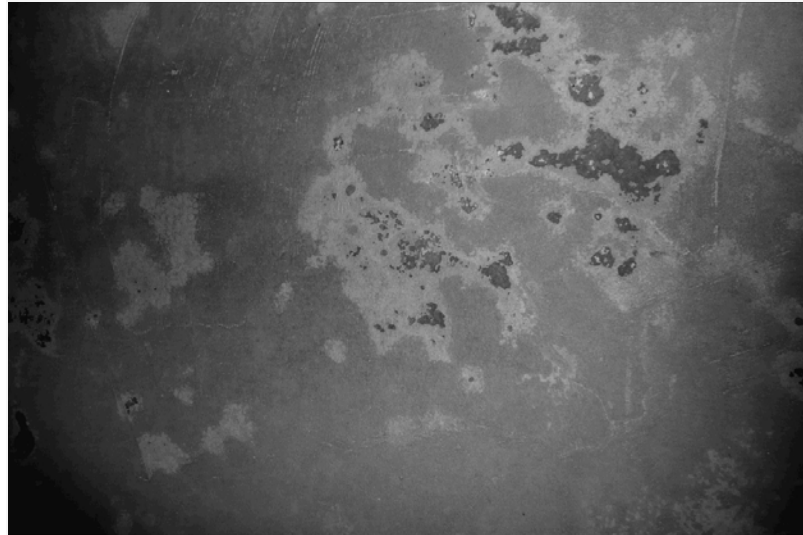
**Remark:** In the process of normal aging, coloring and softening may affect cement sealings until the mortar locally appears (Fig. 1).

When a sanding effect occurs, it generally evolves towards stabilization after the skin layer of the mortar has been removed. Sanding means that the skin layer was weakened by hard troweling, which may have generated an enrichment in water at the surface and thus increased porosity.

*Fig. 1 different stages of alteration on cement sealing*

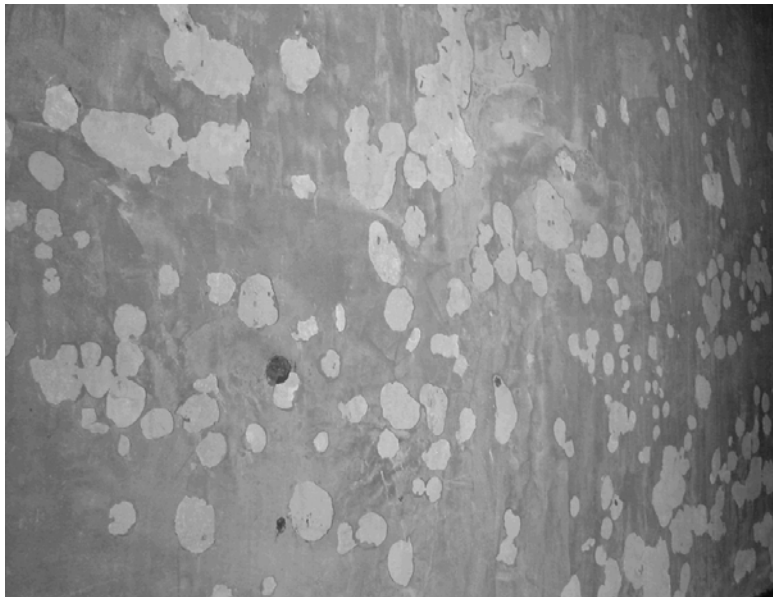
Used between 1991 and 1993 for the rehabilitation of 3 tanks totaling 11'200 m<sup>3</sup> in a reservoir built in 1946, the coating has shown since 1995 severe blistering and delamination (Fig. 2), together with biofilm formation (Fig. 3). However, gluing tests were performed beforehand, with one year waiting time and good results at pull tests.

*Fig. 2: Delamination on modified mortar*

Analyses were carried out, showing the presence of a polyvinylacetate polymer in the coatings. In alkaline conditions, this polymer is hydrolyzed to acetic acid which then reacts with the calcium available in the mortar to form soluble and hygroscopic calcium acetate. Two situations can result: if the coating is intact, the induced osmotic pressure forms blisters containing a concentrated (0.1 molar) solution of calcium acetate, smelling typically of the traditional photo labs. If the coating is perforated, calcium acetate seeps out of, forming a local nutrient source on which a biofilm begins to grow (Fig. 3).

**Remark:** Here, the main source of problems is the bad conception of the material. A definitive solution requires its replacement. On a temporary basis, pluriannual cleaning and disinfection limit biofilm growth.

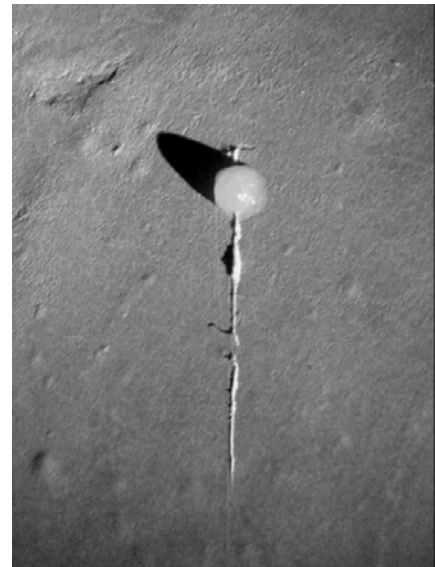
*Fig. 3: Biofilm on modified mortar*

Applied in 1994 as local rehabilitation in another tank, the product shows the same defects. Interestingly, the biofilms host a different combination of microorganisms,

which supports the assumption that in our case the primary cause of biofilm development has to be linked with nutrient supplied by the support rather than with the presence of a particular bacterial species in the water.

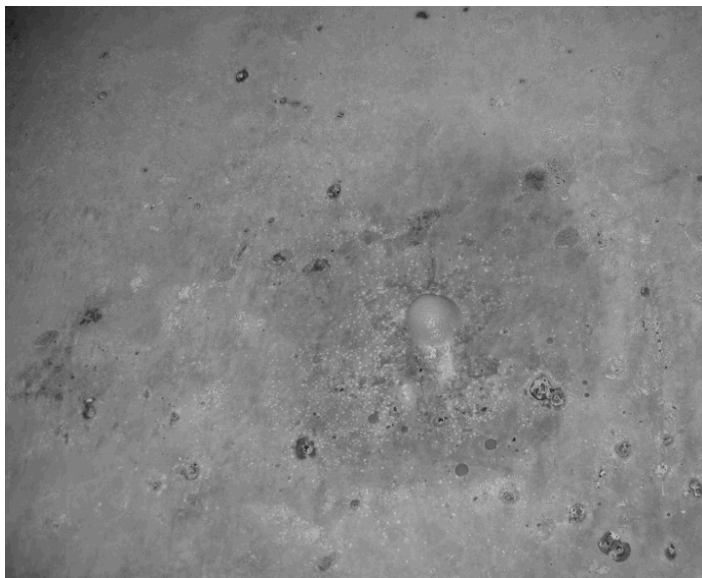
In a reservoir built in 1970, the two tanks, totaling 15'532 m<sup>3</sup>, have been coated with a conventional mortar with cement sealing, underlain by an adhesion layer. The walls show locally delamination as well as biofilm growth on fissures or humidity haloes (Fig. 4). Analyses show that the adhesion layer releases organic components into the water seeping through cracks in walls and coating. The resulting solution, highly concentrated in organic components, causes blisters or delamination by osmotic pressure, or oozes through local defects feeding the biofilms.

*Fig. 4: Moisture and biofilm on cement sealing underlain by an adhesion layer*

**Note: No adhesion layer should be needed at the interface between two products based on hydraulic binder. However adhesion layers are sometimes used whereas the surfaces to be coated are too smooth and badly absorb water (excessive smoothing and metal forms that produce such surfaces should therefore be avoided in this case). The present example shows that a mechanical preparation is far better than the use of an adhesion layer.**

**Remark:** Due to the use of an adhesion layer under a suitable and classical mortar coating with cement sealing, these water tanks will still show throughout their entire service life delaminations and biological issues requiring repeated local repairs and frequent cleaning and disinfection.

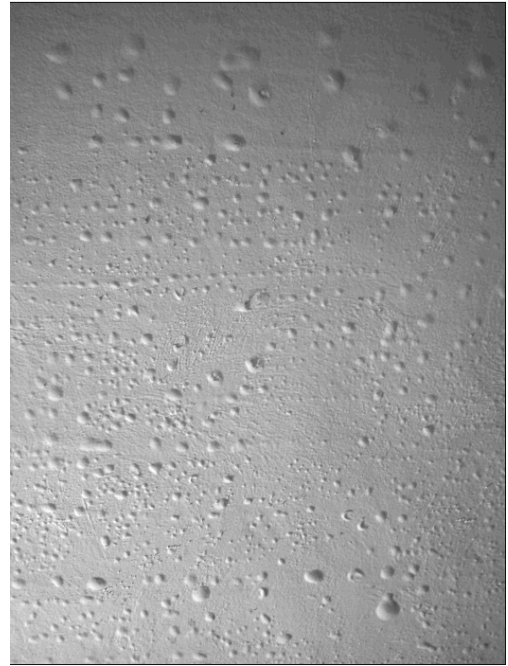
Two water tanks totaling 5'400 m<sup>3</sup> have been covered during construction with an epoxy coating. The product had been successfully applied beforehand in a smaller tank (500 m<sup>3</sup>). However, isolated problems like soft or oily spots as well as perforations were observed in the new reservoir after only 8 months, quickly followed by blistering. Despite repairs, blistering (Fig. 5) became widespread enough

to jeopardize coating adhesion. A complete renovation of the two water tanks had to be carried out.

The problems encountered here and studies undertaken have shown that, basically, the material does not appear to be really adapted to the coating of large concrete water tanks. The substrate must be dry during implementation (< 4% residual moisture), which is hard to achieve while being possible as shown by the results in the small tank. The product is also potentially sensitive to the alkalinity of the concrete in case of polymerization defects. This appears to have been the case here.

Laboratory trials carried out on epoxy samples taken from the tanks have confirmed that the material is hydrolysable in the presence of KOH, which serves as catalyst. Now the pore solution of the concrete of the walls contains around 1.5% KOH and the fluid in the blisters too!

**Remark:** Failure in the respect of the requirements of implementation has undoubtedly played an aggravating role.

*Fig. 5: Blistering on epoxy coating*

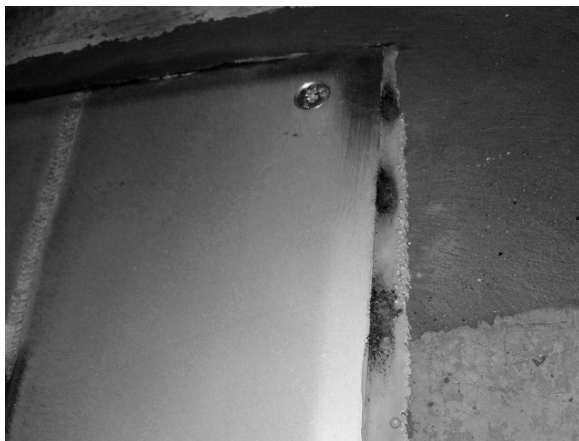
Repair sealings are frequently made of organic material. They may show a high risk of bacterial growth and biofilm formation (Fig. 6). A careful placement during concreting will generally spare the use of these products (Fig. 7).

*Fig. 6: Biofilm growth on door sealing*

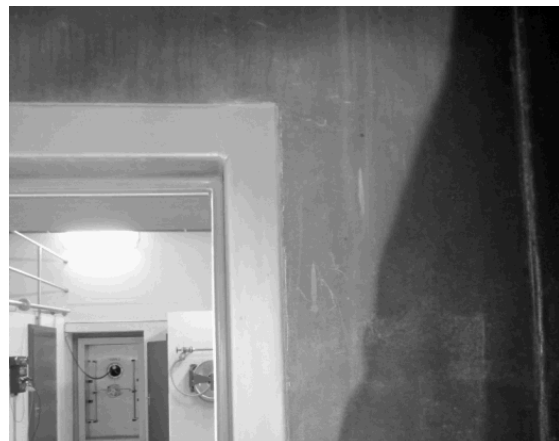
*Fig. 7: Well built in door*

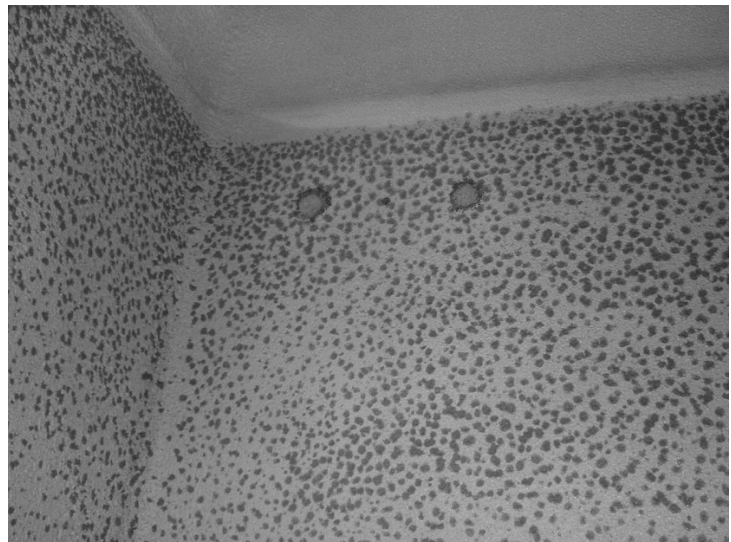
In tank 1, the coating has a wild roughcast aspect with fragile, binder depleted peaks. Alteration of the asperities was observed within two years after application. The weathered zones have softened and spread, forming numerous brown spots (Fig. 8). The depletion of binding, and the ensuing alteration, could be due to local dilution by a punctual supply of water during the early phases of curing, as a result of condensation for example. The material is known to be sensitive to water films throughout implementation and curing.

*Fig. 8: Spotted alteration in tank 1*

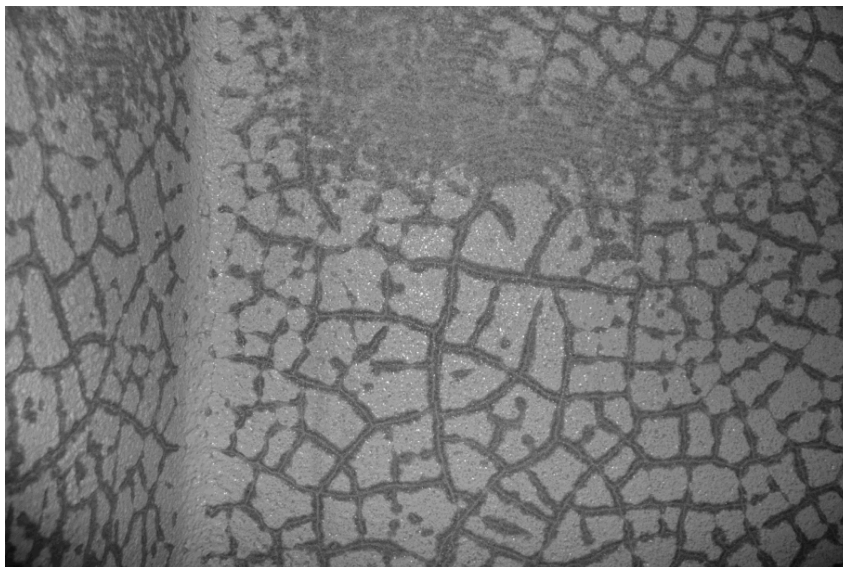
*Fig. 9: Alteration following desiccation cracks in tank 2*

In tank 2, implementing hasn't been optimal either, the undertaker using the technique for the first time. The coating shows a polygonal network cracking, probably desiccation cracks made visible two years after application by the beginning of alteration. Desiccation cracks are caused by a superficial moisture deficit during setting, i.e. insufficient curing

proven here. In the submerged zone of the walls alteration continues on both sides of the healed fissures (Fig. 9).

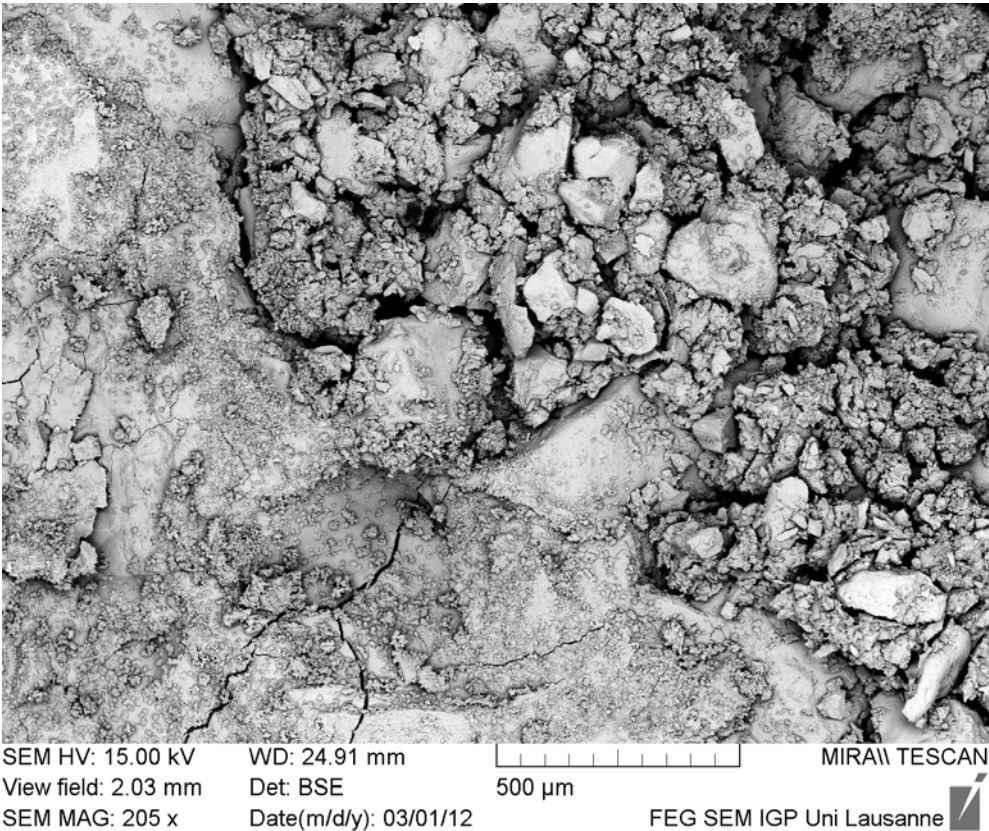
Microscopic examination (Fig 10 and 11) shows in both cases a severe superficial deterioration, sharply delimited, including: binder loss, loosening of aggregates and increase in porosity. Underneath, a second area shows a digressive destruction of

cement matrix. The two deteriorated areas represent together 20 to 30 % of the thickness of the product. Cracking through the top coating doesn't affect the base coating.

Fig. 10: SEM of thin mineral coating, altered (top right) and sound surface

**Remark:** Sensitive both to condensation and moisture deficit, this product requires a good control of local conditions. Moreover, thin layers induce specific fragilities when improperly implemented. Existing fragilities have furthermore been enhanced during the first years of service by acidic cleaning, which is abandoned today. Nevertheless, microscopic examination has shown that rehabilitation is premature at the time, in spite of the impressive appearance of the alterations, and thanks to the absence of organic compounds and the related risks.

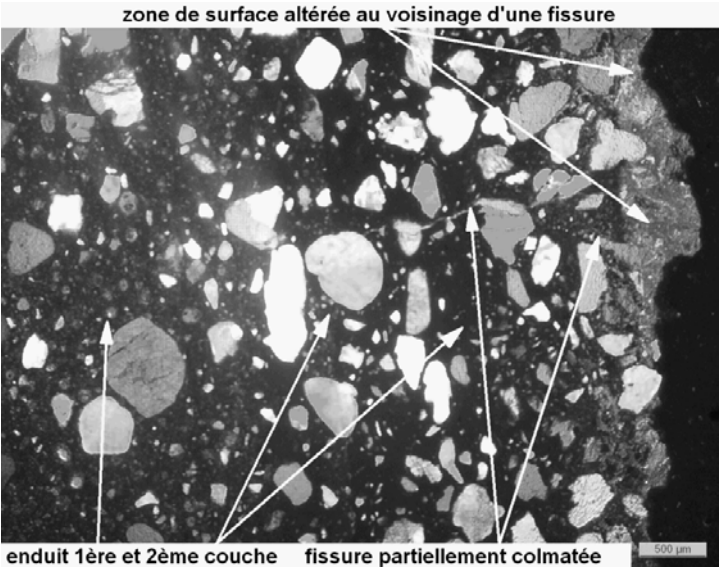
Fig. 11: Microscopic view of mineral coating

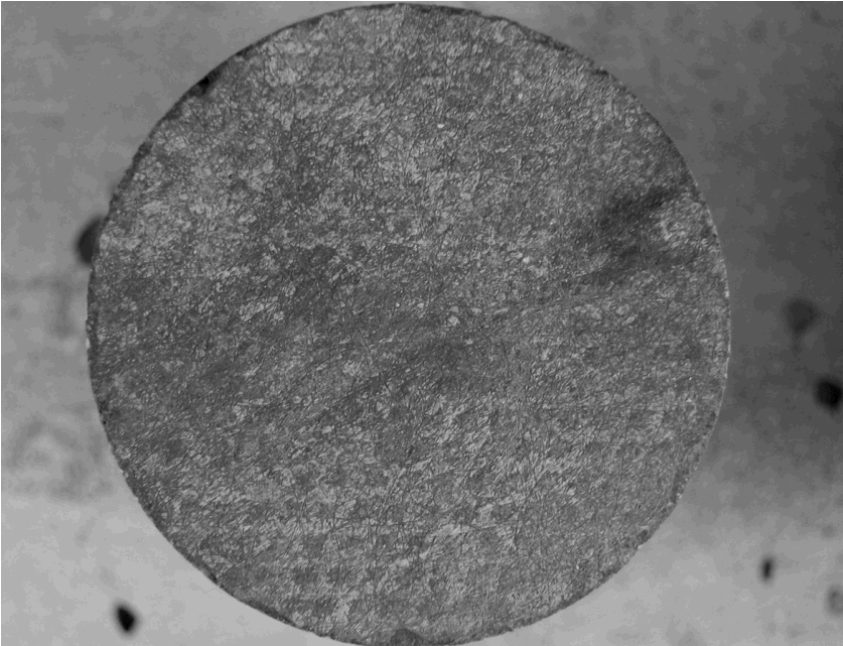
*Fig. 12*

Resulting surfaces are characteristic (Fig. 12) and may astonish. As they are dark, marked by the structure of the draining formliner, the obturations of the spacer holes remaining visible, they appear less flattering than smooth cement sealing or the less durable light coatings.

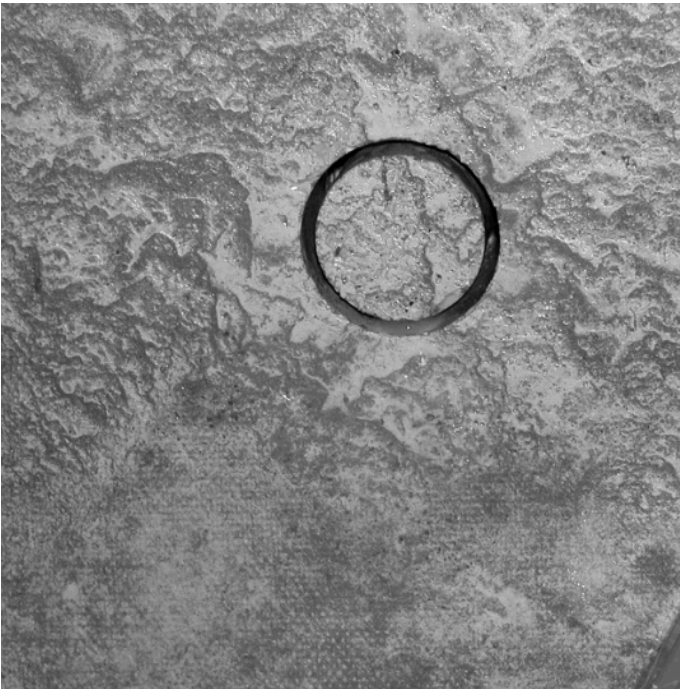
**Remark:** Nevertheless, surfaces have locally displayed beige areas reflecting slightly more capillary areas of concrete skin (Fig. 13). Microscopic examination shows that they are resulting from local conservation of cement slurry at the surface, resulting either from local incorrect concrete internal vibration, or from a locally insufficient or impeded drainage (formliner locally soiled prior to use, incompletely cleaned in case of reuse, etc.). The defect remains minor.

*Fig. 13: Local cement slurry conservations*

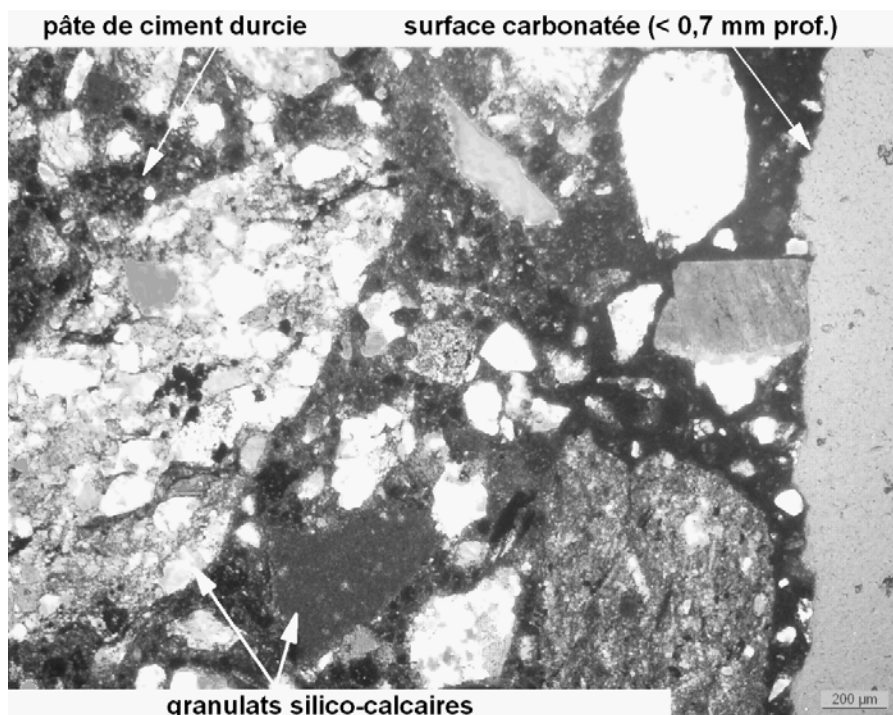
The resulting concretes show characteristics of quite remarkable quality (Fig. 14): surface with low capillarity of cement paste, good bonding between cement paste and aggregates, low cracking content. They were well implemented and compacted and are successful examples of watertight concretes, matching with concretes for civil engineering structures subjected to high solicitations and requirements. Surface qualities are similar to those obtained by the cement sealing of the past.

*Fig. 14: Microscopic view of excellent fair-faced SF concrete with CPF*

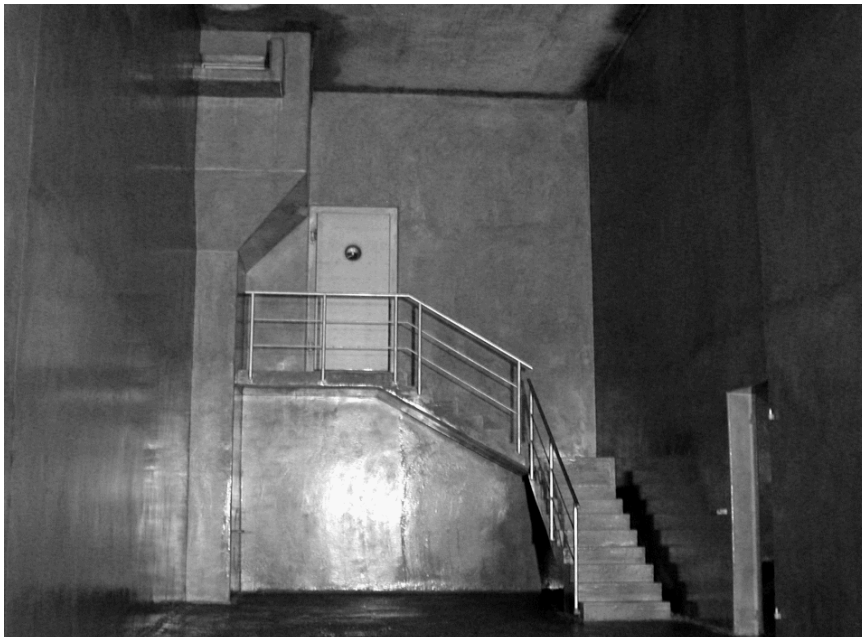
The system was implemented in 2004 (Fig. 15). The mortar was made with a CEM I cement with an addition of SF and carefully selected and controlled aggregate (a bad surprise with a ready to use mortar may be noted here: during the tests it has shown significant but unannounced changes in composition between batches). Our dry process sprayed mortar was applied in a single layer, 12-16 mm thick (3 to 5 times the maximum diameter of the sand, beyond which there is a risk of cracking) and troweled.

*Fig. 15: Successful rehabilitation with dry process sprayed mortar, on walls, stairs, gully and over-flow*

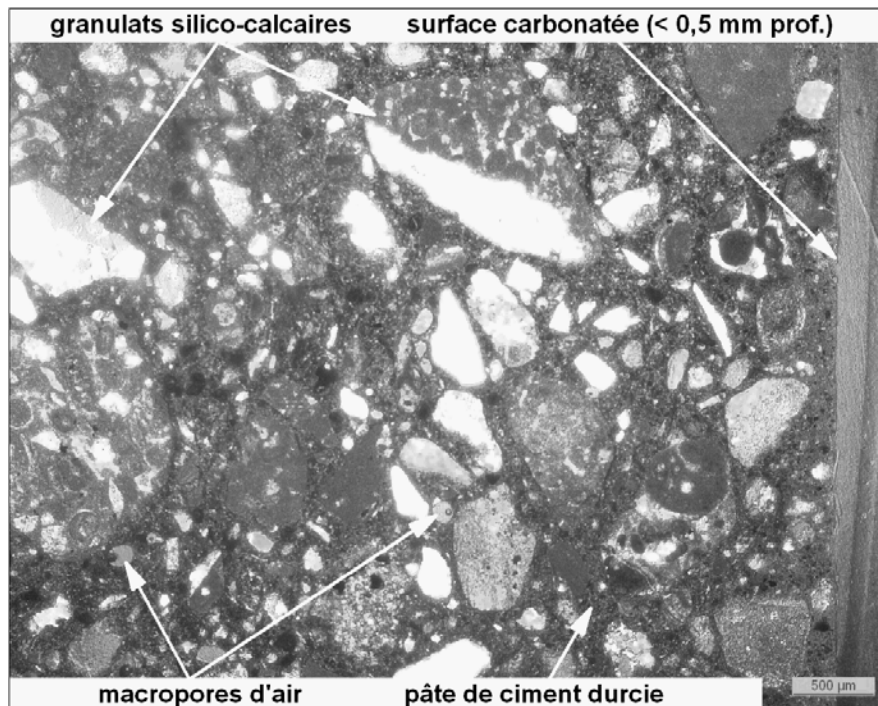
*Fig. 16: Microscopic view of dense shotcrete*

Microscopic examination (Fig. 16) shows that the mortar was well implemented and applied in a compact manner on the concrete support. It has outstanding quality characteristics: low capillarity of the cement paste up to the surface, particularly good bonding between cement paste and aggregates (due to the impact force of the projection on a rough and moist concrete surface), low cracking content. This is a good example of successful application of a watertight system on a concrete which isn't, but is sufficient for the mechanical stresses to which it is subjected. The dry sprayed mortar corresponds to that applied on engineering structures exposed to bad weather and subjected to high solicitations and requirements. The quality of the surface, in particular the closure of porosity, is greater than that obtained by the cement sealing of the past, while being obtained by mechanical means ensuring a rapid advance the work. The expected service lifetime exceeds the one of the structure.
