Florence DAYS 5th – 6th June, 2013

Ductile iron pipes with cement mortar coating according EN 15542

Mr Steffen Ertelt – Dipl.-Ing. (FH) – Head of Applications Engineering

This paper presents the results of excavations carried out to examine the pipe conditions of pipes with cement mortar coating after three decades with and without zinc coating.

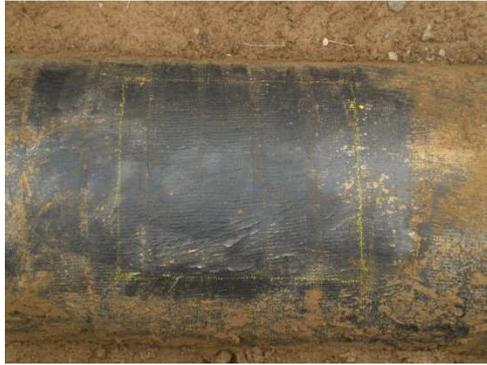
A pipe having been exposed, its ZMU showed itself to be firmly adhering, undamaged and in a good as new state (Fig. 4). The exposed surface of the pipe had a zinc coating and an epoxy bonding layer (Fig. 5). No evidence was found of any corrosive attack. The native soil was examined under DIN 50929-3 [8]. The result was a rating figure of 0 points corresponding to soil class I (not aggressive). With a rating figure of -3, the embedding material resting directly against the pipe was of soil class Ib (of low aggressiveness). In this part of the route, the pipeline had been installed in not aggressive or slightly aggressive native soil. The native soil had been used as an embedding material.

After a period of 25 years in use, the state of the pipeline at the test dig was found to be as good as new. A technical operating life of 100 to 140 years will certainly be achieved.

Fig. 4 Excavation – exposed ZMU

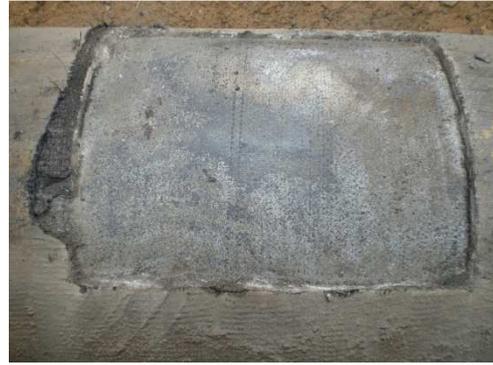
Fig. 5 Zinc coating with epoxy bonding layer

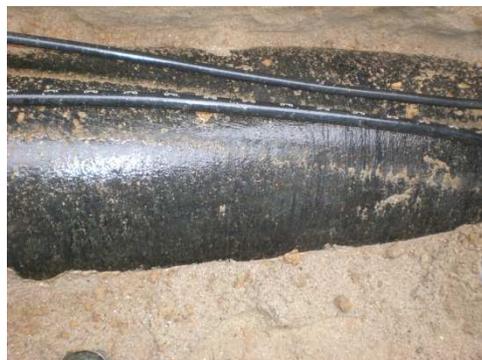
The pipeline having been exposed (Fig. 6), its ZMU showed itself to be firmly adhering, undamaged and in a good as new state. The exposed surface of the pipe did not have a zinc coating at that time but did have an epoxy bonding layer. No evidence was found of any corrosive attack (Fig. 7). In this part of the route, the pipeline had been installed in not aggressive or slightly aggressive native soil with chemically neutral sand as an anode backfill (Fig. 6).

After a period of 32 years in use, the state of the pipeline at the test dig was found to be as good as new. The assumed technical operating life of 100 to 140 years will certainly be achieved.

Fig. 6 Excavation – exposed ZMU

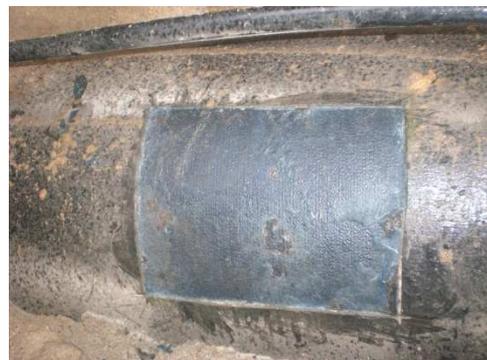
Fig. 7 Epoxy bonding layer without zinc

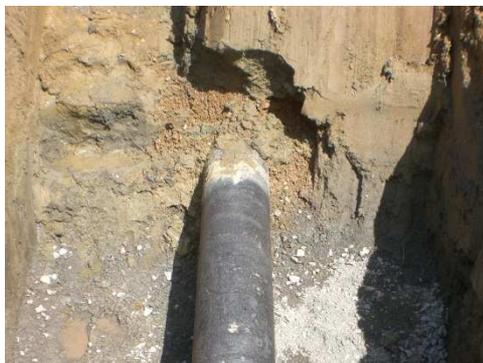
The DN 300 ductile iron pipeline having been exposed (Fig. 8), its ZMU showed itself to be firmly adhering, undamaged and in a good as new state. The exposed surface of the pipe had an epoxy bonding layer but not a zinc coating; no evidence was found of any corrosive attack (Fig. 9). In this part of the route, the pipeline had been installed in highly aggressive native soil. The embedding material used had been the native soil or, in the region of the bottom of the pipe, gravel (Fig. 10). The pipeline was also below the water table in this part of the route. The vertical inhomogeneity (gravel at the bottom of the pipe, corrosive cohesive soil as backfill at the sides and over the top of the pipe) resulted in differential aeration cells (corrosion cells) forming.

Although the conditions encountered at installation had been highly adverse, no evidence was found of any external attack after a period in use of 32 years. A technical operating life of 100 to 140 years will certainly be achieved.

Fig. 8 Excavation – exposed ZMU

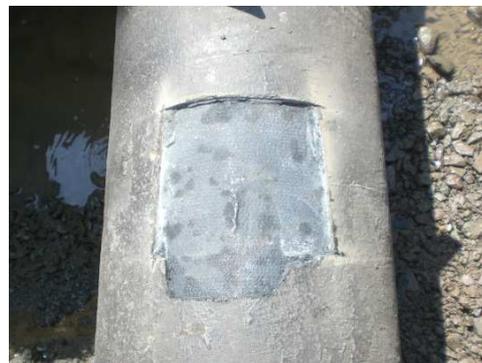
Fig. 9 Epoxy bonding layer without zinc

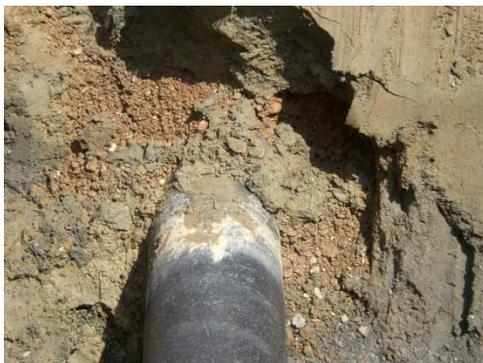
Fig. 10 Embedding in highly aggressive soil
