Stainless steel: Two case studies of corrosion.
Importance of choosing the components
with which they are in contact and cleanliness of manufacturing
on the behaviour of installations

P LEROY*, F VUILLAUME**

Abstract:

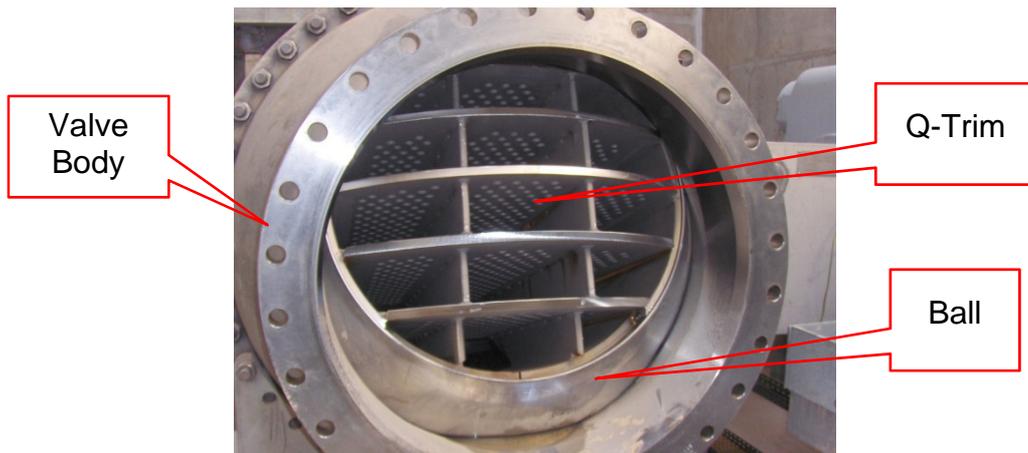
Fig. 1.1

Each station is fitted with \varnothing 900 mm flow control valves. The valves are made of duplex stainless steel AISI 329 (1.4460) for the valve bodies and for the ball. The Q-trim is made of 316L austenite steel (1.4404) (Fig. 1.1). The balls are coated with hard chrome to reduce friction when changing position.

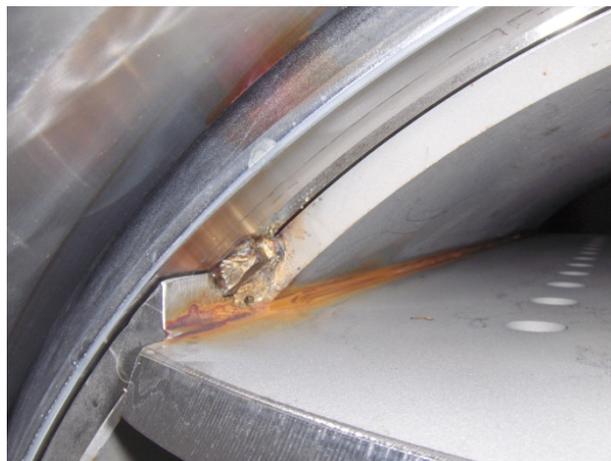
Fig. 1.2

A few weeks after water filling of the pumping stations, the corrosions appeared on the welds of Q-trim plates (fig.1.2). Despite a local pickling followed by passivation, these traces of attacks appeared again immediately after filling.

After careful inspection of the valves, the Finnish manufacturer has diagnosed the presence of mild steel shims used for mounting plates and were not removed during welding. These shims are corroded very quickly as a result of galvanic couple formed by stainless steel and mild steel.

Although this corrosion does not substantially affect mechanical characteristics of the Q-Trim, it was decided to remove the valves for repairing them in the Finnish workshop.

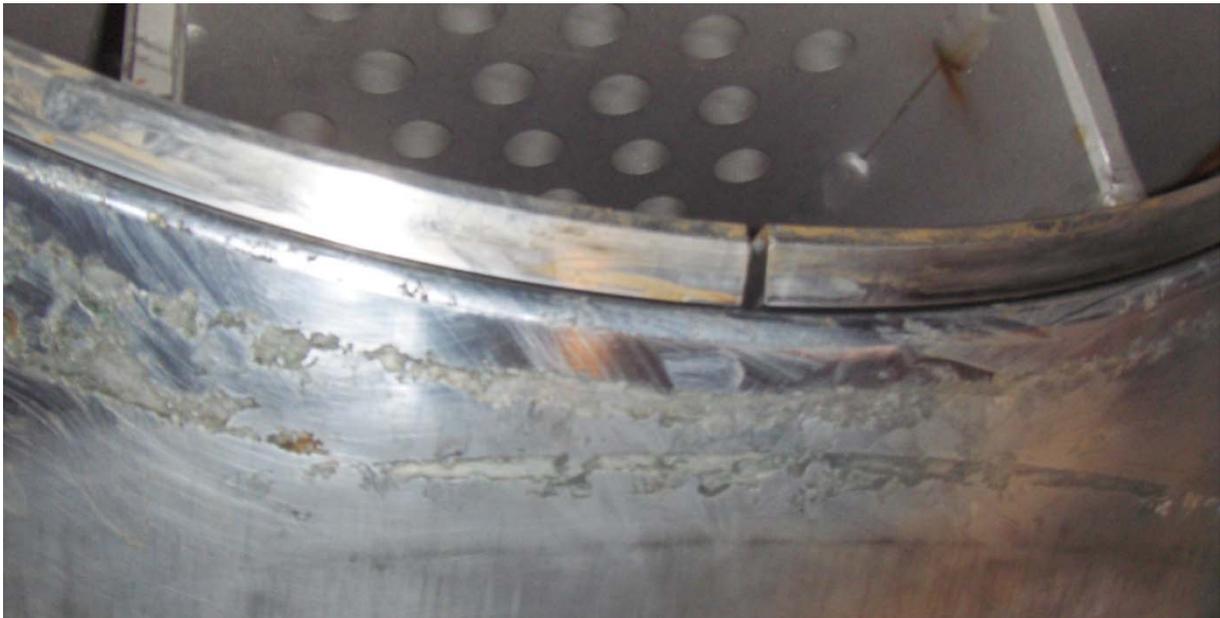
When dismantling the valves it was found that the hard chromium coating of the ball corroded particularly under the sealing joint made of super duplex stainless steel (fig. 1.3).

The coating deposited by electroplating directly on the duplex steel without nickel sublayer had a high porosity. The presence of pores in the coating allowed to maintain contact between the duplex and the water promotes the formation of galvanic cells that the support metal is the anode. The valve being not in use, the ball remains in the same position over several weeks. Thus the attacks are particularly located in the areas where the medium is confined that is to say under the sealing joint. Fig. 1.3 shows that the corrosion also appeared on the flow bore edges of the ball.

Considering the porosity of the chromium coating and the extent of corrossions, the manufacturer proposed to substitute a coating consisting of tungsten carbides and chromium. According to the manufacturer, this type of coating is best suited for contact with corrosive environments. Indeed, it also contains nickel and which constitutes a sealed reagent which screens the duplex steel.

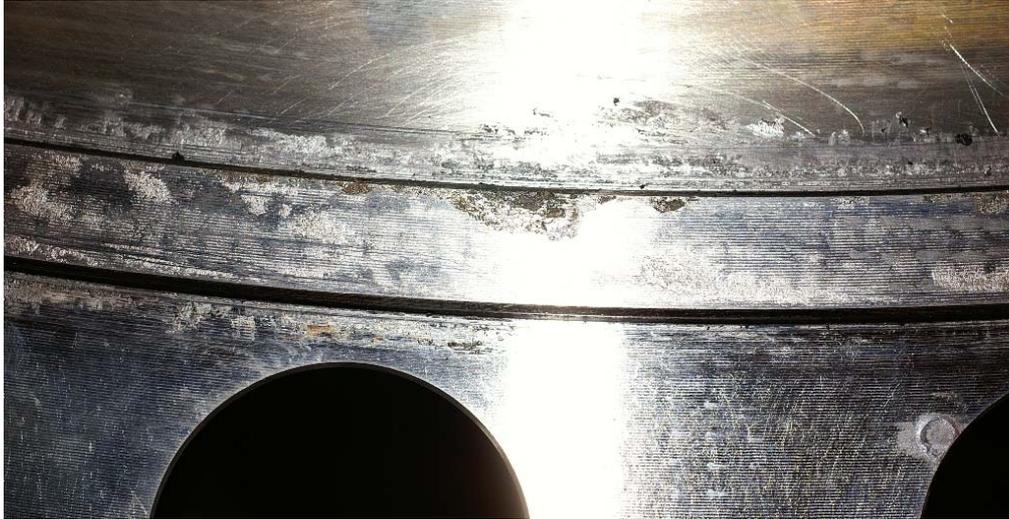
Fig. 1.4

But after two months of operation, during an inspection of works reception there was very large craters of corrosion on the sealing surfaces (Fig. 1.4). On fig. 1.5 we can see the graphite gasket still in place in the female part and traces of attacks in the immediate vicinity of the gasket.

The manufacturer explained that corrosion by the excessive chloride content of the water. But he finally admitted that the corrosion results from galvanic corrosion due to the couple created by the presence of the graphite gasket whose potential is very high and similar to that of gold or platinum.

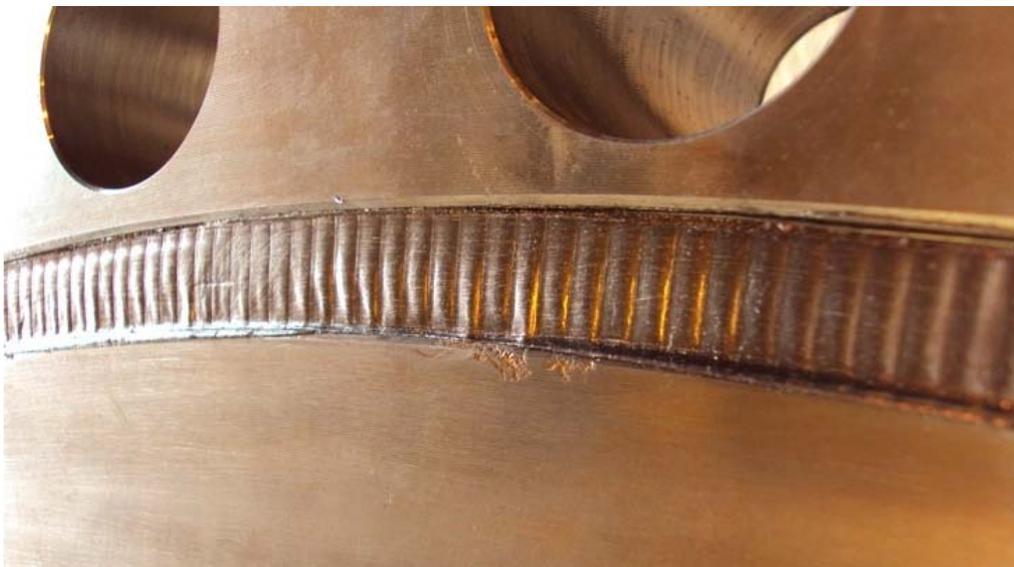
Fig. 1.5 : Female body with the graphite gasket ;
Corrosion craters are visible near the gasket

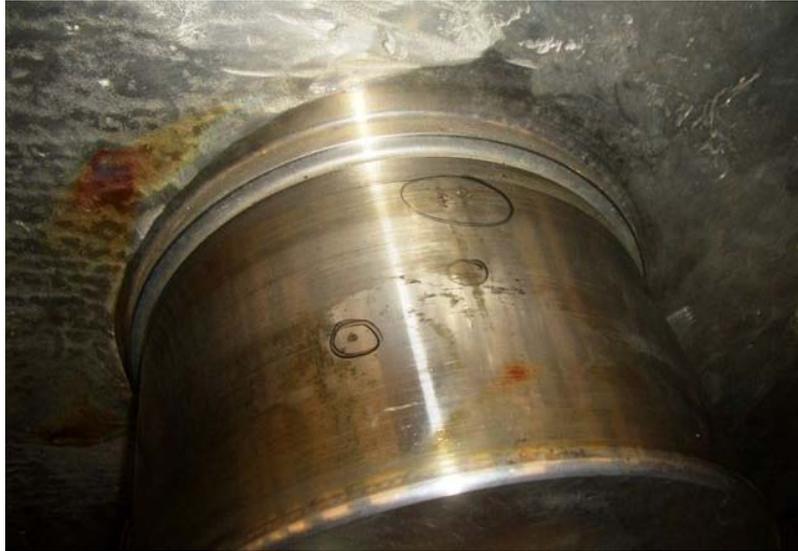
Fig. 1.6

On the other hand, the implementation of this graphite gasket requires special precautions because of the high friability of the material. It was noted that other

points of corrosion had been initiated by graphite dust deposited during assembly (Fig. 1.6).

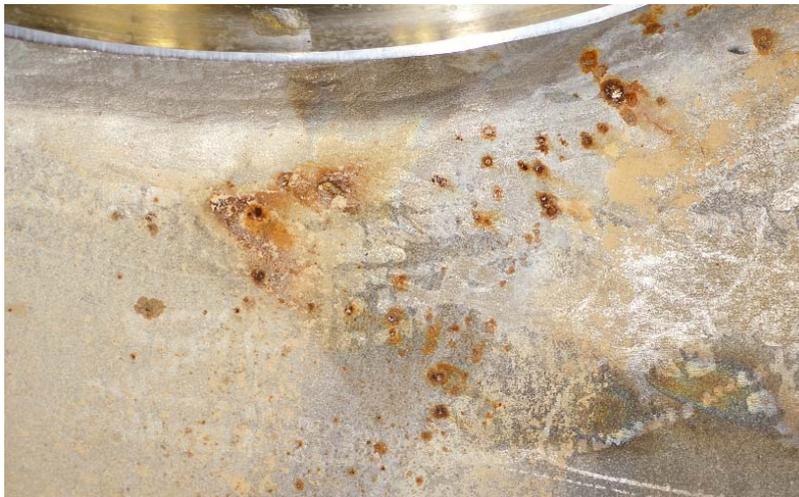
Fig.1.7

Finally, very many points of attack were found on the walls of the valve body both inside (Fig. 1.7) than outside.

This corrosion results from the presence of iron particles or iron oxide on the walls. These particles come from grinding operation of carbon steel or even duplex. Indeed, the workshop of the valves has no dedicated area for stainless steels work and flying particles during grinding castings can reach the walls of adjacent valves during machining.

During transport by sea between Finland and Libya, the iron particles on the surface of the valves were oxidized in contact with the salty air. Thus, when opening containers arriving on site, the valves appeared already corroded.

While taking into account the thickness of the walls, these points of attack have no effect on durability of valves, we asked to conduct a pickling followed by passivation mainly to preserve the aesthetics of the stainless steel.

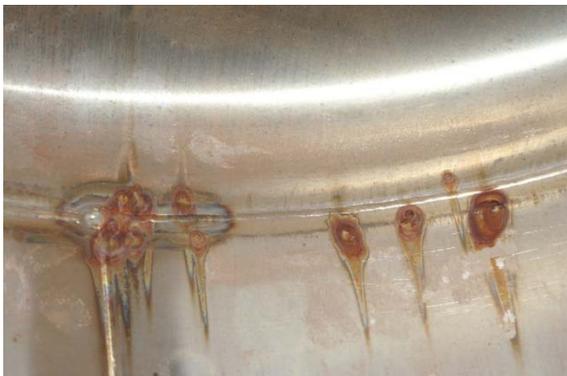
Fig. 2.2

The openings observed on the tanks walls are linked to the pitting corrosion of metal mainly localized close to the weld in the heat affected zones (HAZ) (Fig. 2.2). Some other attacks are also observed on the solid sheet walls, but they rarely lead to perforations (fig. 2.3).

The openings appear after a few months of service and are usually located in the HAZ adjacent to the upper circular weld where the water is the warmest.

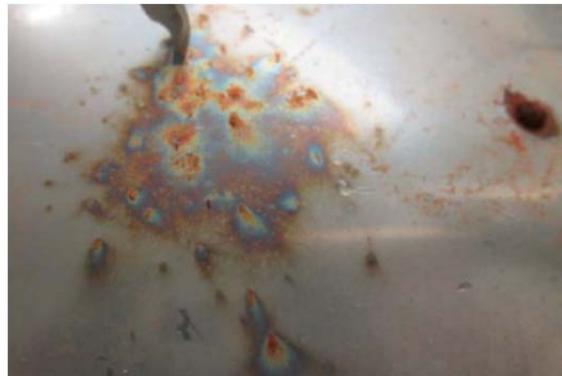
Fig. 2.3

These pitting of the solid sheet are related to ferrous pollution that result from:

- The grinding of welds presenting irregularities,
- The deposit of dust of mild steel, machining of the two types of materials being carried out in the same room,
- From iron deposits coming from the degreasing bath that is common to both types of materials.

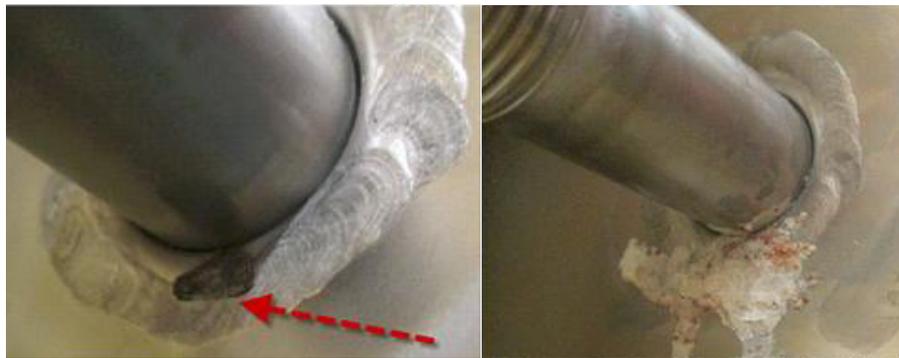
Fig. 2.5

However intergranular corrosion appeared after 9 weeks of testing on one of the two tested tanks. This corrosion led to the perforation of the wall two weeks after (fig. 2.5).

This intergranular corrosion is due to the presence of unremoved grease on the walls of the elements in steel 1.4521 that is carbonized during welding. The carbon formed during welding leads to the formation of titanium, chromium or silicon carbides which precipitate in the grain boundaries.

A: Black deposits
appearing after 9 weeks

B: Pitting appearing
two week after

It therefore appears necessary to improve the degreasing process currently applied and to extend it to the all elements before welding.
