Quality control in the passive corrosion protection – the coating inspector

Hilmar Jansen, Andre Graßmann, Open Grid Europe GmbH, Germany

Dr. Thomas Löffler, Kebulin-Gesellschaft Kettler GmbH & Co. KG, Germany

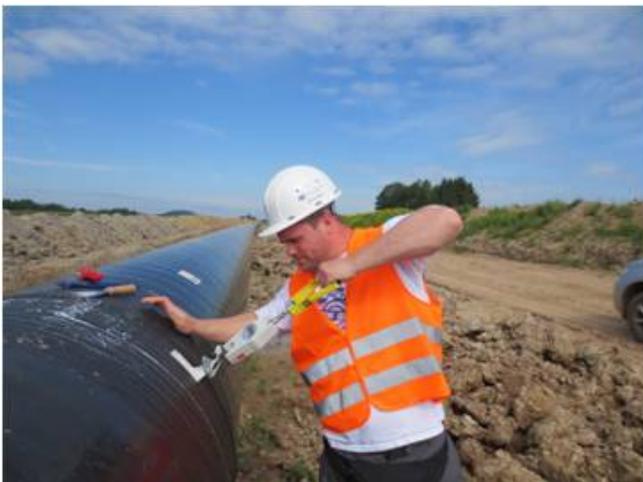
Figure 4: Destructive testing –peel resistance on cold applied PE/butyl rubber fjc

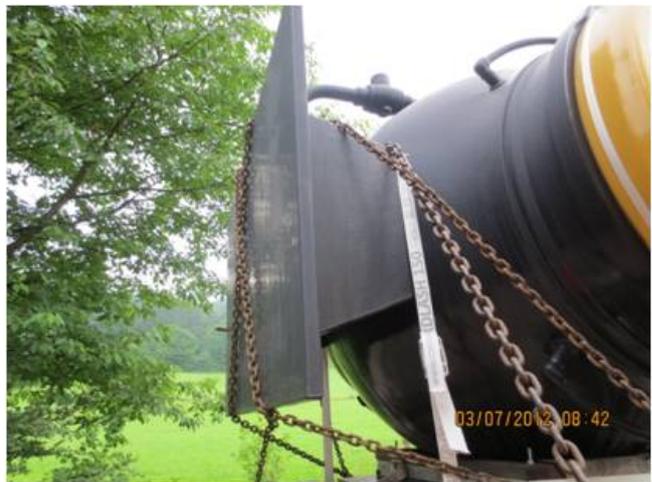
Figure 5: Coating damage during transport at valve support

- 16% of observed discrepancies were due to mechanical damage whereas 42% of these defects are caused during grid welding due to inaccurate deposition of welding equipment on the adjacent factory coating of the pipe ends
- 14% were poor or non-specification conform paintings / coatings. 94% belong to faults and non-conform mixing ratios of polyurethane coating of pipe fittings and valves
- 5% refer to damage caused during transport and 90% have been detected on transported valves and pipe fittings
