Stockholm (Sweden) 3th – 4th June 2015

## **Asset Management of drinking water reservoirs**

FoWa - Research Project: Corrosion and spots on wall

*by Adrian Rieder (Water Supply Zurich, Switzerland)*

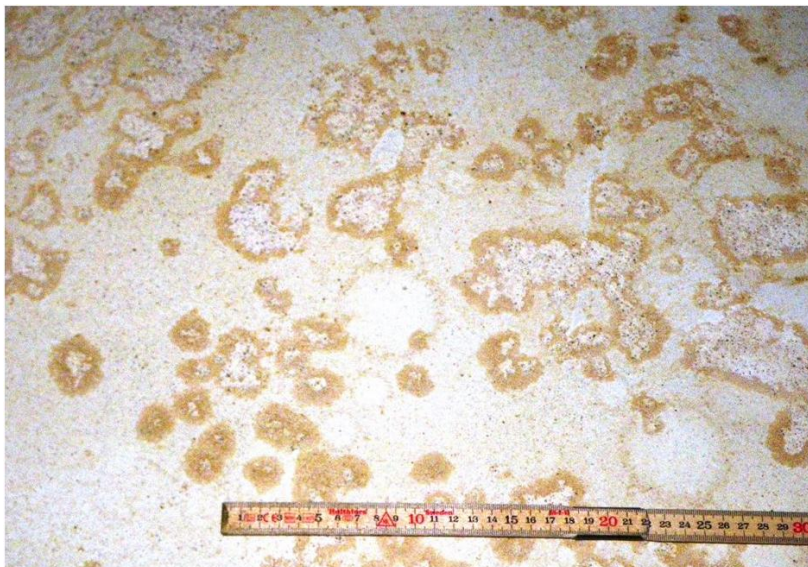
But the practical experience shows, however, that even with careful planning and construction with qualified materials, brown spots may become visible on the cement mortar lined walls within only a few years.

**Bild 1** Fleckenbildung in Reservoirs (70 % Grundwasser/ 30 % Quellwasser pH 7.2  
Formation of brown spots (70 % GW, 30 % SW, pH 7.2, 37 °fH), Picture: SGK

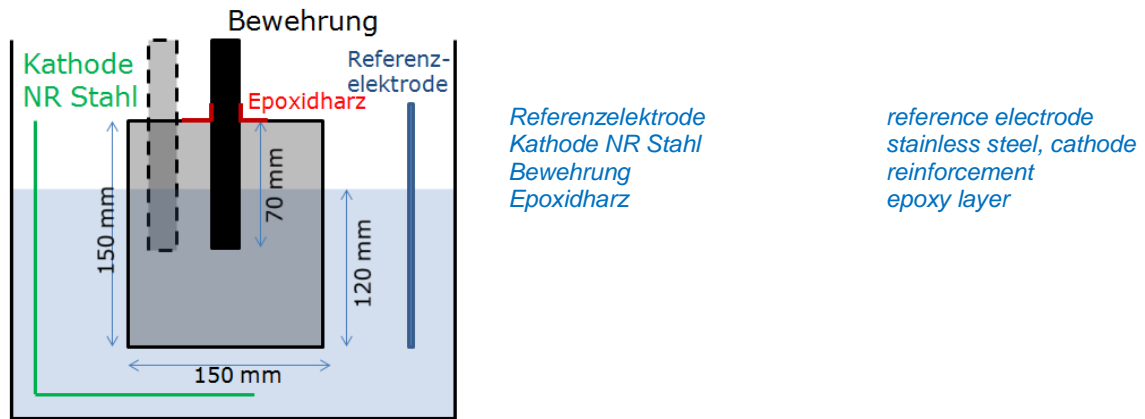
Abbildung 1 Versuchsaufbau für die Makroelementkorrosion, Skizze SGK  
Experimental setup for macro element corrosion simulation

The results show that the corrosion has stopped on all concreted rebars. The time until the corrosion stops depends on the used concrete quality for the four concrete cubes (cement CEM I and CEM II, water/cement ratios 0.60 and 0.45).

There is no corrosion if the reinforcing bar is properly bedded in concrete even with an electrical contact to stainless steel. Due to the inhomogeneous concrete structures and quality defects during concreting on construction sites, an electrical isolation of the metals is recommended and helps to prevent damages.
