Accelerated Corrosion Under the Combined Influence of SRB and Anodic Interference - a Case Study

During the construction of a new water pipeline, a section of the pipeline was subject to anodic interference from a nearby pipeline under cathodic protection which it crossed.

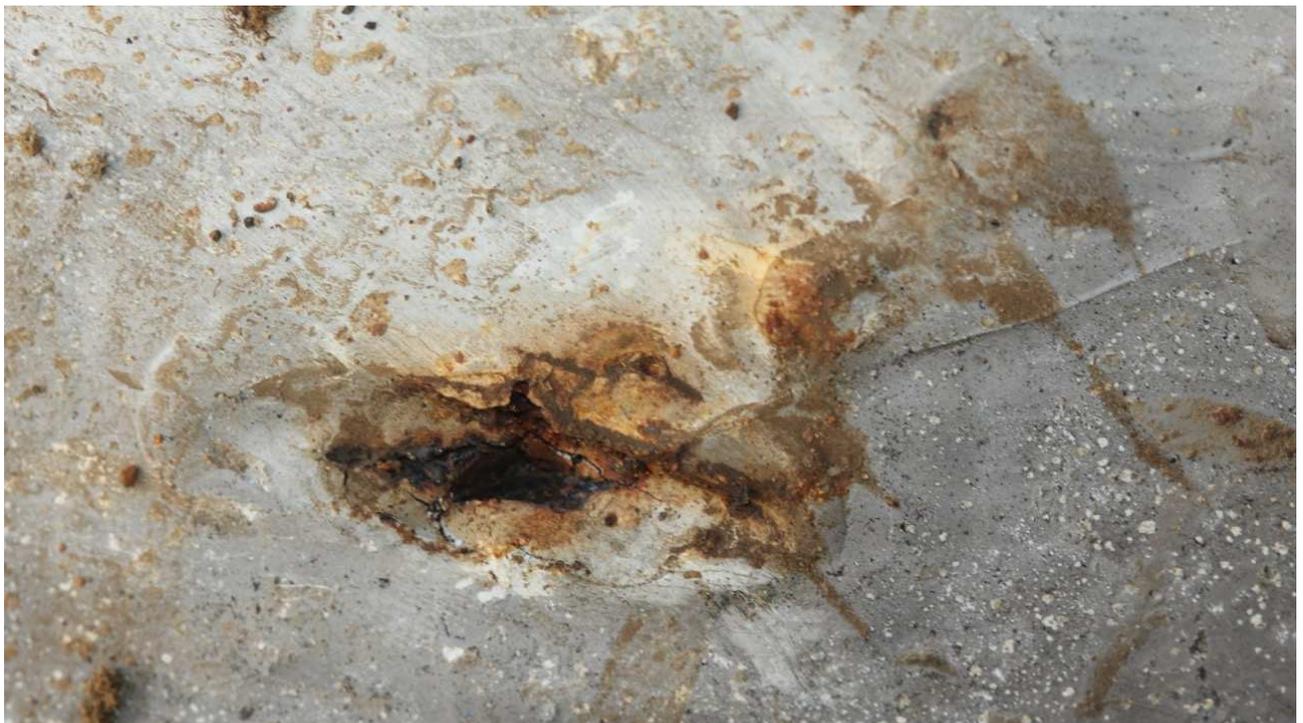
Corrosion site at location of coating damage prior to examination.

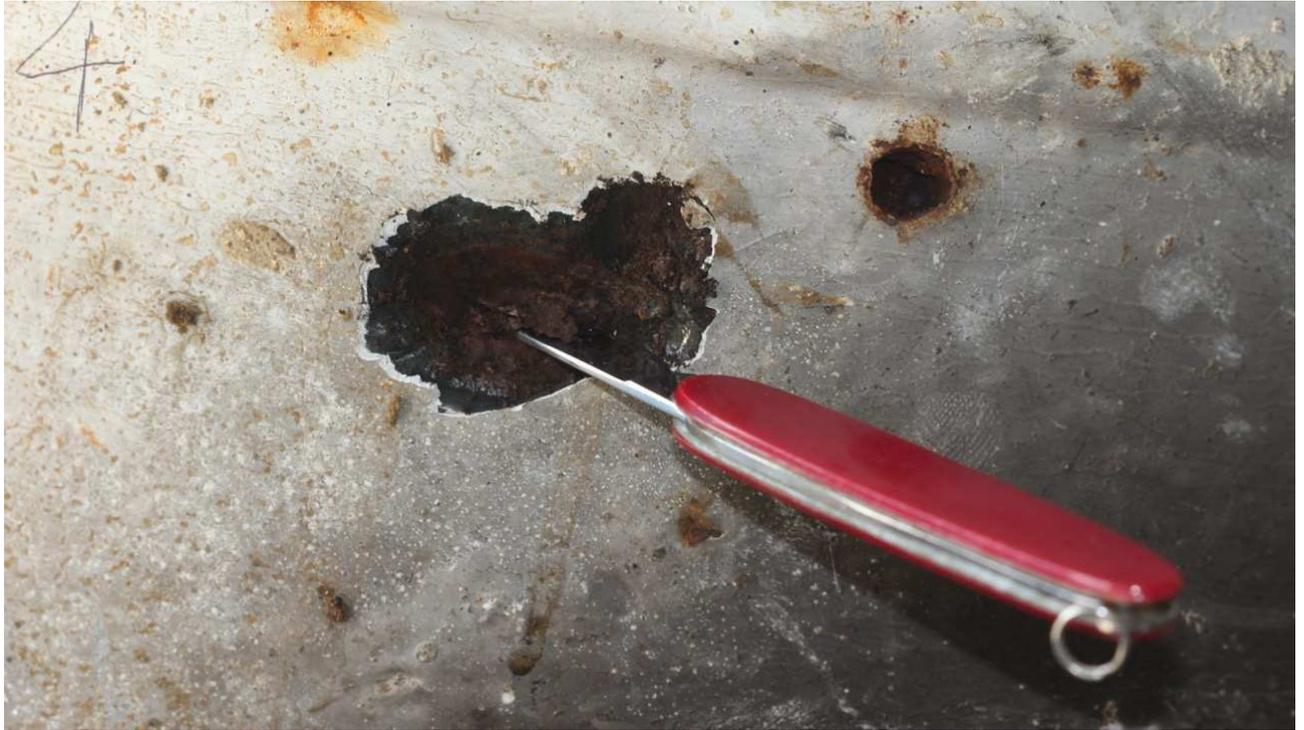
Corrosion pit beneath coating filled with corrosion product.

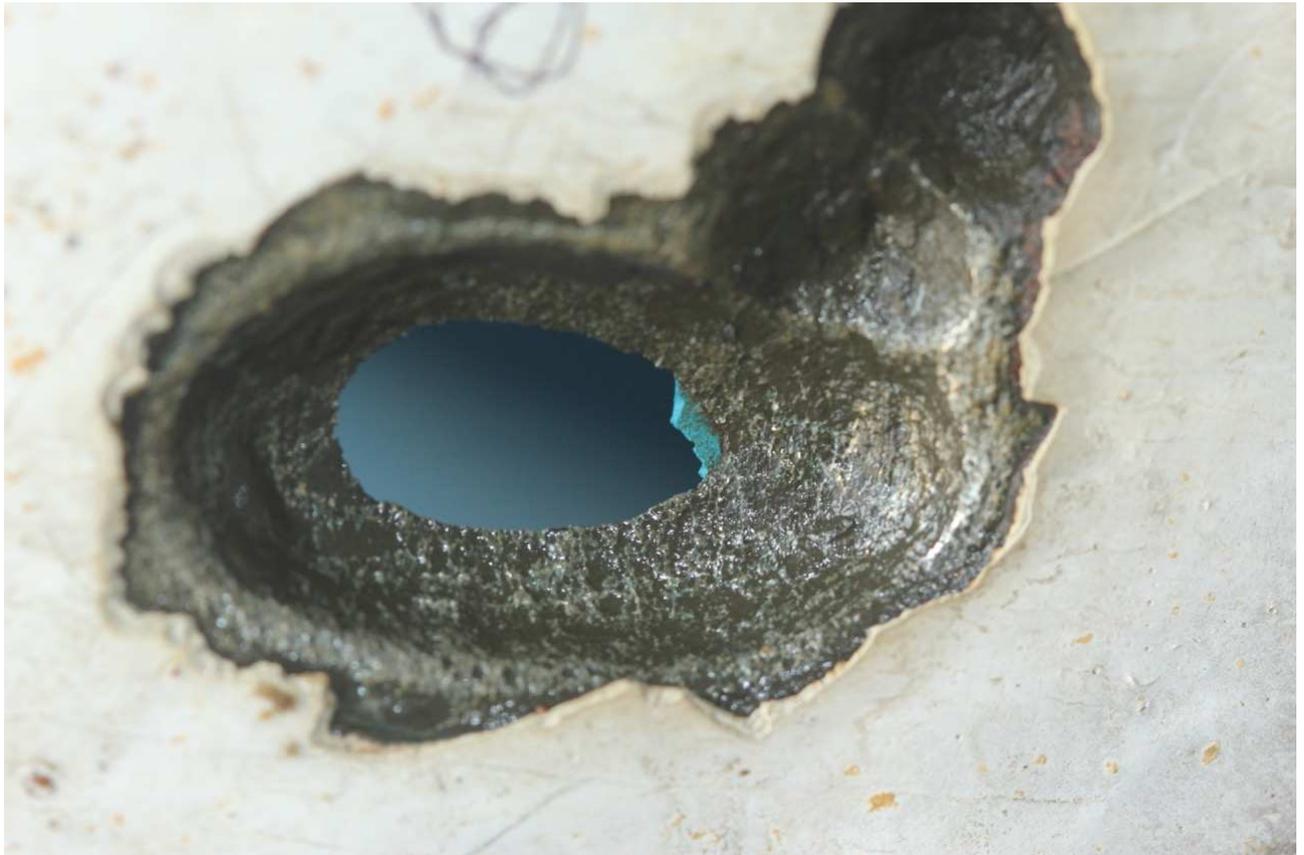
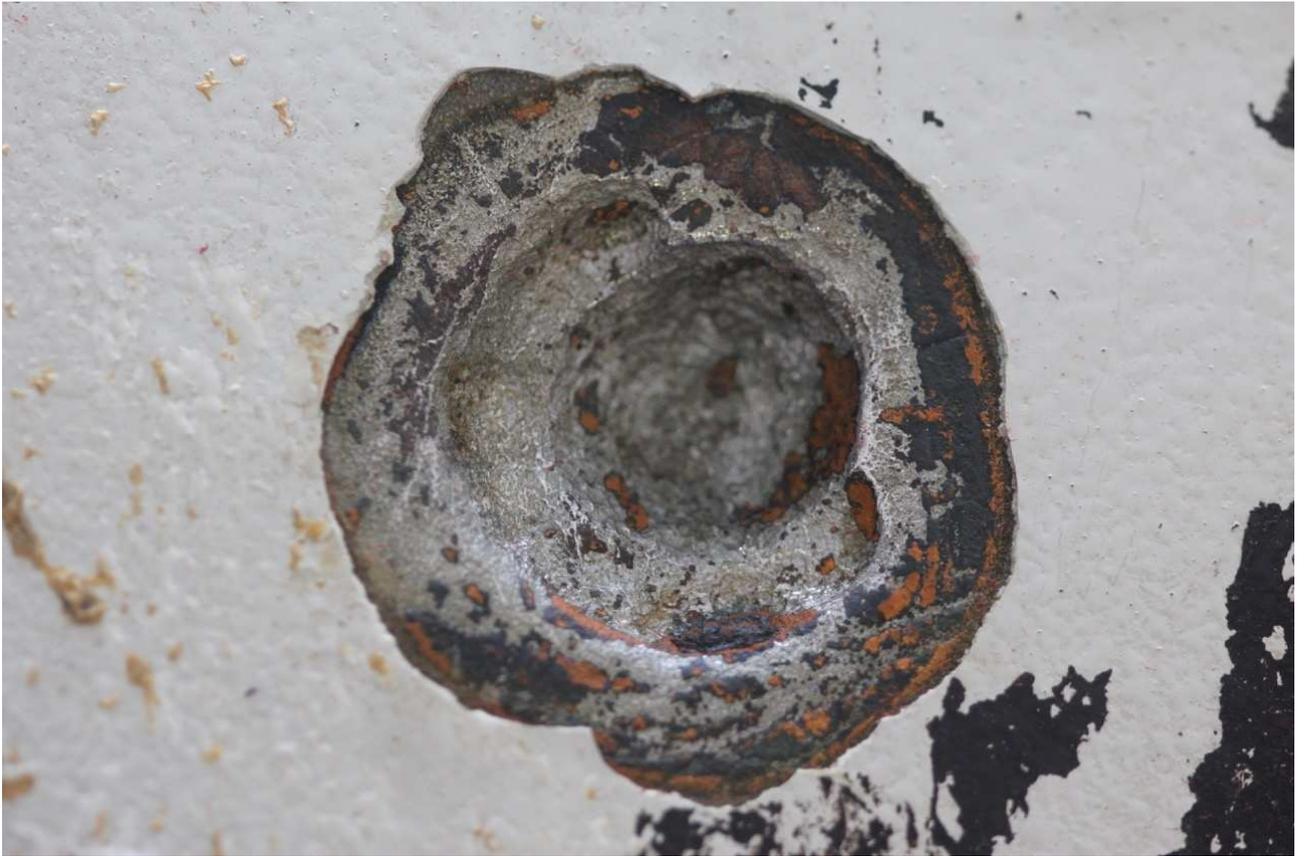
The morphology of the corrosion was typical of bacterial corrosion in that the corrosion pits were filled with black corrosion product which could easily be removed, leaving a shiny steel surface exposed. The base of the pits also had a characteristic scalloped

appearance. This black corrosion product rapidly oxidised to the familiar red-brown hydrated oxides on exposure to air. These characteristics are peculiar to sulphate reducing bacteria (SRB) corrosion.

Corrosion pits showing shiny scalloped surface after removal of corrosion product

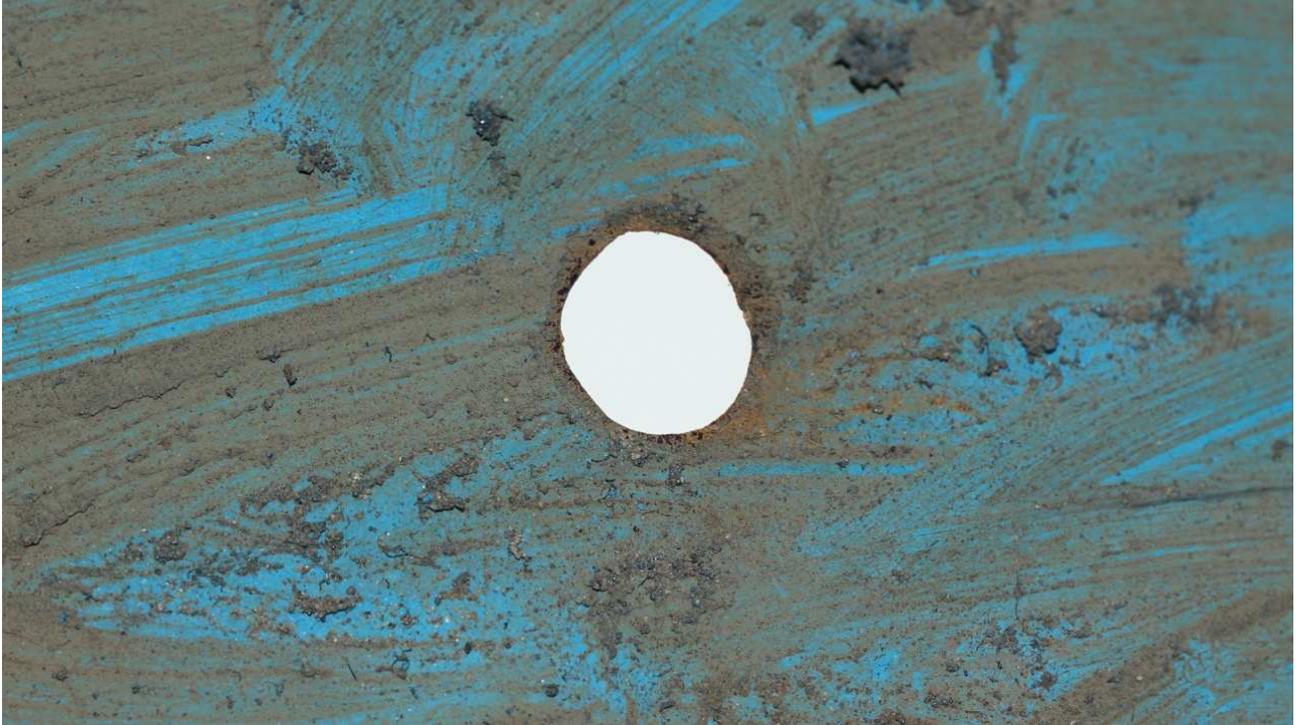
Internal view of corrosion perforation.

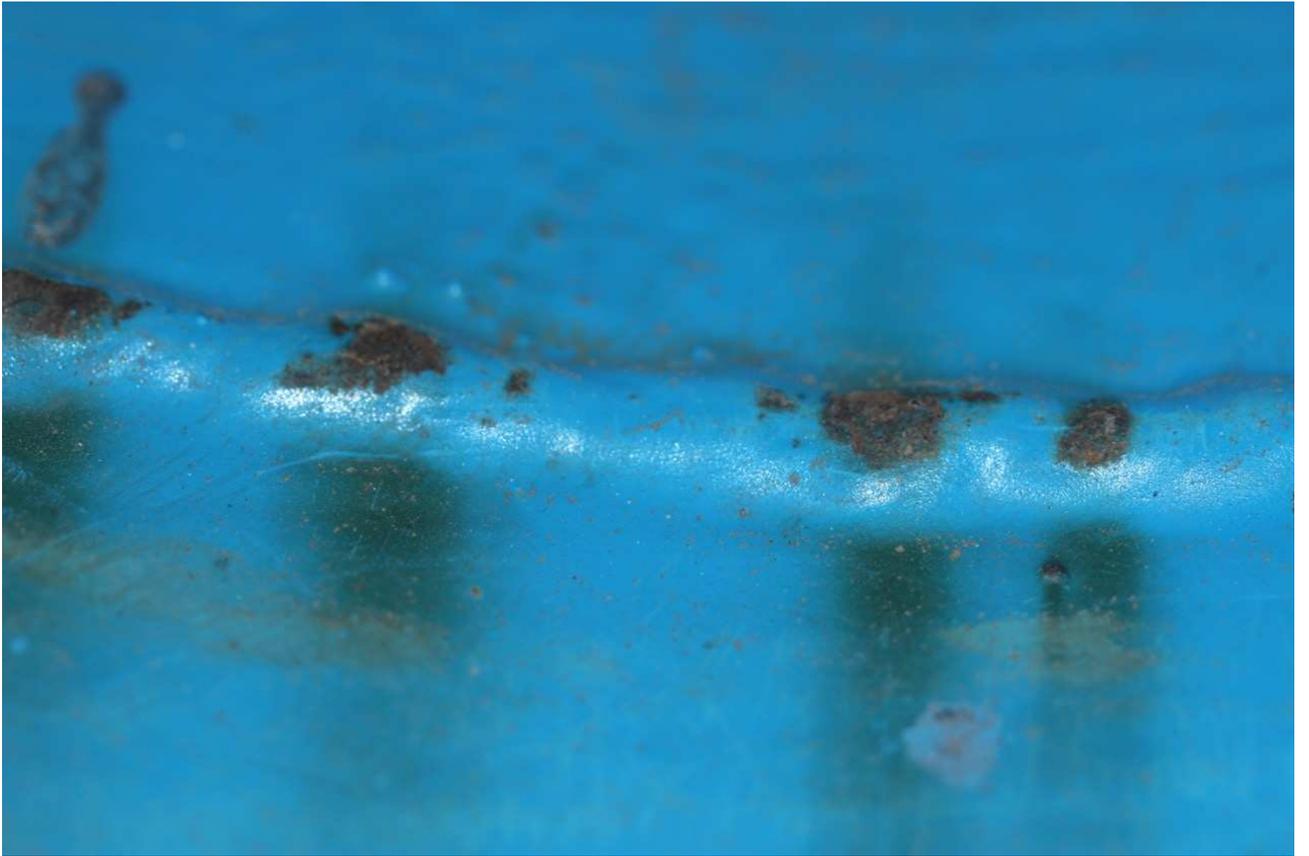
Internal corrosion at defects on internal weld - not significant.

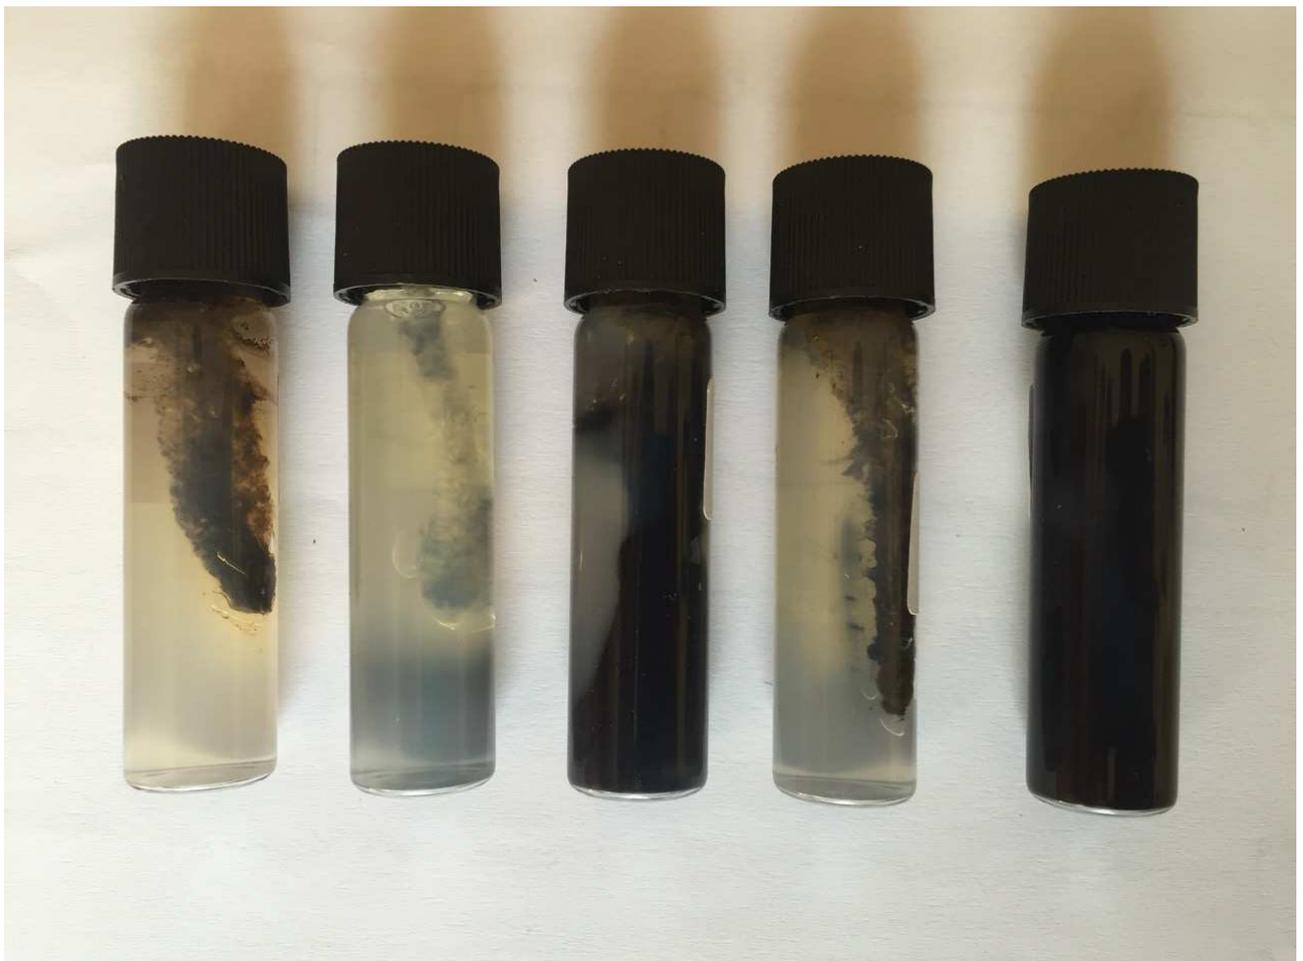
Samples were taken from the various corrosion pits on the outside of the Tee. Positive results were found in 3 of the 5 sites tested. The photograph below shows the results of the SRB tests.

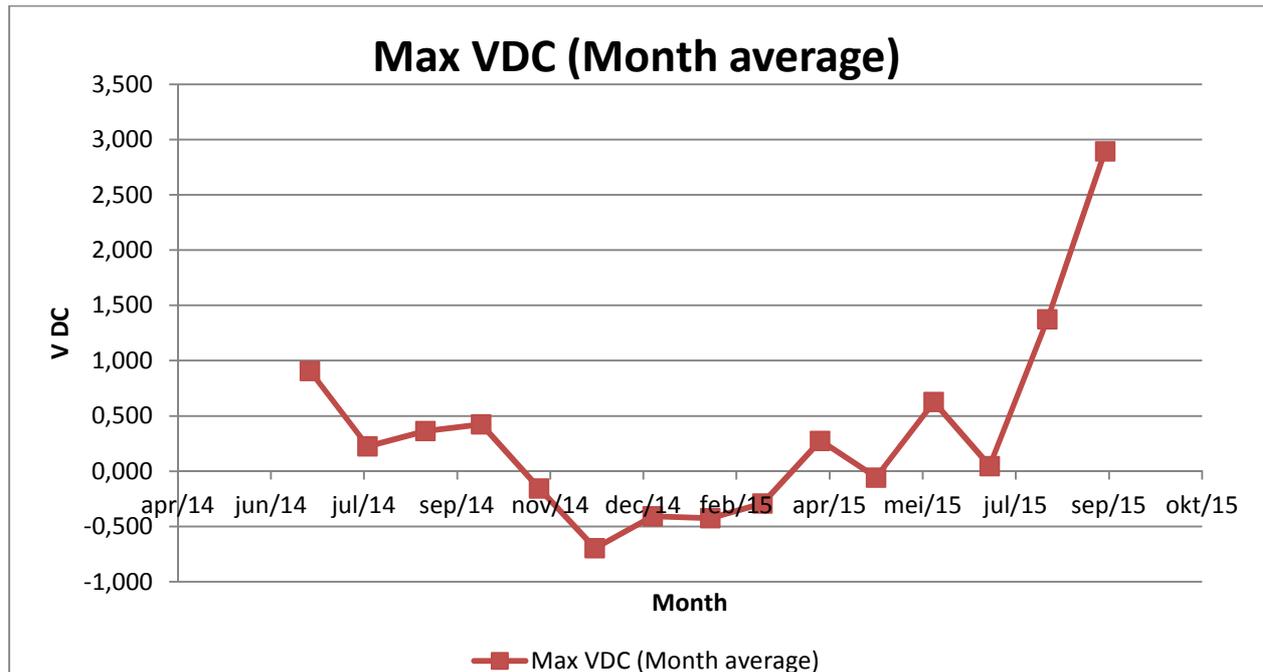
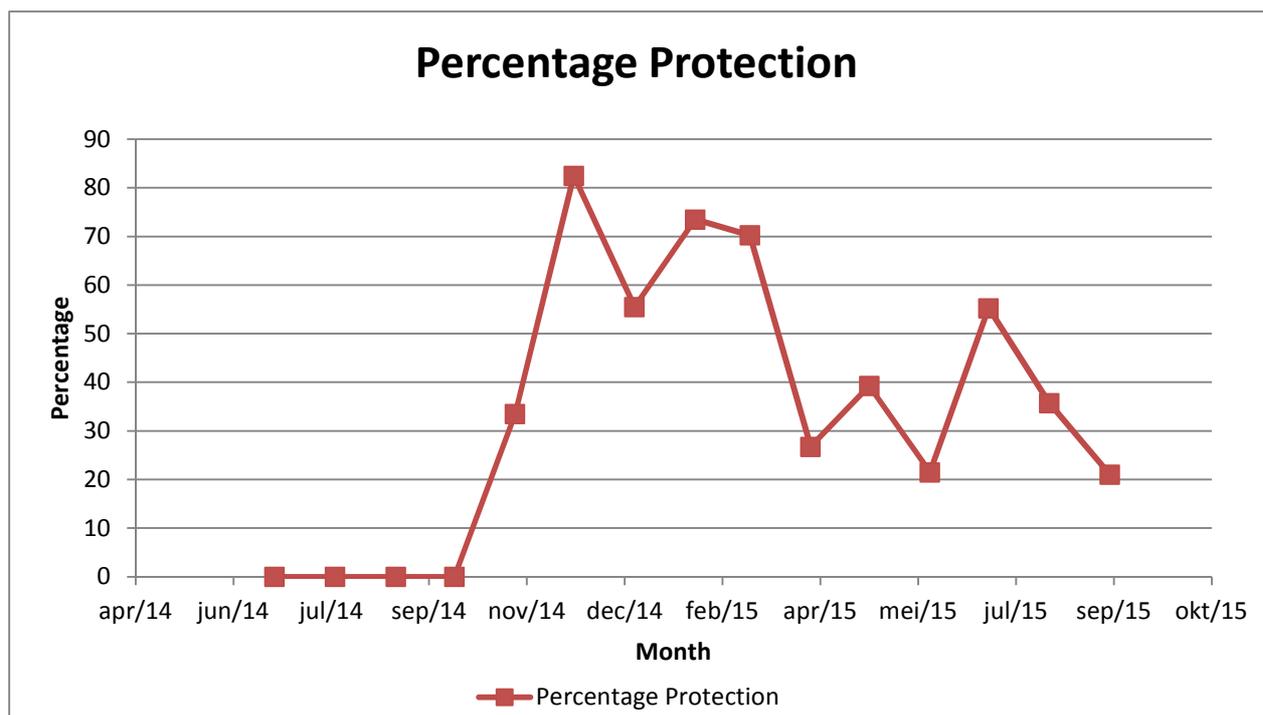
At the time of the inspection, the pipeline potential at the scour Tee was +2V (**two volts positive**) (CSE) and the temporary cathodic protection which had been installed was not operational.

The potential history of this section of the pipeline is shown in the graphs below, which have been taken from the monthly monitoring records for the pipeline.

It is clear from these graphs that this section of the pipeline has been at risk since July 2014 when it was installed.

- The perforation of the Tee was caused by external corrosion at coating defects.
- The corrosion mechanism was bacterial corrosion, exacerbated by anodic potentials resulting from the influence of the nearby cathodically protected pipeline.
- Temporary cathodic protection during construction at this location had not been implemented.
- Coating defects on the internal lining showed the onset of corrosion, but no significant metal loss had occurred.
- It is critical that temporary cathodic protection of pipelines must be undertaken and maintained during construction when monitoring data indicates the existence of anodic potentials..
