Failures of insulating joints and spark gaps on the Hellenic Gas Pipeline System - a case study

Hellenic Gas Transmission System Operator (DESFA) S.A.

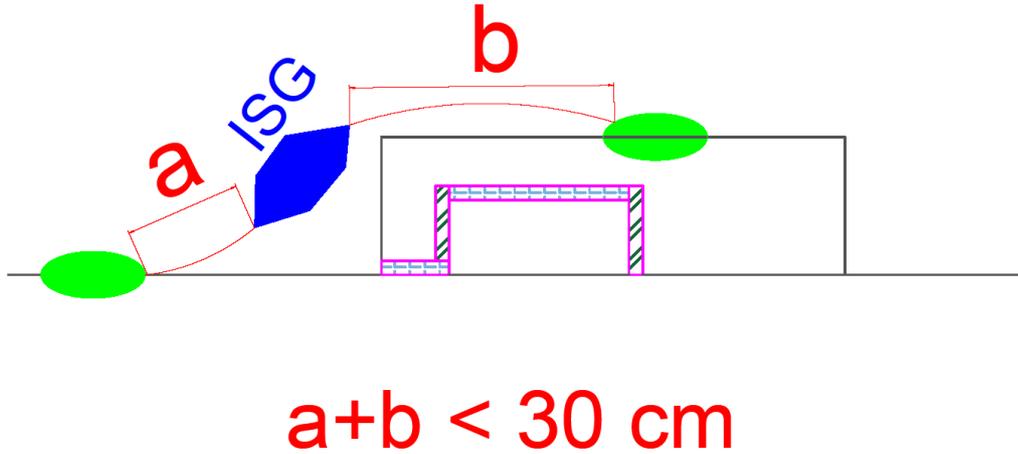
Figure 2: Installation of the ISGs

This failure figure (7/69) was considered a serious problem and an urgent project was launched to ensure that the remaining buried IJs would not fail. The remedial action involved the installation of ISGs on buried IJs of the gas transmission system, except on those IJs that had already failed. The ISGs were connected with 25 mm² cross section wiring with the shortest possible length to reduce their inductive impedance according to Afk no.5 [7] (see Figure 2).

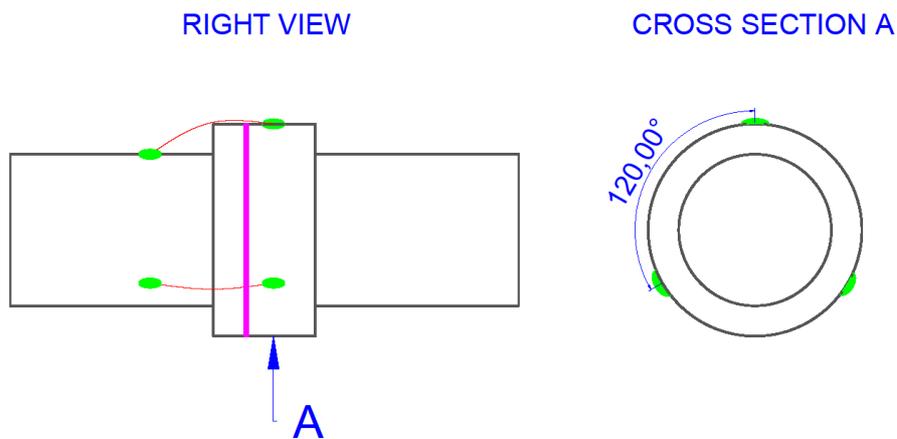
Figure 3 : Bridging of the failed IJs

immediately discarded because of the high inductive impedance of the bridging cable - produced by its relatively long routing and low cross sectional area of these cables [7]. The second option considered was to directly bridge the IJs at their physical installation locations (i.e. underground). The decision to enforce this action on all failed joints took place on February 2013. The bridging was enabled via three short cables of 25mm² pin brazed at symmetric positions around the IJ (see Figure 3).

Through this interim action (i.e. the intentional underground bridging of the faulty IJs), the safety was reassured, since any lightning and fault currents would flow through the short circuit wires. A secondary benefit to the system's operation was that the insulating materials of the IJs would not be overstressed by lightning/overvoltage effects and thus the possibility, of a further damage that would result in a gas leak - through the insulating material - would be minimised. Of course, following the IJ underground bridging option, the CP levels were readjusted accordingly to ensure the protection's effectiveness.

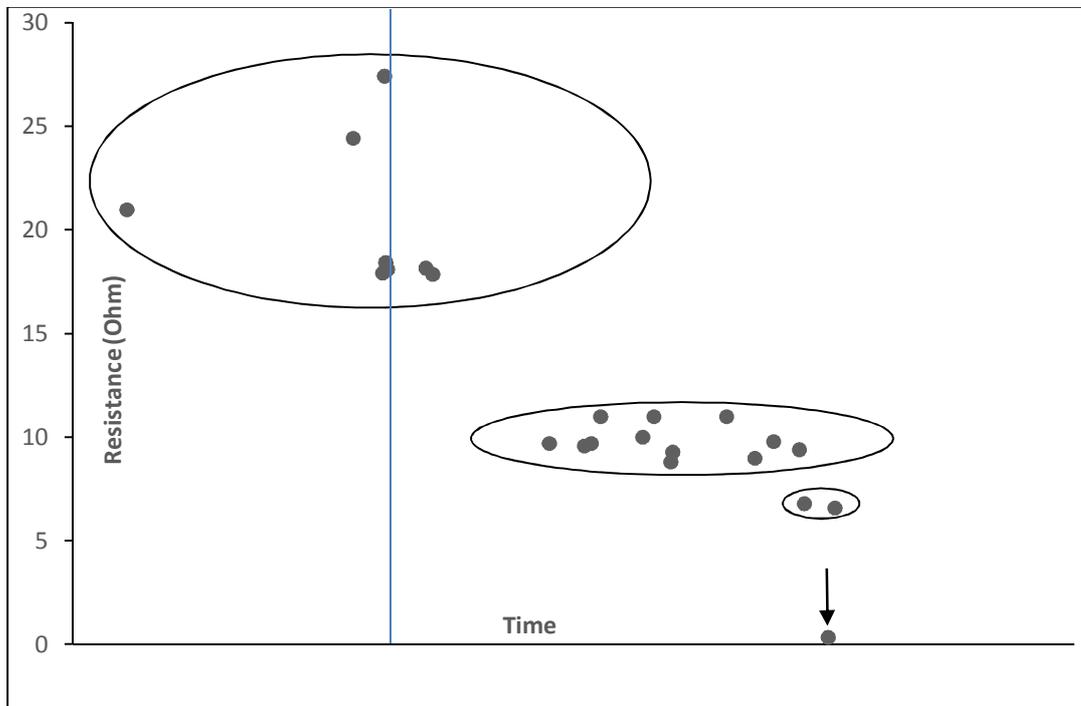
Graph 1 : IJ's Effective Resistance (to Earth Measurements) between CP areas 2-3 through the years

The results shown in Graph-1 can be interpreted as follows:

The effective resistance value of the pipeline sections that fall under CP area 2 and 3 had been gradually diminishing over the years. This diminishing was due to the IJ degradation or due to the pipeline's coating degradation. In either case, the degradation suggests that the pipeline was subjected to electrically hazardous events (i.e. lightning activity, short-term EMI, etc.)

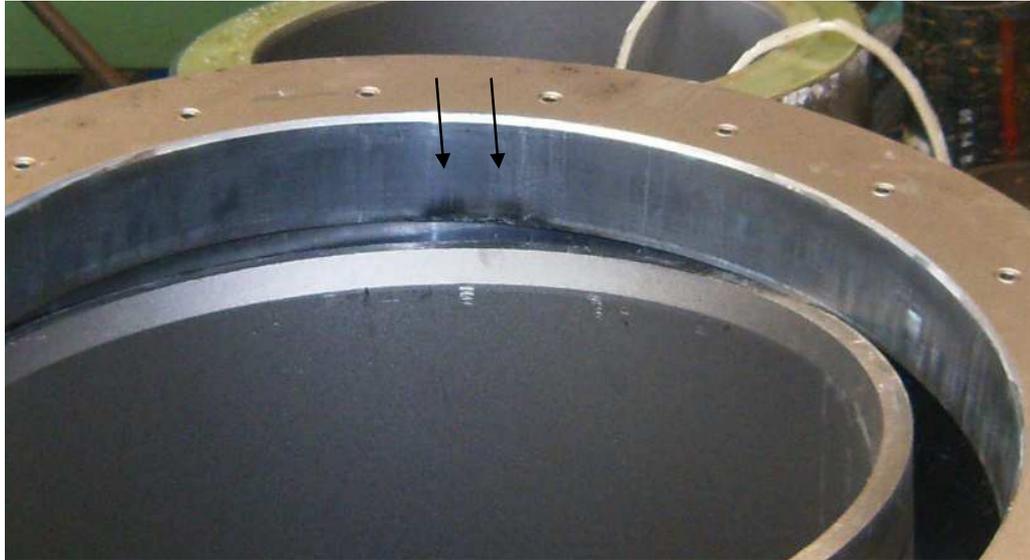
During the disassembling only mechanical pressure was applied in order to separate the IJs parts. After disassembling the IJs, this was one view of the appurtenances. The burnings from the sparkover are visible (see arrows).

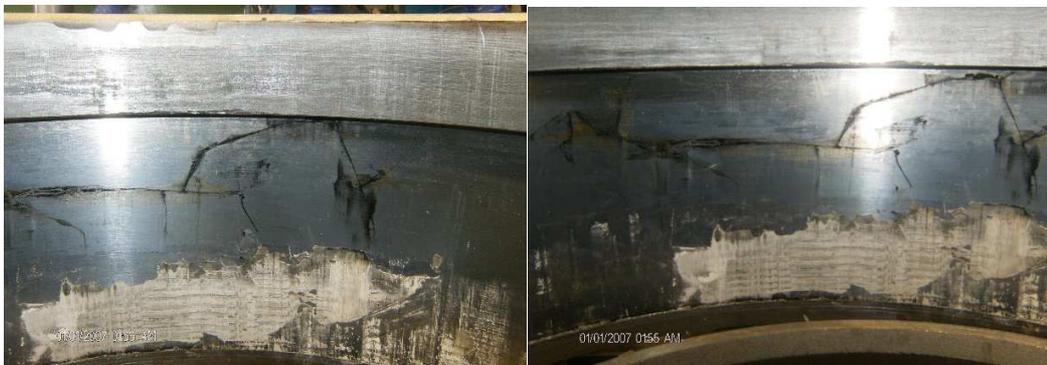
An other view of the IJs main body proves the existence of lightning sparkovers. The shape of the burnings proves indeed that the cause was surge/lightning currents.

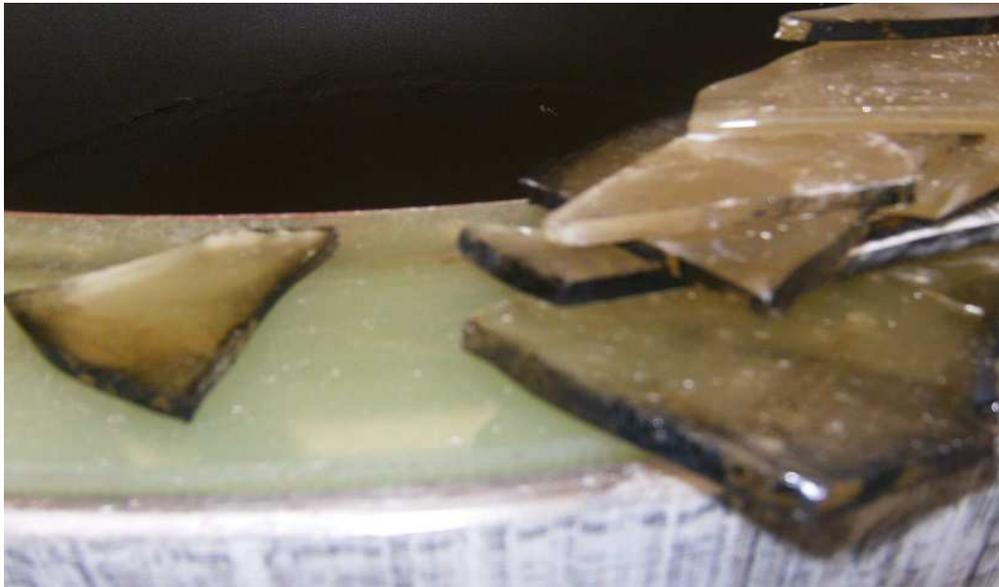
In the following picture we can witness the mechanical damage that was caused by the repetitive lightning strikes.

It is obvious that all insulating properties are lost and that the IJ has been susceptible to non-desirable effects; i.e. further mechanical damage with worst case scenario the creation of arcs when lightning strikes occur.

Important note: Despite this damage the O-rings maintained the sealing properties.
