Corrosion inspection of a DN 1800 mm vertical main pipe

Adrian Rieder, dipl. Ing. NDS-U, Head of water distribution

Water Supply Zurich, 8023 Zürich, Switzerland

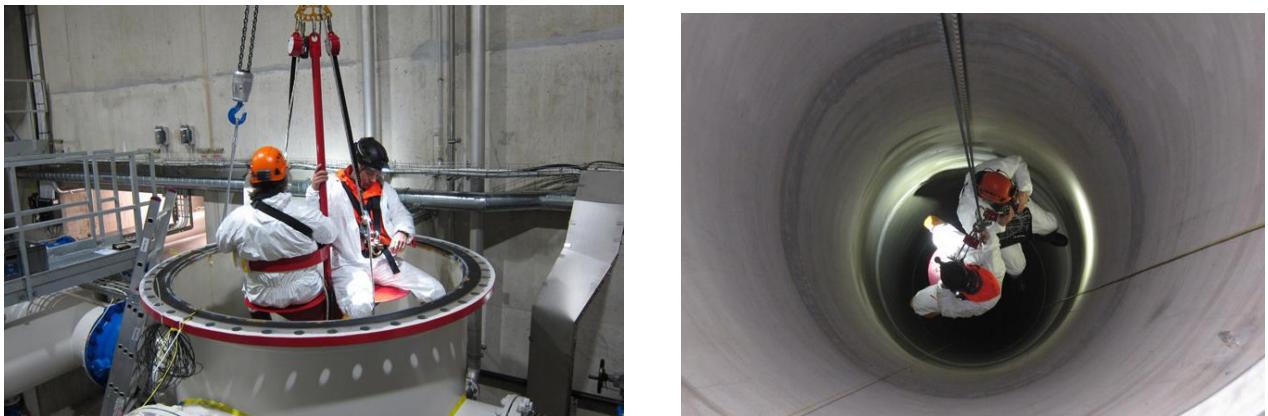
Figure 3: Vertical main pipe „Lyren“, start of the visual inspection (October 2014).

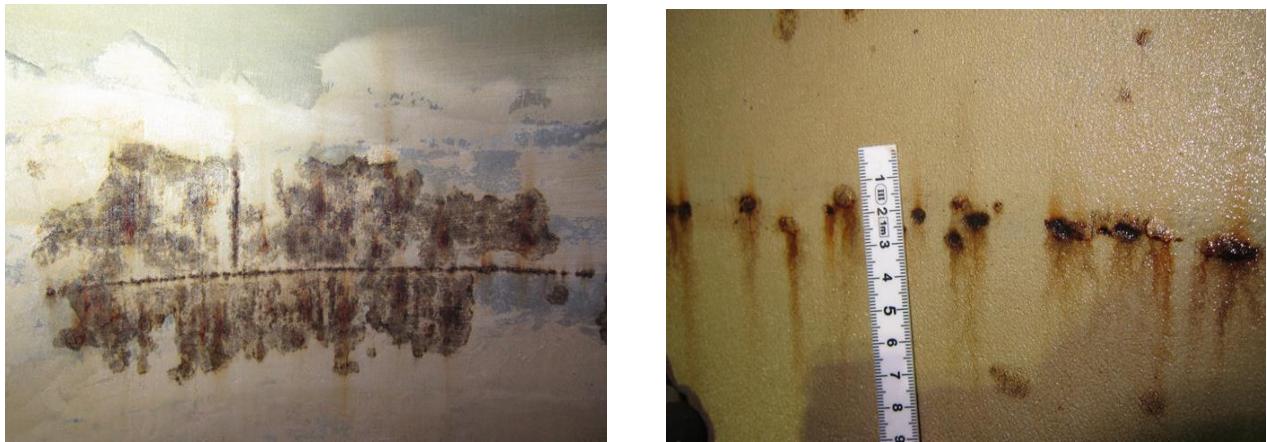
In summary, pitting corrosion at the welding joints and local detachment of cement mortar and blister formation were found. Especially the weld seams were concerned, the internal corrosion was found all over the pipeline. The corrosion problem has already established itself under the mortar layer. However, the dynamics of the corrosion process could not be estimated at this time.

At present, corrosion does not yet present any danger to the operation or safety of the pipeline. The degree of corrosion was difficult to estimate by the visual inspection. It was difficult to estimate the degree of corrosion by visual inspection, but the corrosion protection was no longer fully guaranteed around the joints. This will continue to damage the weld seam. In order to verify this initial inspection of the pipeline shaft, an enhanced inspection of the overall condition must be carried out so that possible rehabilitation options can be prepared and planned.

Figure 4: Pittings and corrosion attacks along the weld seam, local missing of the cement mortar layer (October 2014)

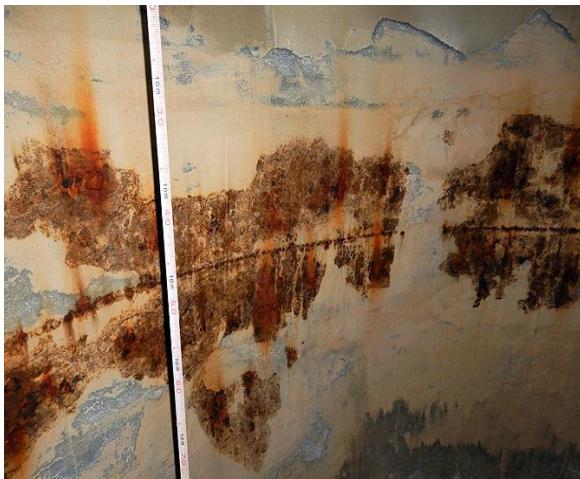
Most of the corrosion attacks are present in the circumferential welding seams. These welds were welded on site. Areas with brown rust spots are often visible over the entire circumference of the manually applied cement mortar coating, there the covering is very slight in places and less than 1 mm thick locally. Probes in these areas shows that below the dark and brown colored mortar areas, the steel surface shows black and brownish corrosion characteristics. These are surface corrosion attacks with very low material removal. The corrosion depth is only 0.1 mm to 0.3 mm. In a few places brown rust blisters were present, but the leaking water was pH neutral. There are areas with cracking, sometimes limestone and/or brown discolorations are visible and the mortar is hollow. At these places corrosion with small depth on the steel are present. Local softening of the mortar surface was found in a few places.

Figure 7: Typical corrosion attacks along welding seam

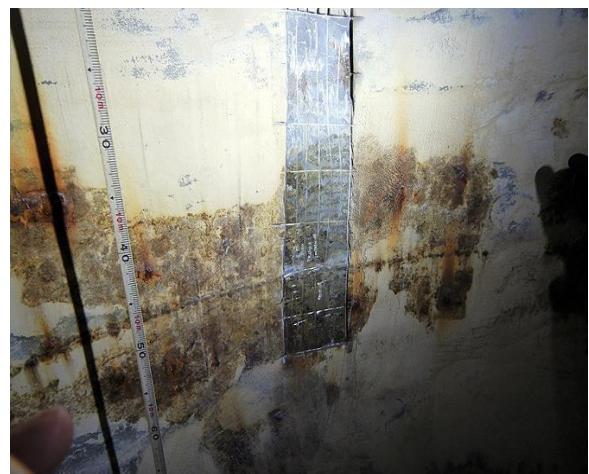
The layer thickness of the mortar and the wall thickness of the steel pipes were measured selectively. However, the measurement of the steel pipes does not allow any conclusions about corrosion on the outside of the pipe. The measured wall thicknesses correspond approximately to the nominal values for the original steel pipe. The layer thicknesses of the mortar coating is partially too thin, not enough mortar was applied here by hand.

Figure 8: Only minor attacks are visible under the exposed mortar
