Detection of coating damage on buried pipelines using an electrochemical method

Abstract

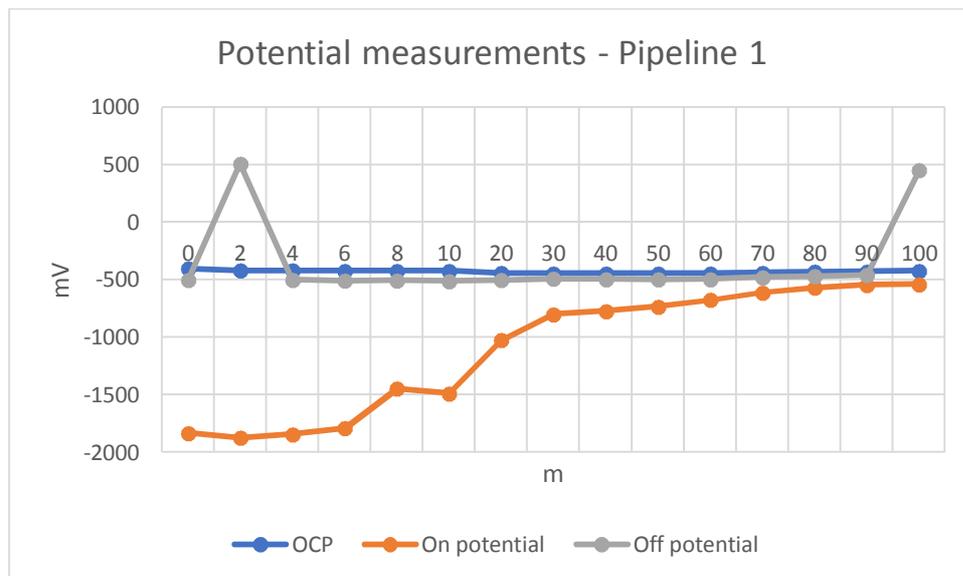
The results of the OCP measurements on pipelines 1 - 3 showed that they probably had electrical contact with copper earthing systems: the OCP values ca -400 mV, see Table 2 to Table 4, and Figure 3 to Figure 5. Therefore, it was not possible to determine the presence of any possible coating damages at these locations.

Figure 3 - Results from the potential measurements of pipeline 1.

For the other pipelines investigated it was not possible to obtain meaningful polarised potentials or potential gradients using the method due to the presence of earthing systems connected to the pipelines. In order use the method on such pipelines one option would be to remove the connection to the earthing systems if possible prior to the measurements.

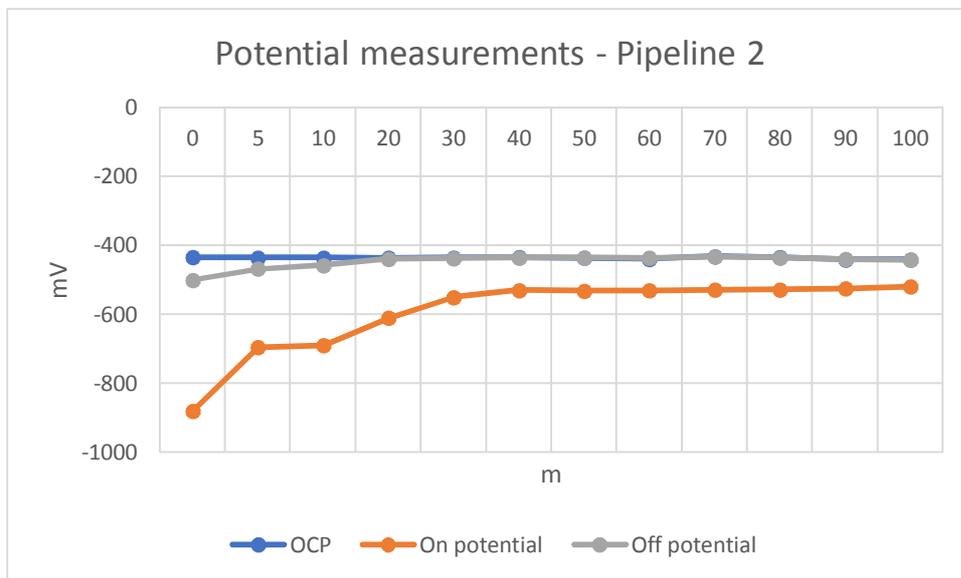
Figure 4 - Results from the potential measurements of pipeline 2.

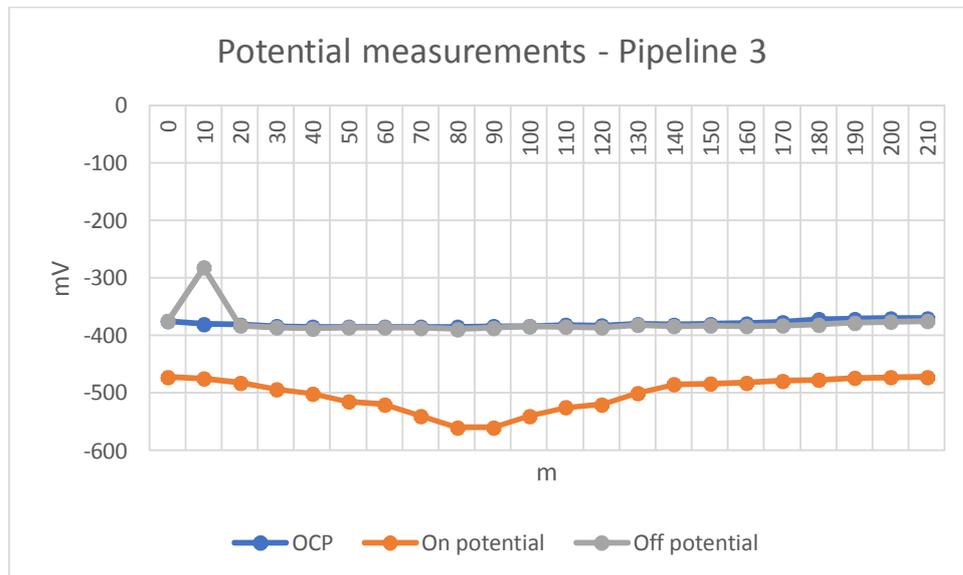
Figure 5 – Results from the potential measurements of pipeline 3.

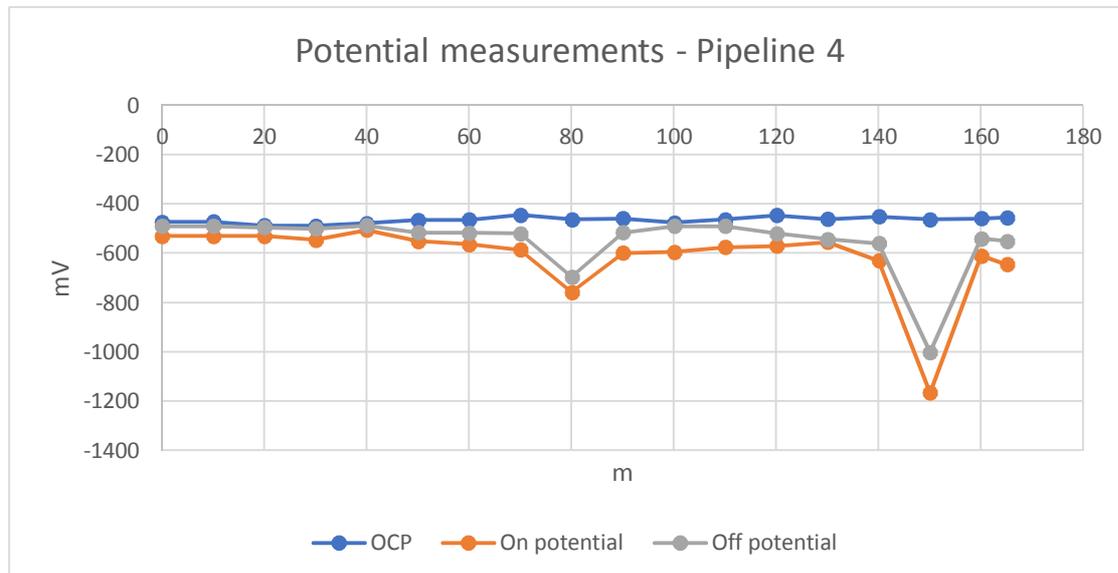
For pipeline 4 the OCP was between -446 mV and -489 mV. When current was applied to the pipeline the potential was polarized to between -530 mV and -1165 mV, see Table 5. Two locations had significantly more negative “on potentials”, located at 78 m and 147 m along the length of the pipeline. The “on potentials” were measured as -757 mV and -1165 mV respectively and equates to a polarisation of 295 mV and 702 mV respectively from the OCP measurements, see Figure 6. It was therefore noted that these locations could be possible sites of coating damage.

Figure 6 - Results from the potential measurements of pipeline 4 showing the two suspected locations of coating damage

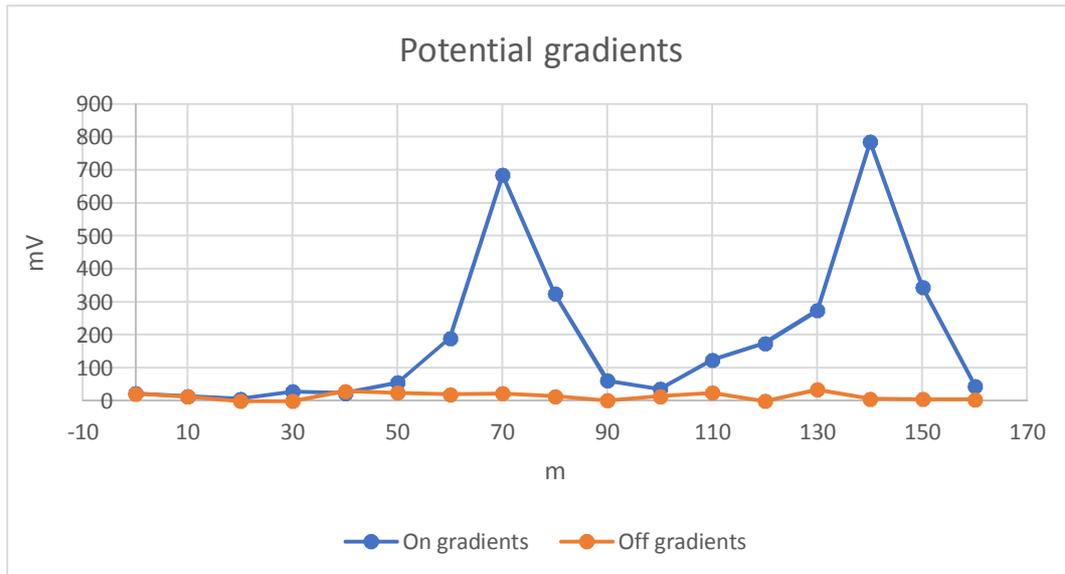
the second location (500 m distance) it was not possible to measure any potential gradients or change of the OCP when current was supplied to the pipeline. This indicated that the current supplied was being conducted to nearby structures in the soil that were earthed and in contact with the pipeline. On pipeline 3 measurements of the potential gradients showed large differences between the reference electrodes when current was supplied to the pipeline. This indicated that the pipeline was in contact with copper earthing equipment. Structures such as lamp posts and substations etc. that have earthing equipment will conduct the current intended for the pipeline during the measurements. On pipeline 4 the potential gradient measurements showed that when current was supplied the gradients increased significantly at the two locations that were suspected as being coating damages from the OCP and polarized potential measurements (at 78 m and 147 m along the length of the pipeline). See Table 6 and Figure 7 . No other changes in gradients were observed in the measurement data.

Figure 7 - Results from the potential gradient measurements of pipeline 4 showing the increasing gradients at the two suspected locations of coating damage.

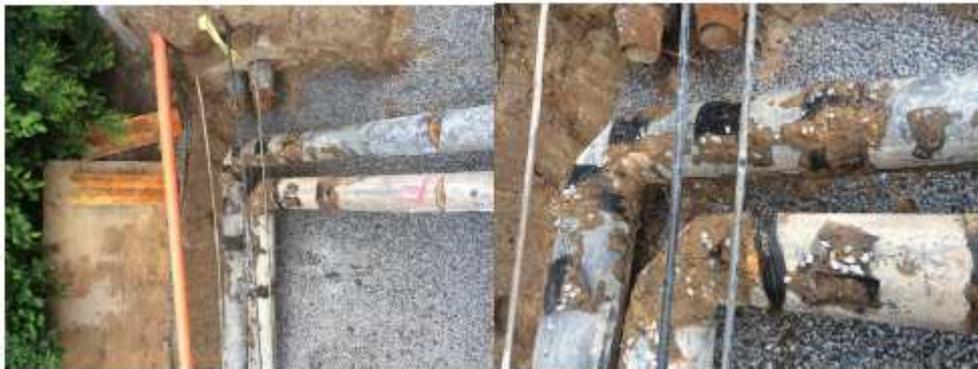
The two locations suspected of having coating damage on pipeline 4 (78 m and 147 m) were excavated in order to carry out a visual inspection of their condition. At both locations it was found that the pipeline was coated with tape. The tape at both locations had detached and the steel of the pipeline was in direct contact with the surrounding soil and had visible corrosion products on its surface, see Figure 8 and Figure 9.

Figure 8 – Visual appearance of the suspected coating damage after excavation located at 147 m along the length of pipeline 4.

Suspected coating damages on a buried district heating pipeline have been successfully located by first characterizing the OCP and then polarising the pipeline and measuring the potential gradients along its length. After excavation it was found that the locations were field joints that had been protected with tape which had detached, and the underlying steel had corroded.

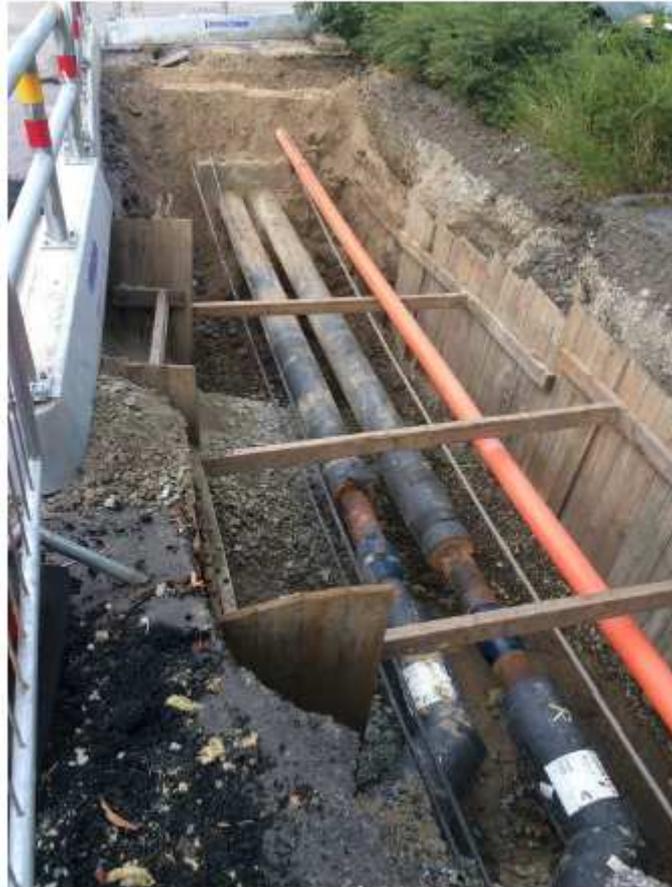
Figure 9 – Visual appearance of the suspected coating damage after excavation located at 78 m along the length of pipeline 4.
