**Paper 2021-20**

**Pipeline Integrity Maintenance and Diagnosis, with particular regard to Stress Corrosion Cracking**

*by Lucio Di Biase (Scientific Consultant, Milano, Italy)  
Osvaldo Fumei (Solaria, Calvi, France)  
Samuel.Lewis (University of Denver, 2199 Blvd Denver, CO 80208, USA)*

## Pipeline Integrity Maintenance and Diagnosis, with particular regard to Stress Corrosion Cracking

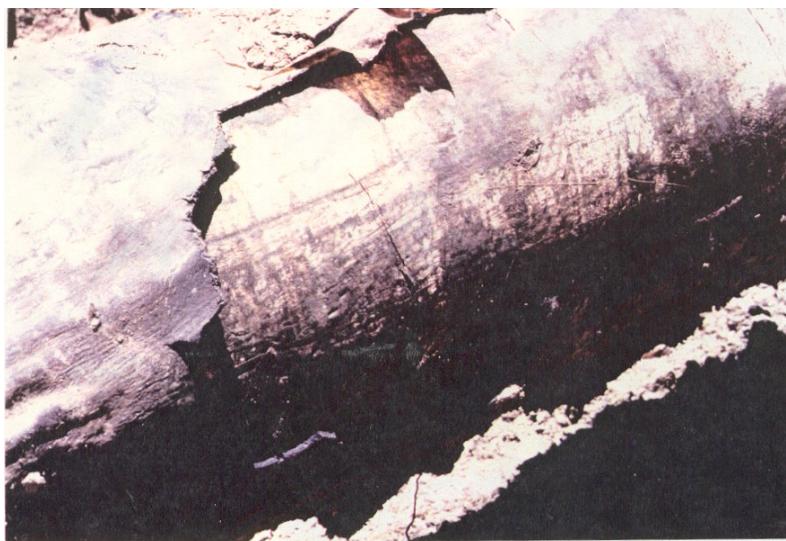
- The visual inspection showed that the original coal tar coating was broken during the bending of the pipeline spool and a cold applied tape was wrapped around the pipe to repair the damaged coating, by forming a rolled layer of polyethylene, without any bonding with the metal (Fig. 3).

- The coating was not bonded to the metal of the pipeline;
- The CP current was unable to reach the metal due to the shield effect;
- The environment was rich of CO<sub>2</sub>, thus reaching the pH for developing the typical
- cracks due to Low pH (or near neutral) SCC (pH 6 – 7).

At 55 m downstream the start of the survey, a group of circumferential cracks have been found. A total amount of 25 groups of cracks has been found and some others isolated along the various spools. The worst crack was 22 cm length, with a depth of max 2 mm, measured with an ultrasound scanner.

**Fig. 3 – Coating damaged by the landslide effect**
