## CeoCor Plenary Days 2008 in Slovakia

Investigation for AC-corrosion on a Danish transmission pipeline  
interfered by HVAC lines

Peter Cohn Energinet.dk

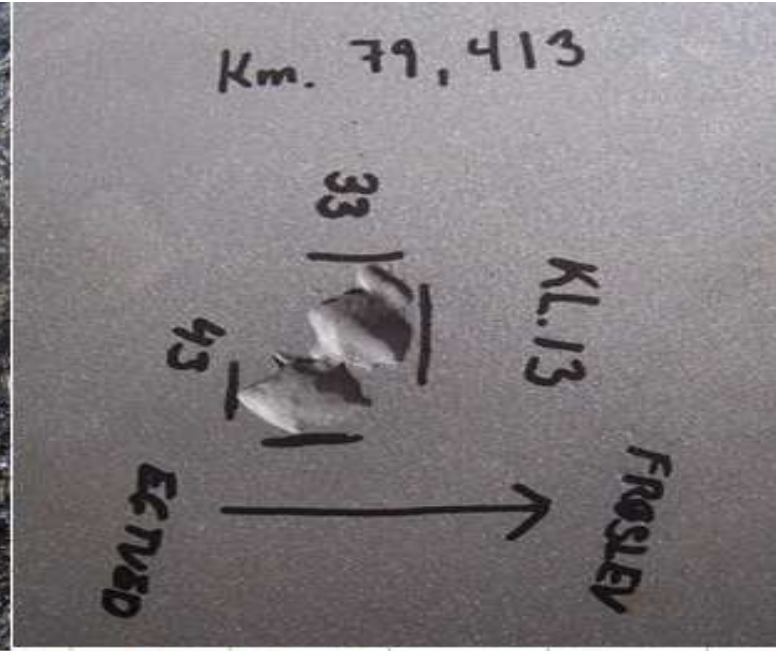
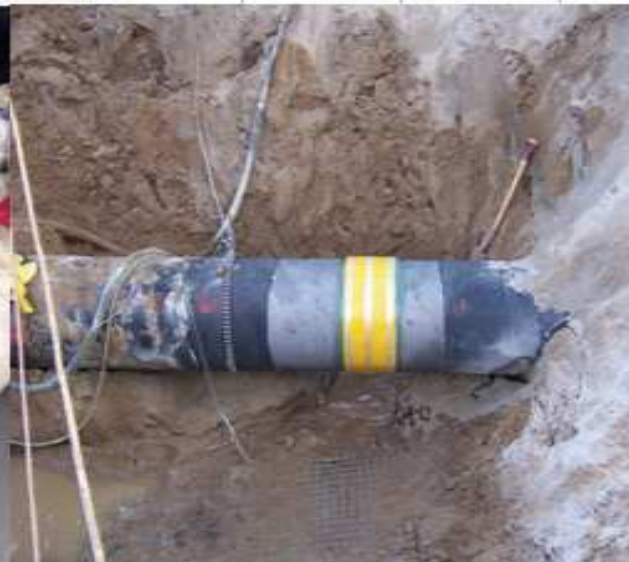
# Metal loss detected by ILI – Milling defect – no coating defect – clock spring

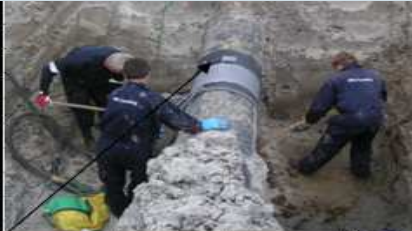
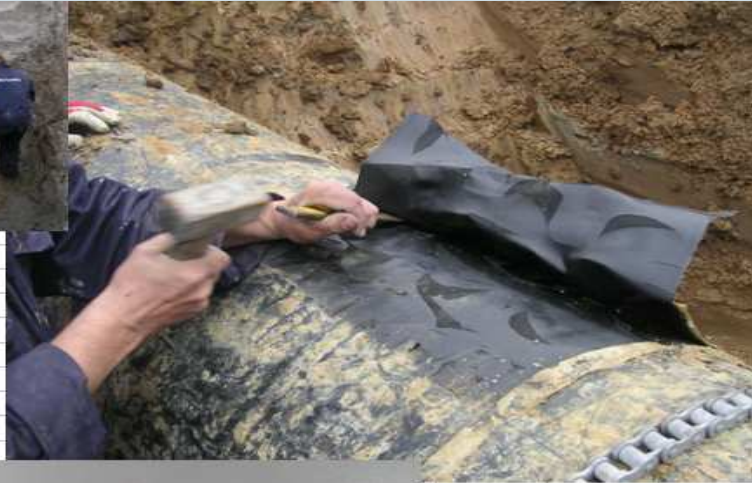
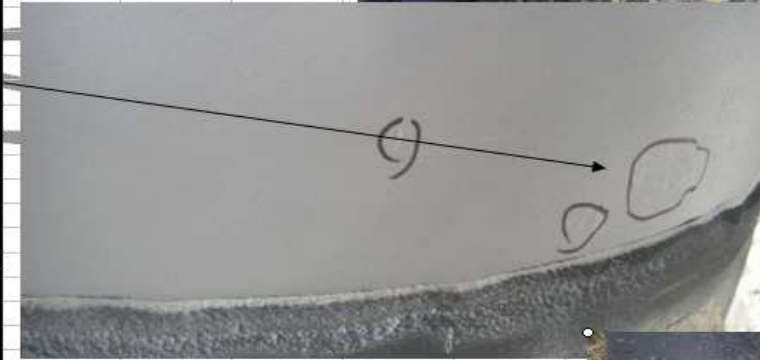
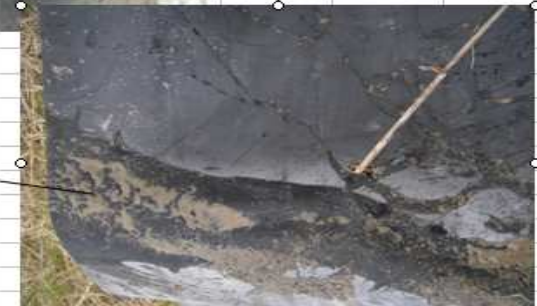
# Metal loss – detected by ILI – no coating defect – “mechanical defect” – polished before fieldcoating

Strækning:	F-E	Ch:	77.016,61
Frilægningsdato:	05-09-2007	Initialer:	pco/kej
Årsag:	Pll pigrun -notat 137527/07		
PSP	35-0202-01-03		
<b>Lokation :</b>			
Factory coating :	2-lags PE	Vedhæftning	100%
Fieldcoating	asfalt bitumen m	Krympemuffe	
Overlap (cm)			5,00
Vedhæftning til rør			100%
Gennemslag ved 25kV			ja
Korrosionsfri			ja
fugt/vand under fieldcoating			0%
EVT Skadesdybde ( beskrives separat)			
<b>Bemærkning</b>			
Recoating	rengøring	sandblæst	
	primer	denso	
	tape	denso AS40Plus	
	entreprenør	Pihl Coating	
Pigging data:		svejsesøm	836
Skadesdata:			
I (mm)	23	b (mm)	29
d (mm)	0,9	KI :	05:05
afstand fra svejsesøm (cm)			13,6
Måleværdi "3-M"			0
Frilægningsdata ( målt på skade)		svejsesøm	661
Skadesdata:			
I (mm)	20	b (mm)	30
d (mm)	0,9	KI :	05:05
Position (afstand fra svejsesøm)			13
<b>Bemærkning: Ingen coatingskade over mekanisk skade</b>			
Mekanisk skade - fra anlæg			
Lap kl 0 ca 100*100 mm i kant af fieldcoating - 100% ok

coatingskade kl 6 ca 6 cm opstrøms svejsesøm uden korrosion			
forårsaget af sten-fundet ved frilægning			
Billedreference :	Q:\6 Diverse Fotos\20070905 - F-E frilægning

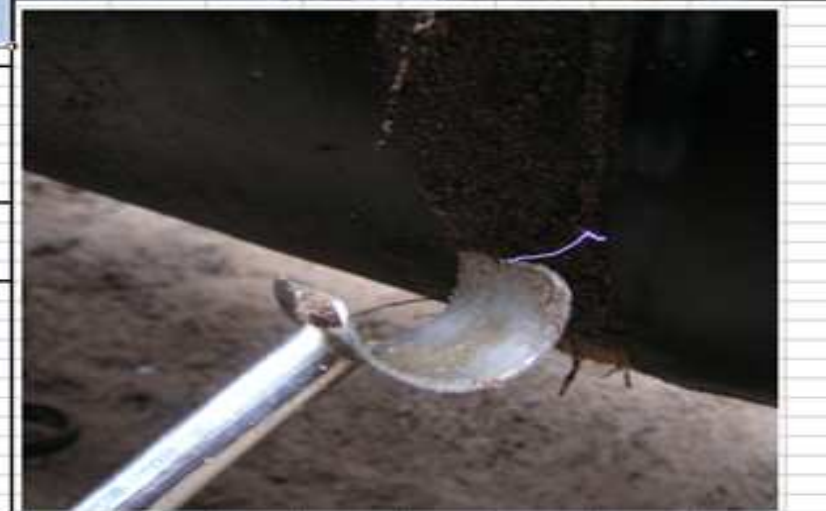
# Coating defect detected by ACVD – No metal loss detected by ILI - corrosion – lack of workmanship

Inspektion af "Fieldcoated svejsesøm"		
Strækning:	Freslev - Eghed	Chc 1,936
Frlægningsdato:	26-10-2006	Initialet: J0J
Årsag:	Fundet ved ICB-måling	
PSP:	35-0202-01-03	
Lokation:		
Factory coating:	Vedhæftning til rør	2-lags PE 100%
Fieldcoating	Type	asfalt på ståloverflade til niveau med PE derefter Reychem krympemuffe med få cm overlæg
	svejsesøm (no)	
	Overlap (cm)	0 til 3 cm 123
	Bredde af fieldcoating	
	Gennemslag ved 25kV	ja
	Vedhæftning til rør	50%
	Vedhæftning til Factorycoating	0%
	Korrosionsfri	overfladerust
EVT Skadesdybde (beskrives separat)		
Fri for fugt/vand under fieldcoating	delvis	
Bemærkning		
Recoating	rengøring	sandblest
	primer	denso
	tape	denso AS40Plus
	entreprenør	Pihl Coating
lap	dimension (cm)	
	position ca 2m nedenstrøms svejsesøm	
	Gennemslag ved 25kV	ja
	Vedhæftning	
	Korrosionsfri	
Fri for fugt/vand under fieldcoating		
Bemærkning		
Recoating	rengøring	
	primer	
	tape	
	entreprenør	
(Rating)

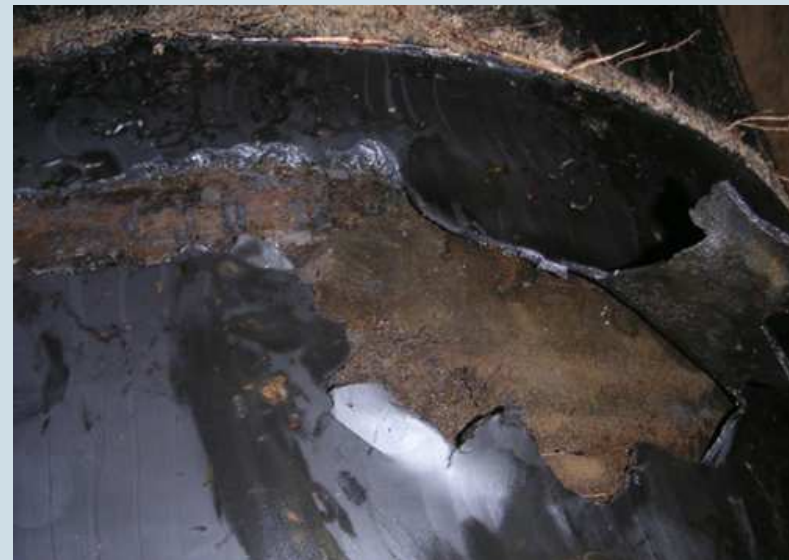
# Raychem sleeve – with asphalt and tree roots
