**a.c. corrosion experiences in ENERGINET.DK**

*P. Cohn – ENERGINET - Denmark*

Investigation for AC-corrosion on a Danish transmission pipeline  
interfered by HVAC lines

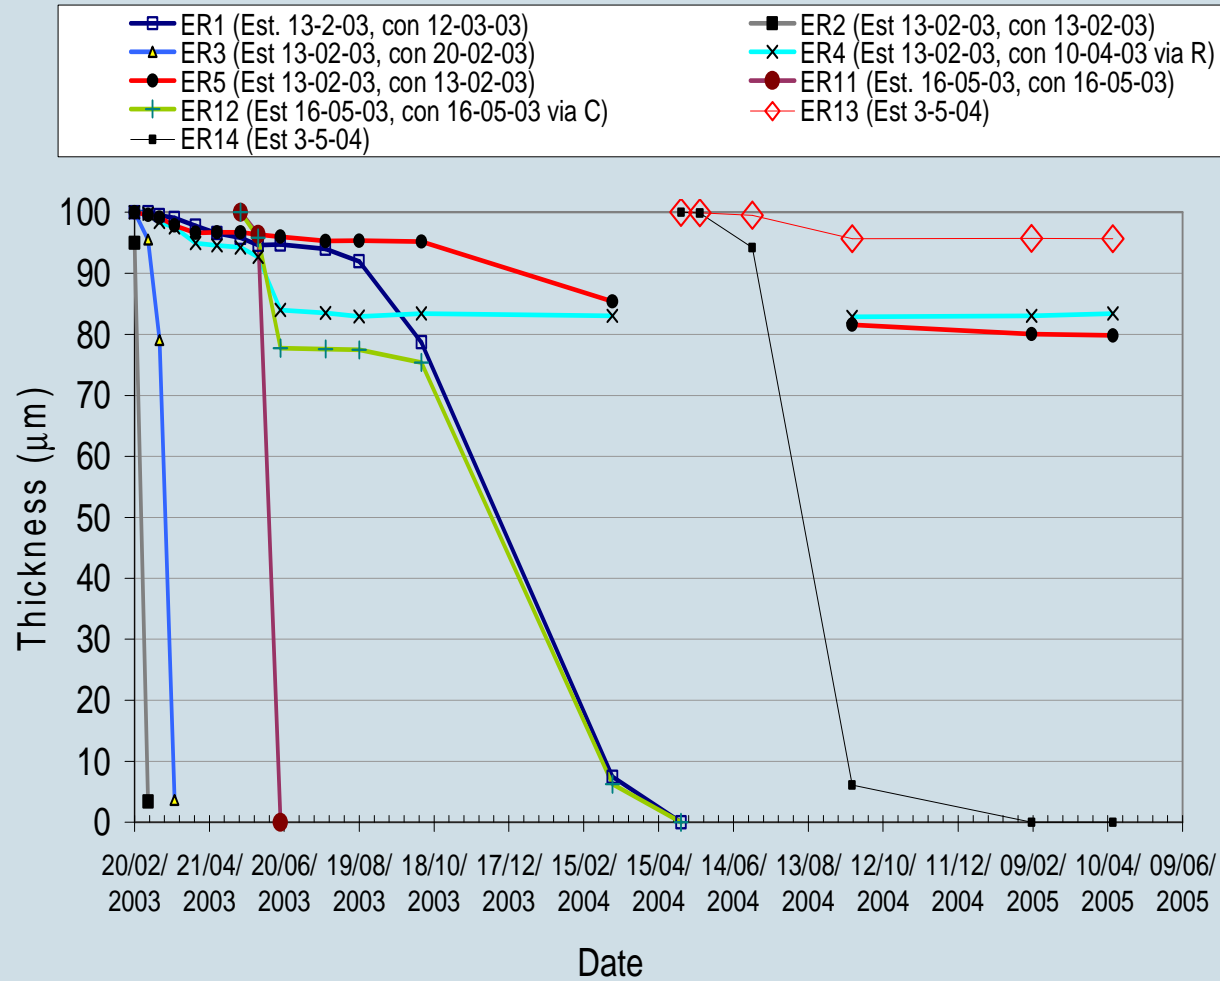
# Corrosion at different ER- coupons

Frøslev-Egtved km 0.9 - ER accumulated 100 micron probes

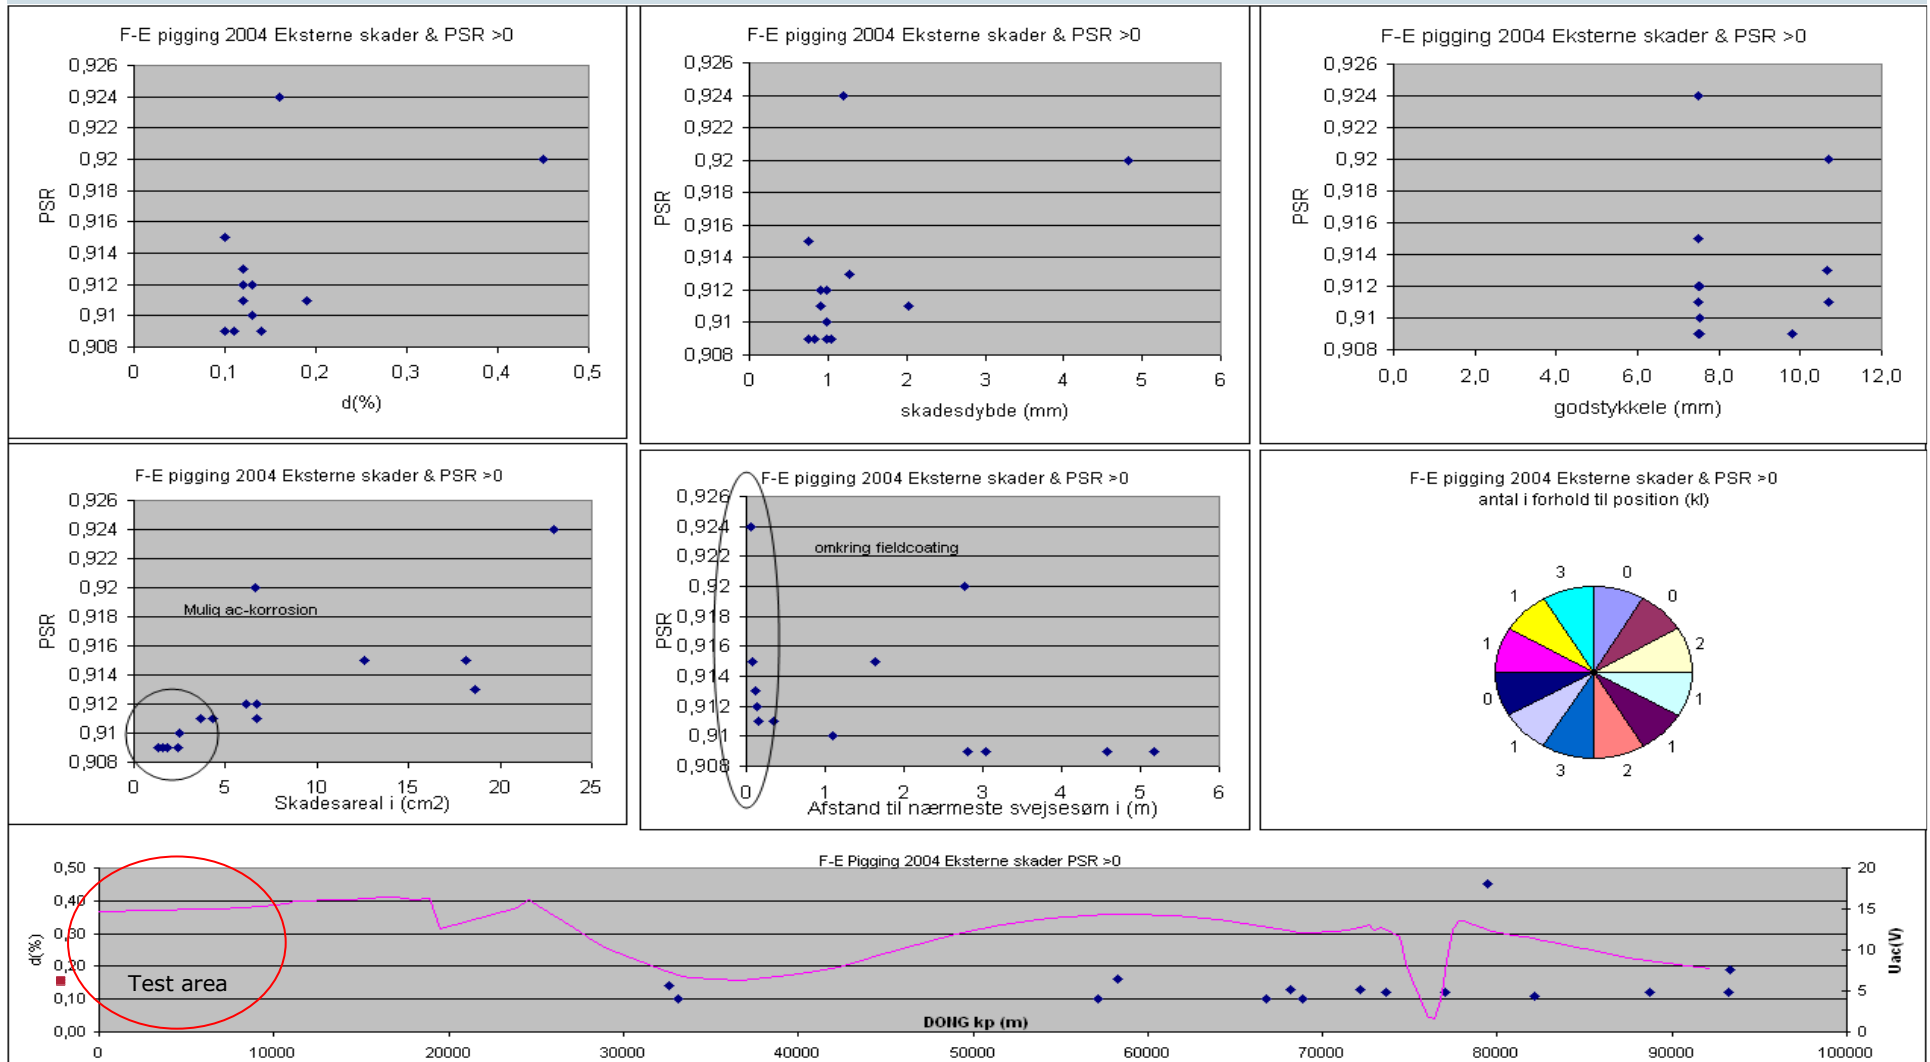
# More analyses – comparison to AC Voltage

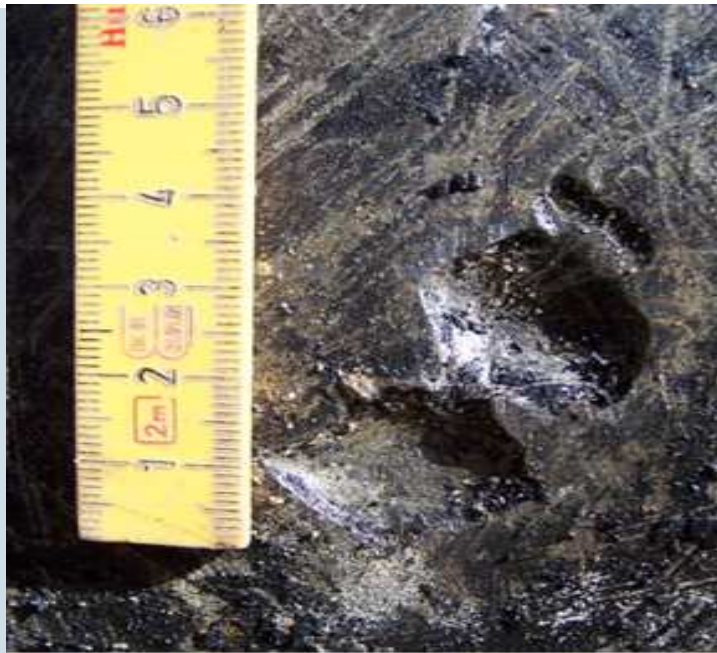
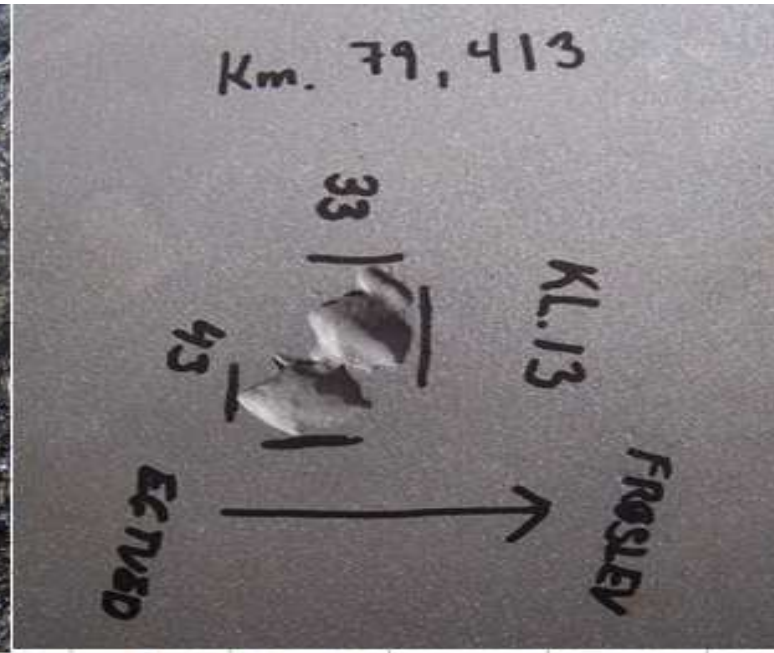
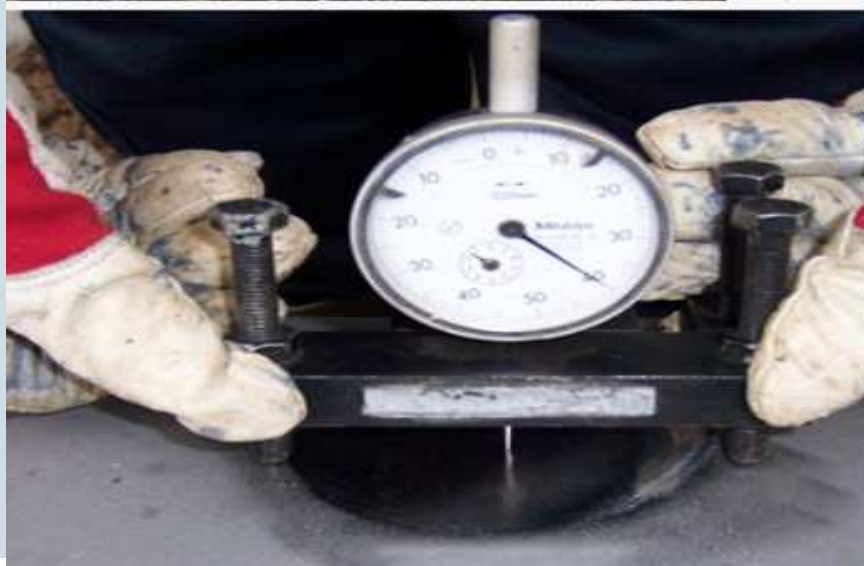
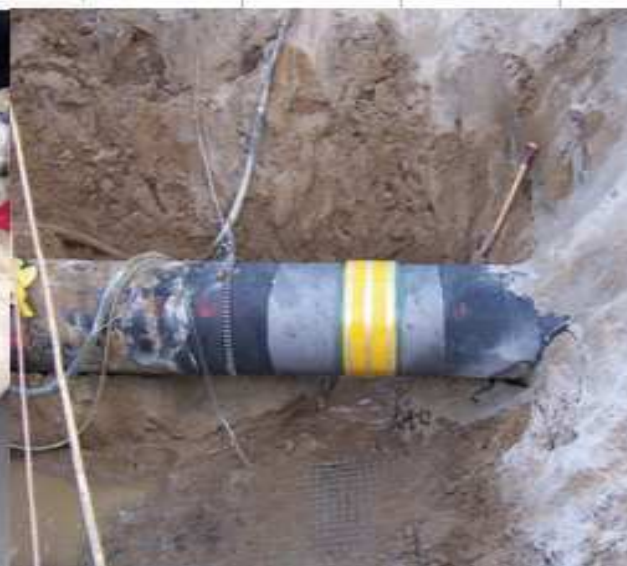
# Metal loss detected by ILI – Milling defect – no coating defect – clock spring

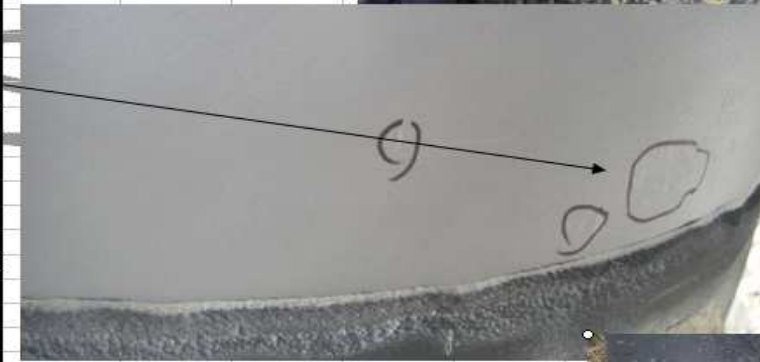
# Metal loss – detected by ILI – no coating defect – “mechanical defect” – polished before fieldcoating

Strækning:	F-E	Ch:	77.016,61
Frilægningsdato:	05-09-2007	Initialer:	pco/kej
Årsag:	Pll pigrun -notat	137527/07	
PSP	35-0202-01-03		
<b>Lokation :</b>			
Factory coating :	2-lags PE	Vedhæftning	100%
Fieldcoating	asfalt bitumen m	Krympemuffe	
Overlap (cm)			5,00
Vedhæftning til rør			100%
Gennemslag ved 25kV			ja
Korrosionsfri			ja
fugt/vand under fieldcoating			0%
EVT Skadesdybde ( beskrives separat)			
<b>Bemærkning</b>			
Recoating	rengøring	sandblæst	
	primer	denso	
	tape	denso AS40Plus	
	entreprenør	Pihl Coating	
Pigging data:		svejsesøm	836
Skadesdata:			
I (mm)	23	b (mm)	29
d (mm)	0,9	KI :	05:05
afstand fra svejsesøm (cm)			13,6
Måleværdi "3-M"			0
Frilægningsdata ( målt på skade)		svejsesøm	661
Skadesdata:			
I (mm)	20	b (mm)	30
d (mm)	0,9	KI :	05:05
Position (afstand fra svejsesøm)			13
<b>Bemærkning: Ingen coatingskade over mekanisk skade</b>			
Mekanisk skade - fra anlæg			
Lap kl 0 ca 100*100 mm i kant af fieldcoating - 100% ok

coatingskade kl 6 ca 6 cm opstrøms svejsesøm uden korrosion			
forårsaget af sten-fundet ved frilægning			
Billedreference :	Q:\6 Diverse Fotos\20070905 - F-E frilægning

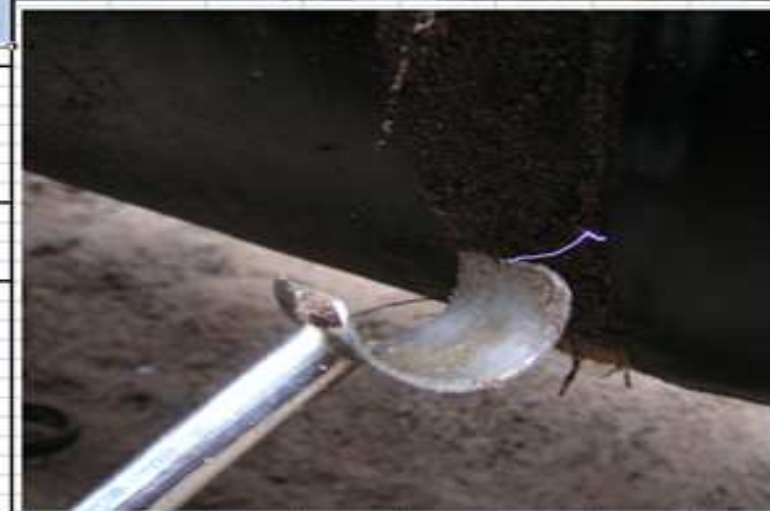
# Coating defect detected by ACVD – No metal loss detected by ILI - corrosion – lack of workmanship

Inspektion af "Fieldcoated svejsesøm"		
Strækning:	Freslev - Eghed	Chc 1,936
Fri lægningsdato:	26-10-2006	Initialet: J0J
Årsag:	Fundet ved ICB-måling	
PSP:	35-0202-01-03	
Lokation:		
Factory coating:	Vedhæftning til rør	2-lags PE 100%
Fieldcoating	Type	asfalt på ståloverflade til niveau med PE derefter Reychem krympemuffe med få cm overlæg
	svejsesøm (no)	
	Overlap (cm)	0 til 3 cm 123
	Bredde af fieldcoating	
	Gennemslag ved 25kV	ja
	Vedhæftning til rør	50%
	Vedhæftning til Factorycoating	0%
	Korrosionsfri	overfladerust
EVT Skadesdybde (beskrives separat)		
Fri for fugt/vand under fieldcoating	delvis	
Bemærkning		
Recoating	rengøring	sandblest
	primer	denso
	tape	denso AS40Plus
	entreprenør	Pihl Coating
lap	dimension (cm)	
	position ca 2m nedenstrøms svejsesøm	
	Gennemslag ved 25kV	ja
	Vedhæftning	
	Korrosionsfri	
Fri for fugt/vand under fieldcoating		
Bemærkning		
Recoating	rengøring	
	primer	
	tape	
	entreprenør	
(Rating)

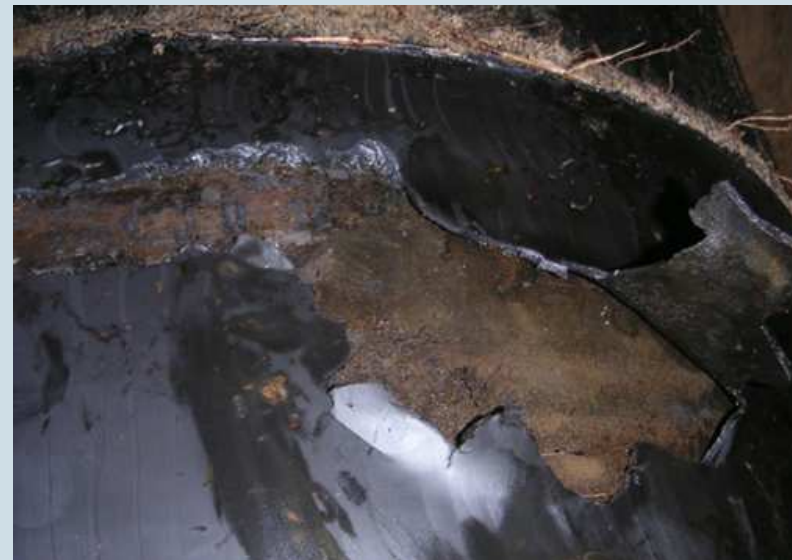
# Raychem sleeve – with asphalt and tree roots
