# Failures of insulating joints and spark gaps on the Hellenic Gas Pipeline System - a case study

Dr. N. Kioupis

Hellenic Gas Transmission System Operator (DESFA) S.A.

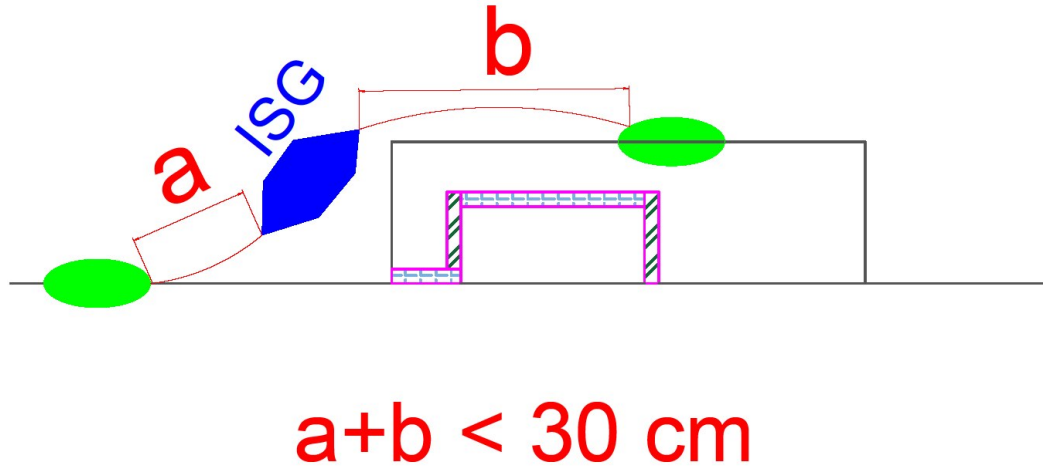
**Figure 2: Installation of the ISGs**

This failure figure (7/69) was considered a serious problem and an urgent project was launched to ensure that the remaining buried IJs would not fail. The remedial action involved the installation of ISGs on buried IJs of the gas transmission system, except on those IJs that had already failed. The ISGs were connected with 25 mm<sup>2</sup> cross section wiring with the shortest possible length to reduce their inductive impedance according to Afk no.5 [7] (see Figure 2).

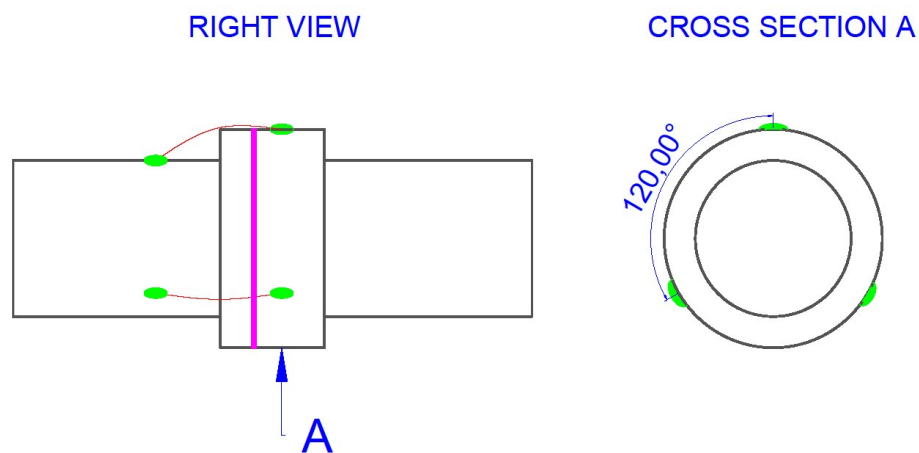
**Figure 3 : Bridging of the failed IJs**

immediately discarded because of the high inductive impedance of the bridging cable - produced by its relatively long routing and low cross sectional area of these cables [7]. The second option considered was to directly bridge the IJs at their physical installation locations (i.e. underground). The decision to enforce this action on all failed joints took place on February 2013. The bridging was enabled via three short cables of 25mm<sup>2</sup> pin brazed at symmetric positions around the IJ (see Figure 3).

Through this interim action (i.e. the intentional underground bridging of the faulty IJs), the safety was reassured, since any lightning and fault currents would flow through the short circuit wires. A secondary benefit to the system's operation was that the insulating materials of the IJs would not be overstressed by lightning/overvoltage effects and thus the possibility, of a further damage that would result in a gas leak - through the insulating material - would be minimised. Of course, following the IJ underground bridging option, the CP levels were readjusted accordingly to ensure the protection's effectiveness.

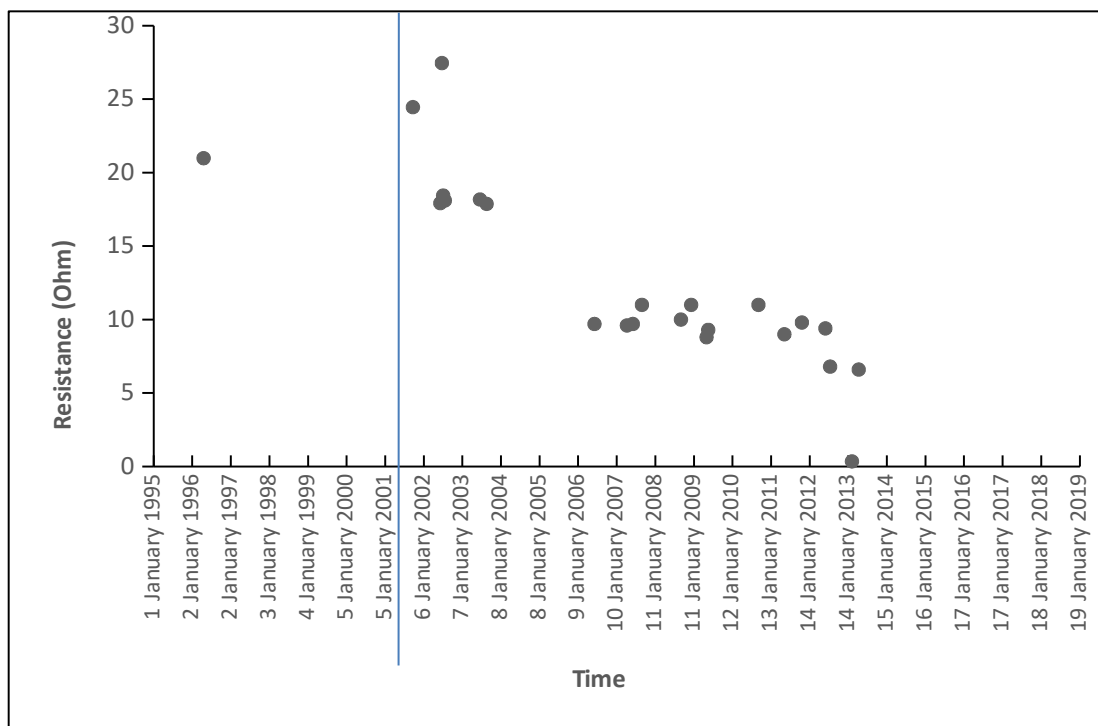
**Graph 1 : IJ's Effective Resistance (to Earth Measurements) between CP areas 2-3 through the years**

The effective resistance value of the pipeline sections that fall under CP area 2 and 3 had been gradually diminishing over the years. This diminishing was due to the IJ degradation or due to the pipeline's coating degradation. In either case, the degradation suggests that the pipeline was subjected to electrically hazardous events (i.e. lightning activity, short-term EMI, etc.)

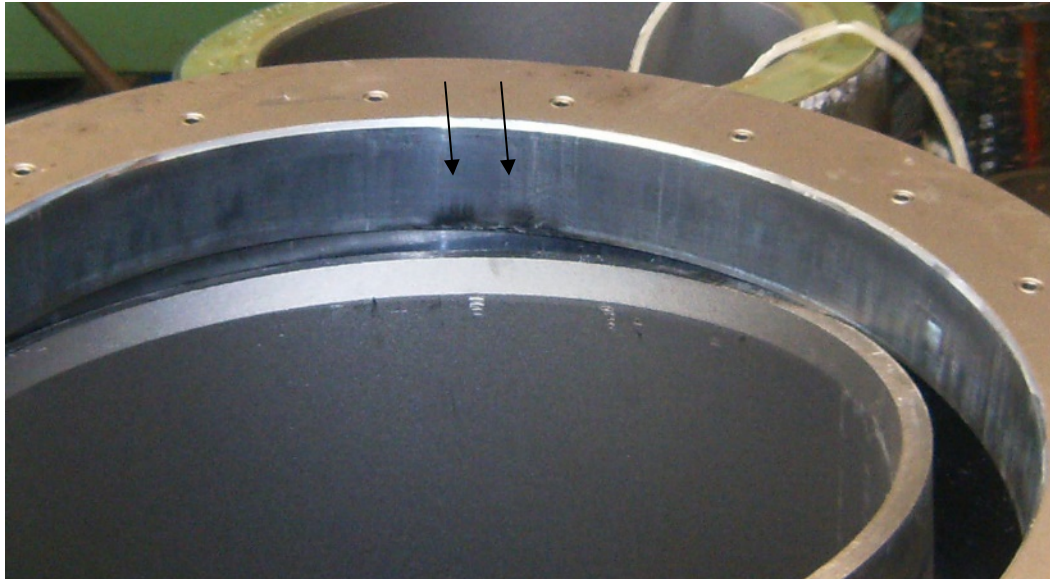
During the disassembling only mechanical pressure was applied in order to separate the IJs parts. After disassembling the IJs, this was one view of the appurtenances. The burnings from the sparkover are visible (see arrows).

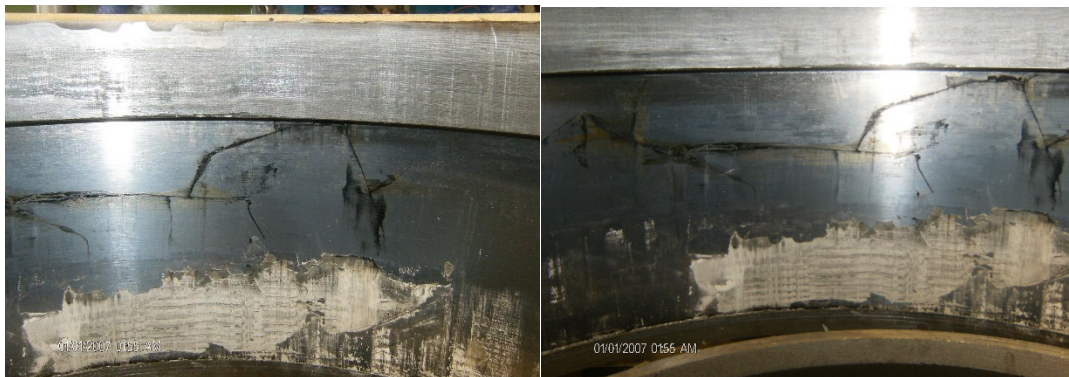
An other view of the IJs main body proves the existence of lightning sparkovers. The shape of the burnings proves indeed that the cause was surge/lightning currents.

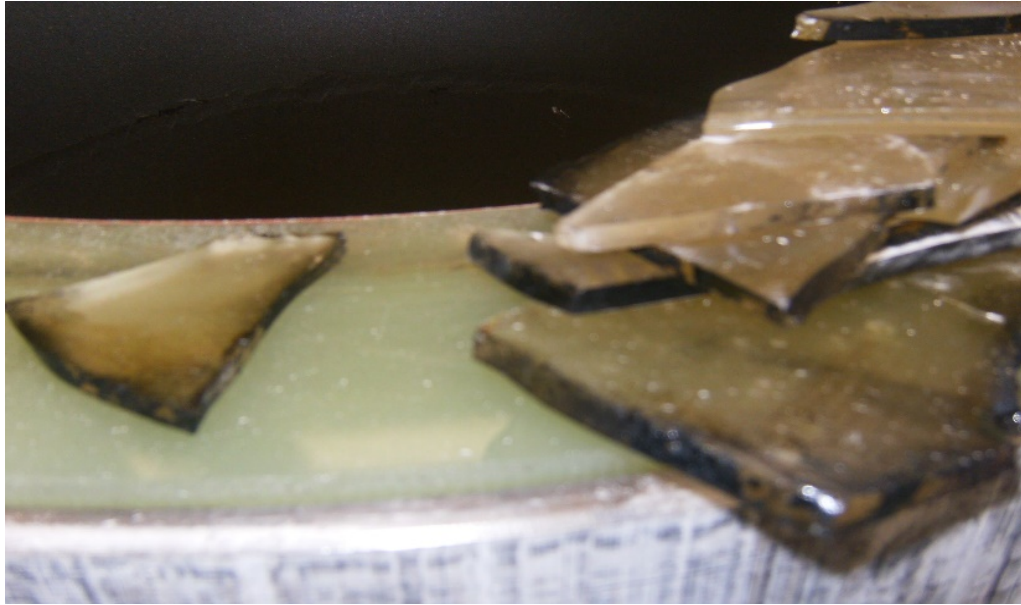
In the following picture we can witness the mechanical damage that was caused by the repetitive lightning strikes.

It is obvious that all insulating properties are lost and that the IJ has been susceptible to non-desirable effects; i.e. further mechanical damage with worst case scenario the creation of arcs when lightning strikes occur.

**Important note: Despite this damage the O-rings maintained the sealing properties.**
