Corrosion of galvanized carbon steel pipes in a new drinking water system – a case study

Authors: Mirjam Bajt Leban, Tadeja Kosec, Andraž Legat

Slovenian National Building and Civil Engineering Institute, Dimičeva 12, SI-1000 Ljubljana, Slovenia

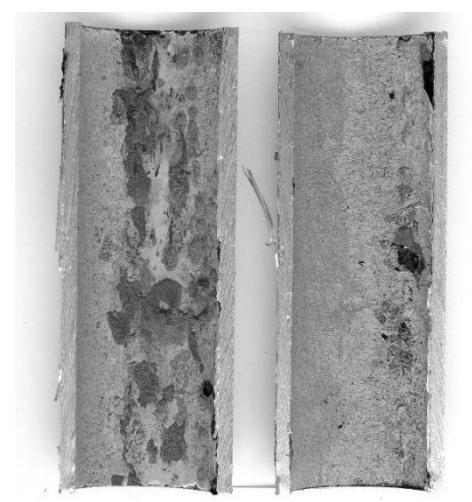
One pipe for hot, and one for hot water taken from the drinking water system in the hospital, were in laboratory cut along longitudinal axes in order to get an insight to the condition of inner wall. On the figure 1a and 1b inner side of pipes for hot and cold water, respectively, after 7 years of use, can be seen.

Figure 1a: Interior of hot water pipe

On the surface of hot water pipe, the presence of Ca and P revealed carbonation and phosphate layer, which is also visible by naked eye as a light-grey layer (Figure 1a). In addition, the amount of Zn found on the surface of this pipe was much greater (approximately 10 times greater) than that found in corrosion products of cold water pipe. It is believed that carbonate/phosphate layer formed intensively because of higher temperatures in hot pipes protected by Zn coating against corrosion. Based on this observation obtained by EDS analysis it can be concluded that all Zn coating on inner wall of cold water pipes was removed during operation of the system. Corrosion products which were found locally on the surface inside hot pipes were mostly iron oxides, but also Zn and Cu were found. Larger amount of Cu in corrosion products of hot water pipe can be explained by galvanic corrosion of brass accessories like are fittings and valves, but also chlorine caused corrosion of copper alloys in this system cannot be excluded. In that case, Cu corrosion products released in the drinking water system by flowing of water and have been deposited to the Zn coated surface. Cu ions caused micro-galvanic couple on Zn coating and caused its local corrosion. In corrosion products of cold water pipe, Ca was not found. In that case corrosion products consisted mostly from different iron oxides. In addition, significant amount of S, which could be explained with biofilm formation inside pipes, was found.

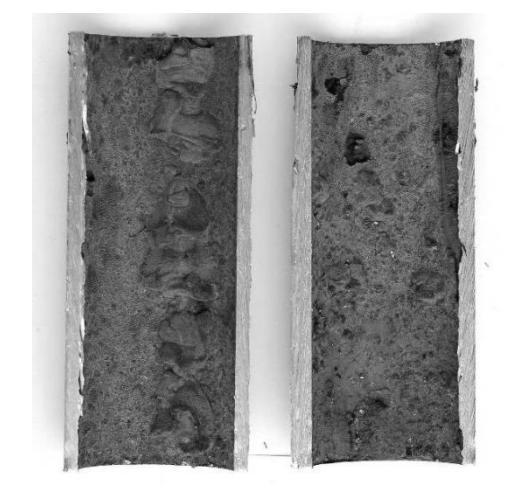
Figure 1b: Interior of cold water pipe

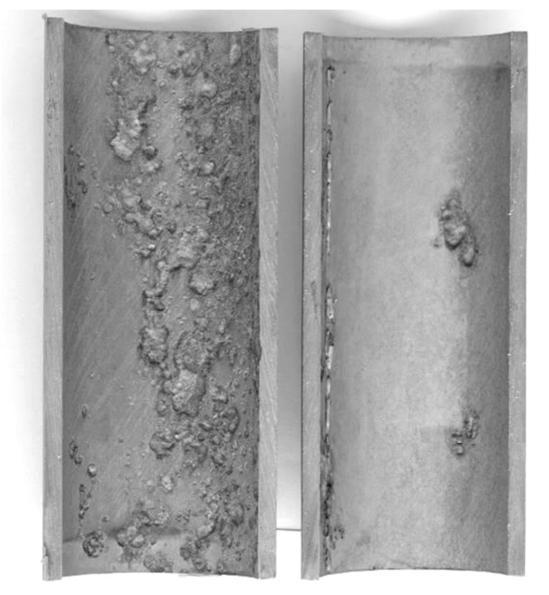
corrosion products removal

Figure 2a: Interior of hot water pipe after Figure 2a: Interior of cold water pipe after corrosion products removal

As it can be seen from figures, pipe for cold water is severely corroder in comparison to pipe for hot water. On the pipe of cold water thick reddish-brown corrosion products are deposited, whereas on the pipe of hot water corrosion products are not so extensive. In the hot water pipe surface, zinc coating is still present, its damage is only local, as observed under reddish-brown corrosion products. On both pipes, a severe localized corrosion pits with depths from some tenth of millimetres up to more than 1 millimetre occurred at the sites with the thicker corrosion products. Seem along the pipe of cold water is heavily attacked (Figure 2a).

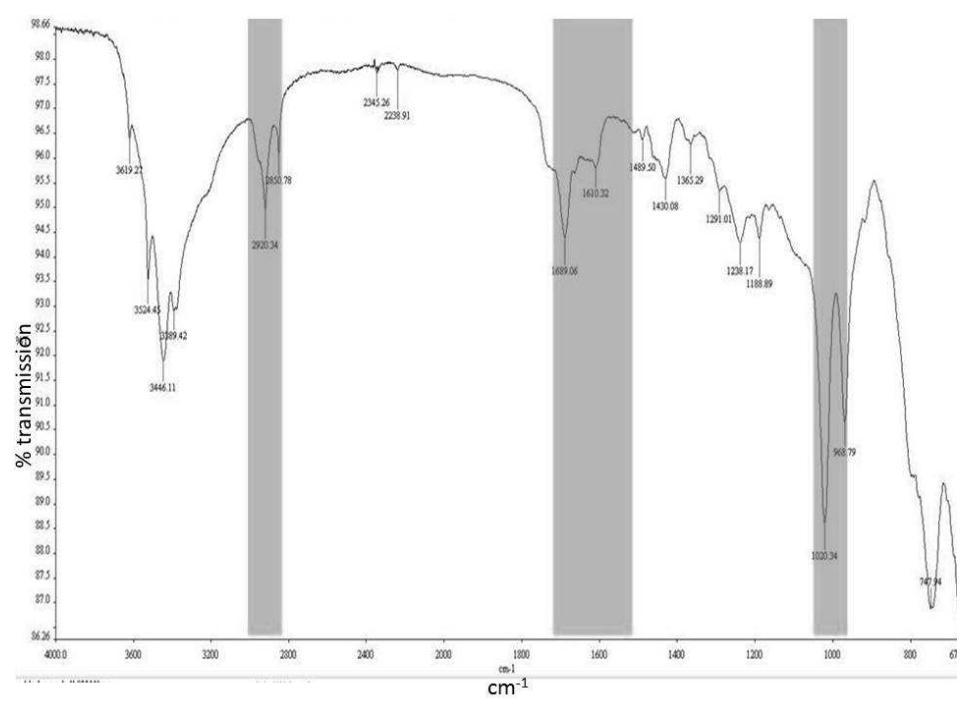
FTIR analysis also proved presence of organic compounds on corrosion products of both pipes, which is visible as a C-H pike on FTIR spectre (Figure 3).

Figure 3: FTIR spectra of biofilm found in corrosion products in cold water system

The bands in the region from 300 and 2850 cm⁻¹ evidence the presence of C-H bonding, the two bands in the region 1750 and 1500 cm⁻¹ show the presence of carbonyl group (C=O bonds). Also the presence of biofilm are confirmed by bands at 1100 and 969 cm⁻¹[10, 11]

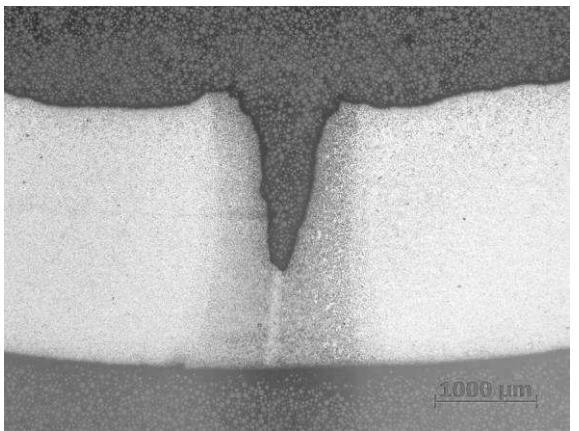
Metallographic samples were prepared from pipes of hot and cold water in different directions after removal of corrosion products. Microstructure of steel of both pipes is ferrite-pearlite, with fine grains from 7 to 12 μ m. In the core of pipe wall stringer like microstructure was observed. In the heat affected zone of cold water microstructure was dendridic and passes into ferrite-pearlite (Figure 4a). Heat affected zone is very wide, more than normally should be. Such microstructure is very sensitive to corrosion. In the case of investigated pipes weld on pipe was the weakest site of steel. In one randomly taken sample the remaining wall thickness was only 0.2 mm, which was alarming fact (Figure 4b).

Figure 4a: Weld on cold water pipe, etched

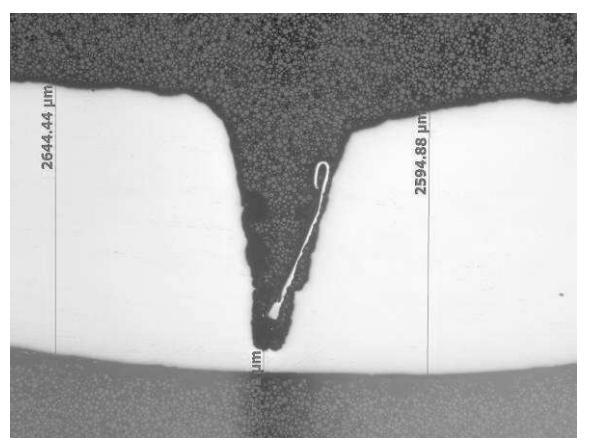
Figure 4b: Remaining wall thickness of cold water pipe reduced by corrosion

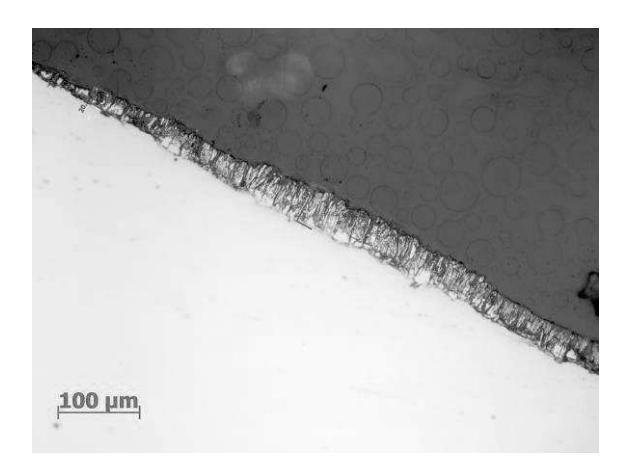
Metallographically measured maximal rest thickness of Zn coating inside the pipe of hot water was up to 55 μ m (Figure 5a). Cracking and scaling of coating was also observed (Figure 5b) and it is believed that temperature shocks caused delamination of zinc coating from steel surface. Zinc coating was locally completely removed and larger corrosion pits where observed. Inside of cold water pipe, zinc coating was completely corroded. Inner surface of this pipe was covered with large corrosion caves. Corrosion products above such damage can be ideal medium for microorganisms such is legionella.

Figure 5a: Zinc coating inside hot water pipe

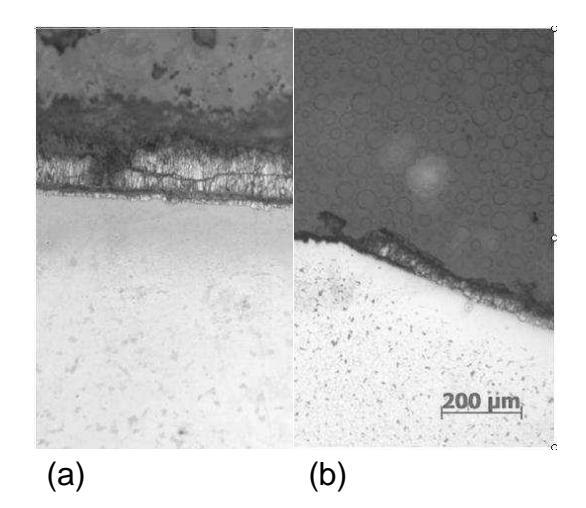
Figure 5b: Cracking (a) and scaling (b) off the zinc coating of hot water pipe

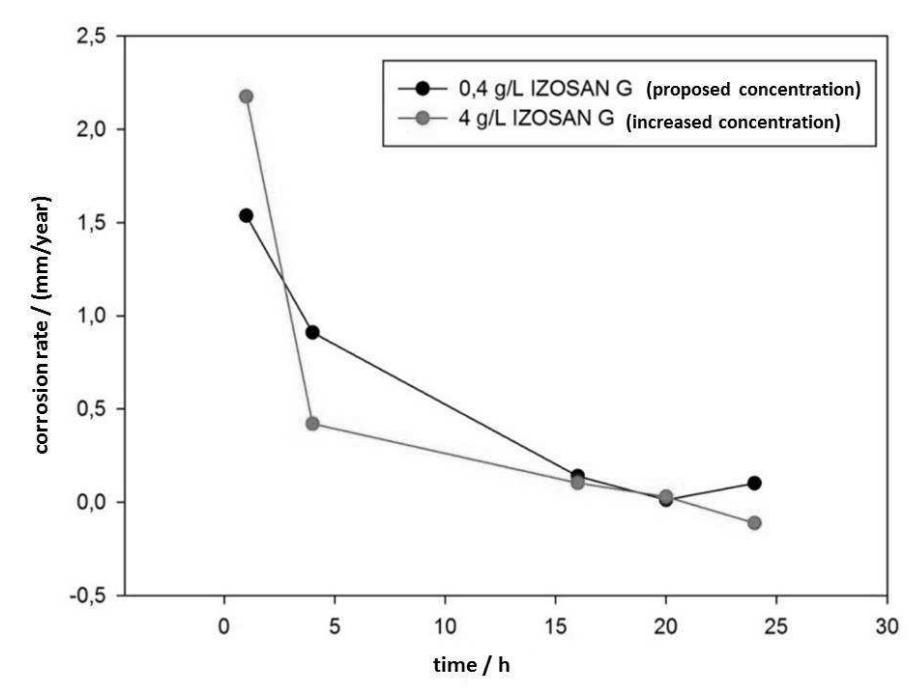
Gravimetrical determination of corrosion rate was carried out on zinc coated steel sheets at two different concentrations of two different disinfectants that were used for disinfection of investigated drinking water system. For the first disinfectant, IZOSAN [®] G, the recommended concentration of 0.4 g/liter, which is commonly used for continuous disinfection of drinking water, was used. Additionally, in order to study effect of overdosing of this disinfectant, increased concentration of 4 g/liter was used. Corrosion rates of Zn coated steel sheets were determined after 1, 4, 16, 20 and 24 hours of exposure in disinfectant and can be seen on Figure 5.

Figure 5: Corrosion rate of Zn in tap water solution of 0.4 g/l (recommended concentration) and 4 g/l (increased concentration) of disinfectant IZOSAN ® G

Corrosion rate decreases with the time of exposure because of formation of corrosion products. During the corrosion products deposition, Zn reacts with oxygen and chlorine, which increases mass of corrosion products. Corrosion products cannot be removed from the surface without removing Zn from the surface. Therefore, corrosion rates determined for longer exposure times are not relevant.
