**CEOCOR 2007
MALAGA (SPAIN) 8 - 10 May, 2007**

Paper A06

a.c. corrosion – Some results of the activities

L. Di Biase – R. Cigna – O. Fumei - ISPRONA S.r.L

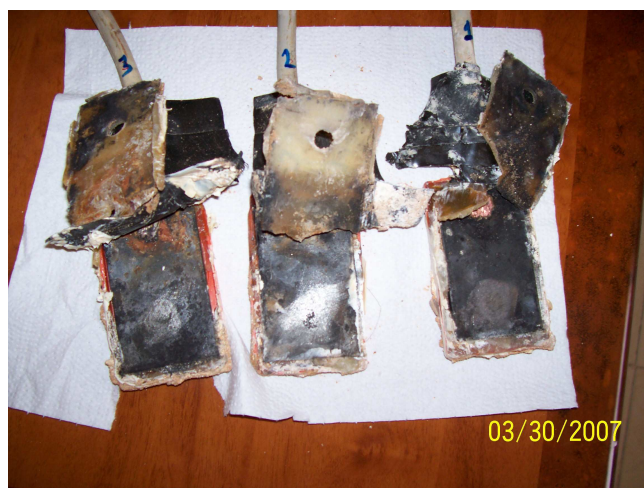
In March, 2007, the three a.c. Corrosion Coupons existing in the Section 3 have been excavated:

All three coupons have been found with a slight a.c. corrosion, as expected. Further, detailed examination are in course in our laboratories.

From the excavation of the first series of three coupons, a certain initial corrosion can be observed, as expected.

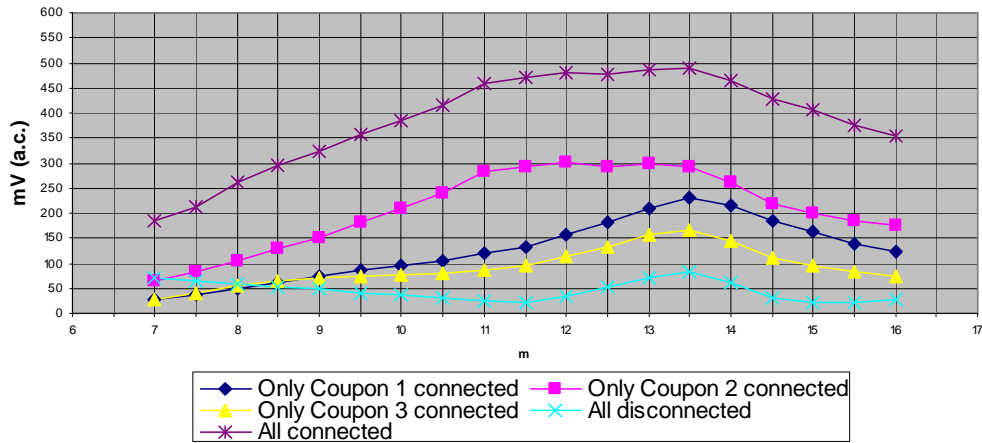
a.c. gradients measured over the Corrosion Coupons

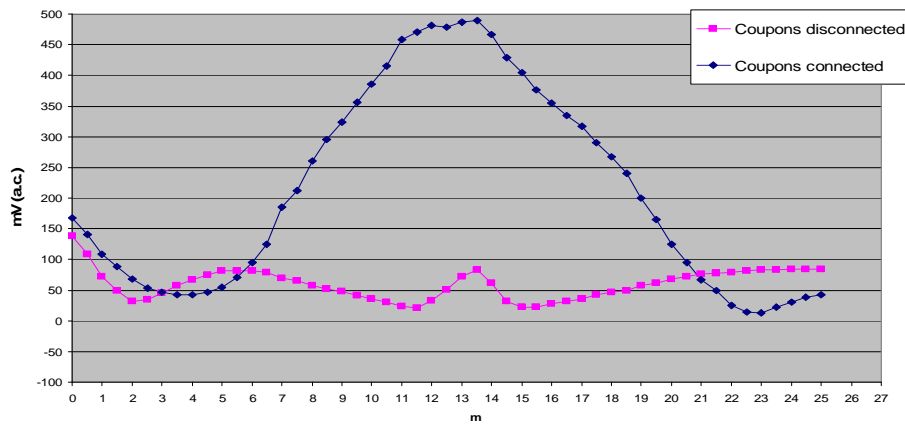
a.c. Transverse Gradients – 1 A a.c. (C.P. Station OFF)

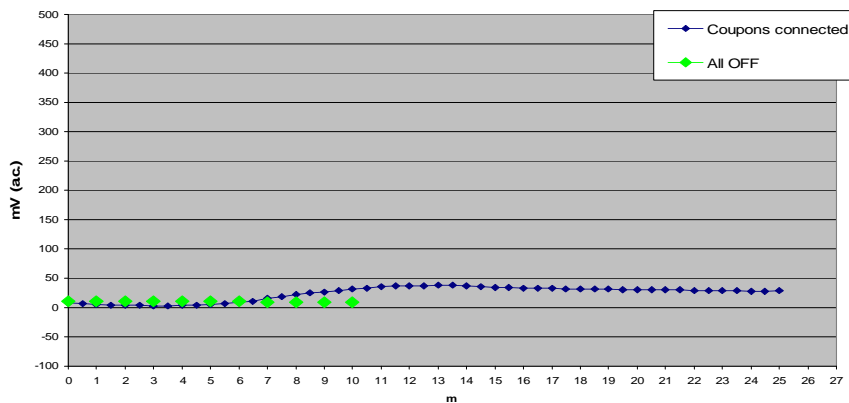
a.c. gradients measured over the Corrosion Coupons (a.c. Discharge Device connected)

These graphs demonstrate that the Discharge Device can decrease the a.c. current on the pipe down to NON CORROSION conditions.
