THE STOPPING OF CRACKS INSIDE A REINFORCED CONCRETE PIPE AS A RESULT OF USING CATHODIC PROTECTION

ABSTRACT

This paper shows how a certain secondary reaction resulting from cathodic protection, such as that caused by the reduction of oxygen leading to alkalization, can be fundamental in the filling of fissures appearing in concrete. At first, several small trial tests were performed. Later, the results are applied on an industrial scale, with satisfactory results.

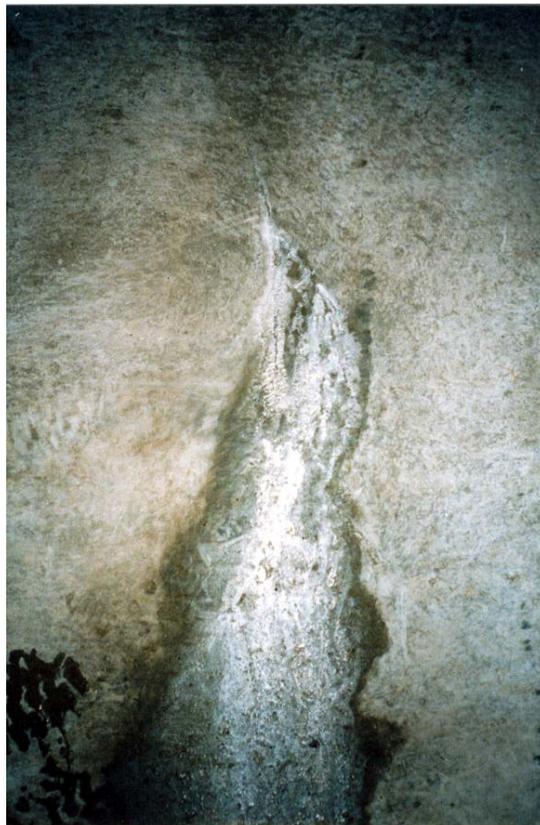
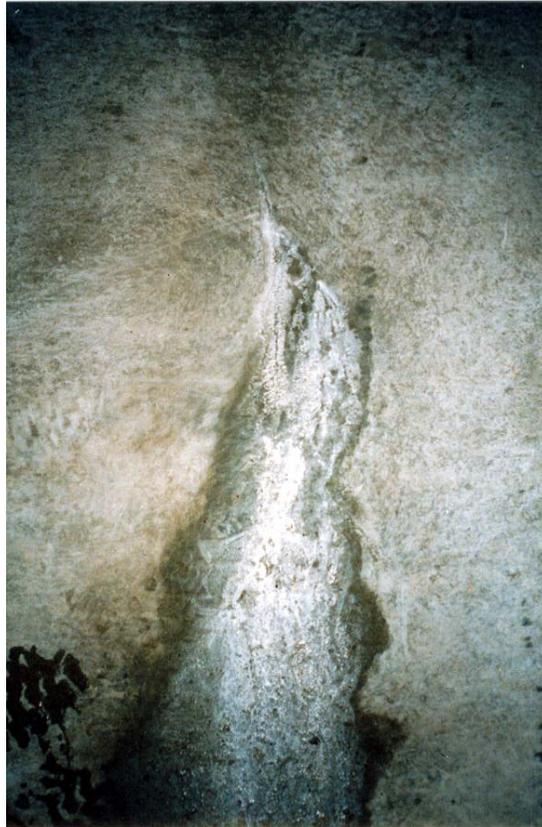
FIGURE 1- The drain was dry in P-1 after 72 hours

In P-1, with cathodic protection, within 24 hours, water had begun to emerge from the dry section and at 72 hours the drain was practically dry (FIG.3). Meanwhile, water continued to flow throughout the two months of the test in P-2, indicating that the water on its is not capable of sealing the fissures.
