**INFLUENCE OF THE FORMING PROCESS ON THE CORROSION RESISTENCE
OF AA3103 ALUMINIUM PIPES**

1. Introduction

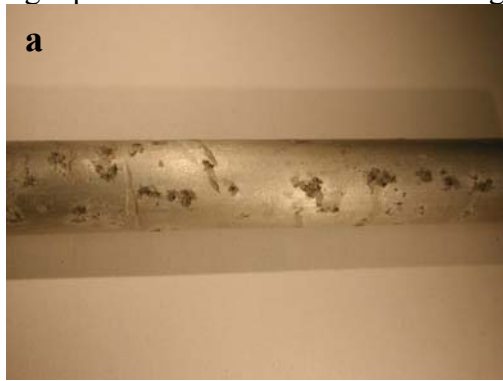
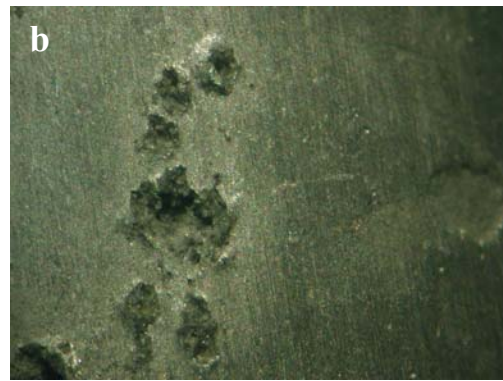
Fig.1 picture of the 1.a tube in two magnifications.

The surfaces conditions are visible in figures 1 to 4.

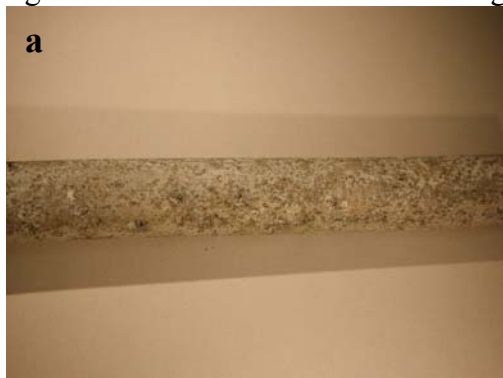
Fig.2 Picture of the 2.a tube in two magnifications.

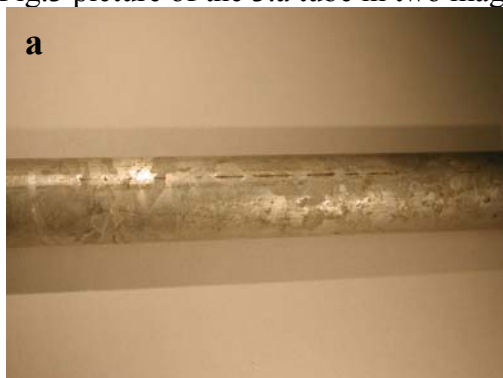
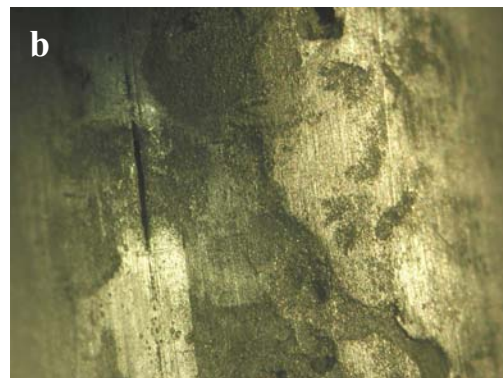
Fig.3 picture of the 3.a tube in two magnifications.

Comparing samples with same processing (samples n°2 and n°3) it can be seen that the composition heavily influences corrosion resistance (the long life alloy seems to be more resistant than AA3103); it has to be said however that sample n°3 failed mostly along the seams (see Fig.3). Anyway, comparing the pit morphology of sample n°2 (Fig.14) with that of sample n°3 but out of seam zone (Fig.15), it can be seen that they are similar, being the depth of sample n°3 higher (in less time).

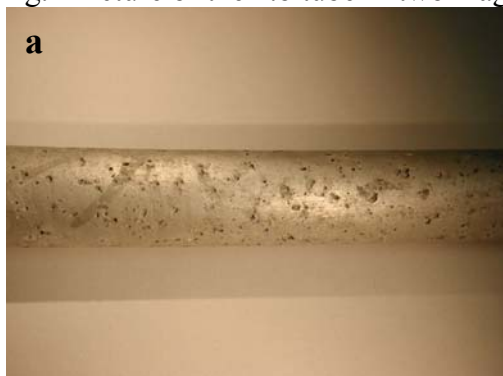
Fig.4 Picture of the 4.b tube in two magnifications.

In Fig.16b it can be note how the pit propagation is slowed down in the recrystallized band (the depth of the pit is smaller than that in the other samples, although the time of exposition is longer); in general, after their formation, the pits grow parallel the surface, showing systematically a flat bottom (see Fig.4b and 8b); in some case there is also blisters formation, as reported in Fig.17.

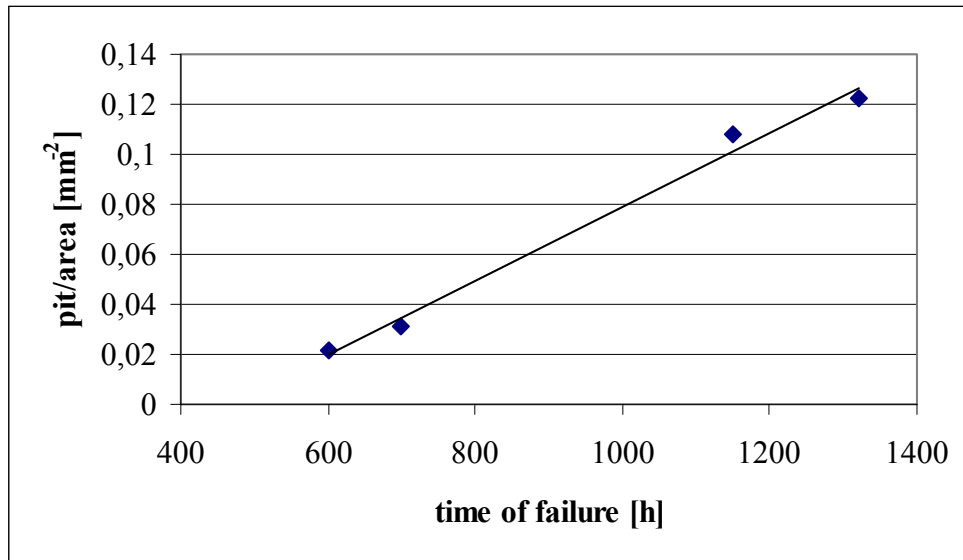
The 1.a, 2.a, 3.a and 4.b samples have been optically examined and the surfaces pits on a similar area counted; the pit density vs. the time of failure is reported in Graph.1.

Graph.1 Pit density vs. time of failure.

Examining the pit density (Graph.1) it can be noted that samples 1 and 3, which have few pits, fail before samples 2 and 4, which, on the other hand, have developed numerous pits.

The most obvious explanation of this fact is that few pits have a faster kinetic of growth (higher ratio between cathodic and anodic area) if compared to that of several pits (lower ratio A_{cat}/A_{an}).

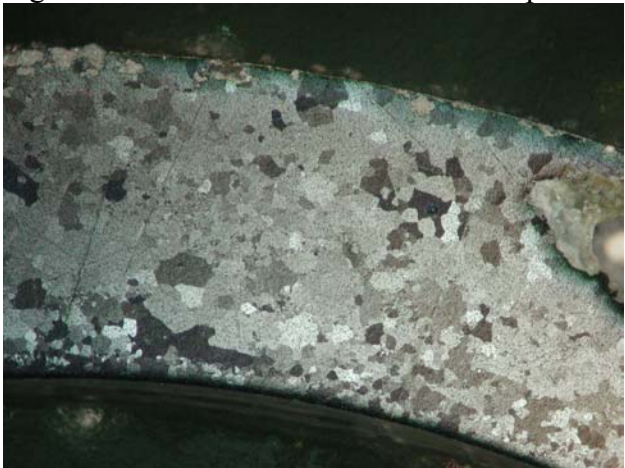
Fig.14 Picture of a etched section of sample n°2.

The sample n°2 (Fig.14) has a less homogeneous microstructure, having a bimodal GS distribution within the section (GS_{mean} is 71 μm); the pit grows well defined in crater shape.

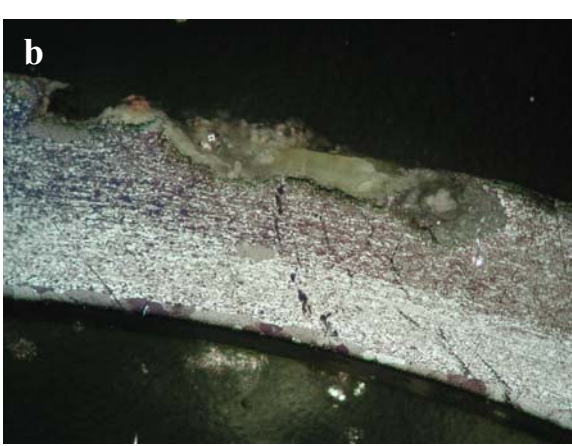
Fig.16 Pictures of a etched section of sample n°4.

In the sample n°4 instead two zone with big GS (137 μm) are distinguishable (internal and external borders, with mean thickness of 72 and 149 μm respectively), while the core has a very fine GS (11 μm).
