# **CEOCOR**

## **SECTOR A - PAPER N. 3**

**Alternating current corrosion of buried and cathodically protected steel  
exposed to varying a.c. voltages -  
And a new model for understanding of a.c. corrosion.**

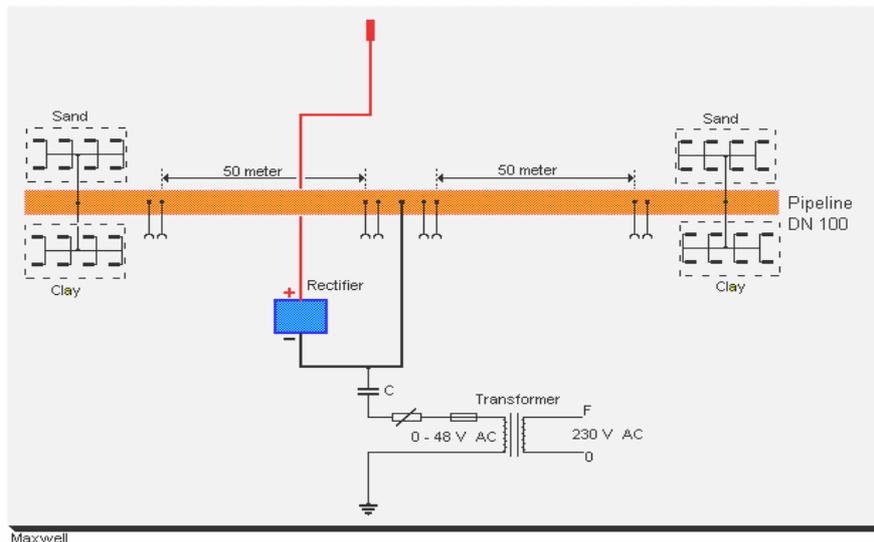
The field test installation includes a 150 meter long PE-coated steel pipe buried to a depth of 1.5 m. See **figure 1**. The original soil at the site consists of clay. Close to each end of the pipe, a large and deep pit was dug in the clay soil, which was then filled with sand. The groundwater level varies with the season but lies roughly at the pipe depth or higher for most of the year.

**Figure 1.** The field test plant with its electrical installations and buried test coupons.

At each end of the pipe coupons were buried at a depth of approximately 1m and were each electrically connected to the steel pipe via a cable. Half of the coupons were buried in clay and half in sand. Before the coupons were buried, they were carefully weighed and then covered with PE-tape. On one side of each coupon, a circular hole was cut in the tape so that a circular steel surface with a given area (1 cm<sup>2</sup> and 5 cm<sup>2</sup>) was exposed. For each area two coupons were exposed in clay and two coupons in sand. Some reference coupons were also installed.

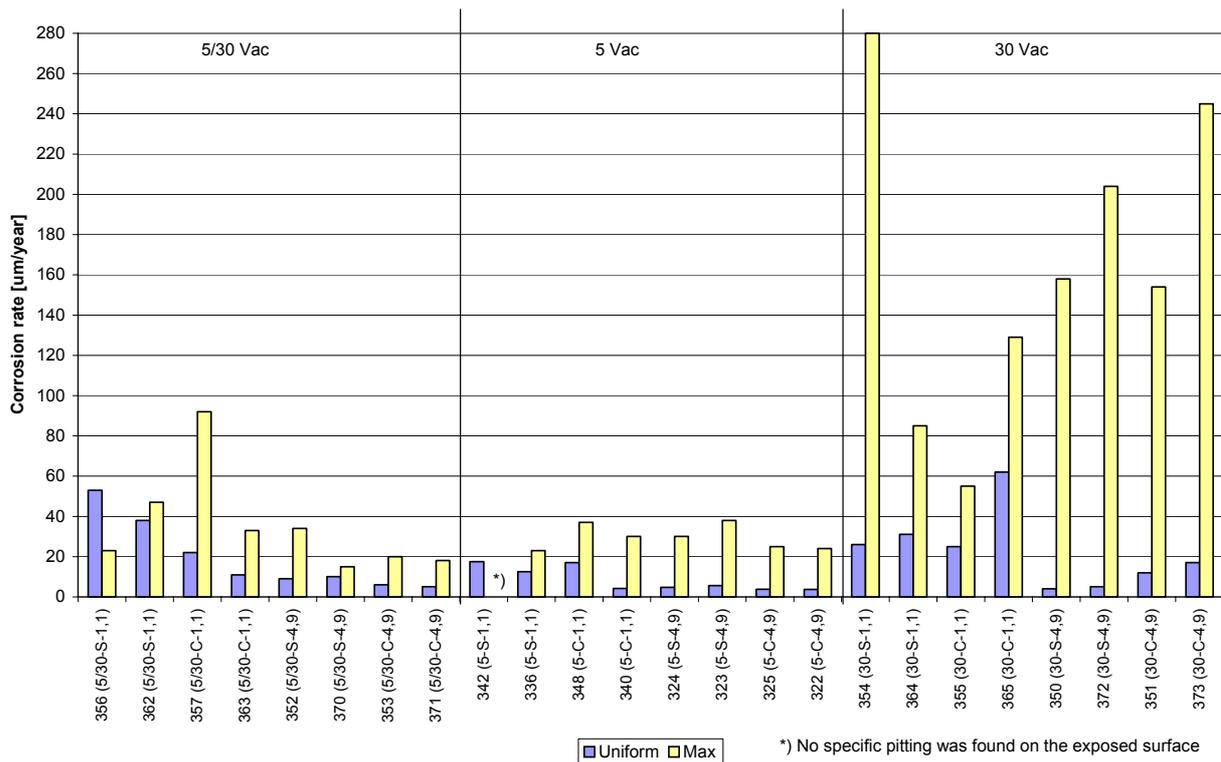
The corrosion rates for the test series 5/30  $V_{AC}$  and for the test series with constant a.c. voltages 5  $V_{AC}$  and 30  $V_{AC}$  are shown in histograms in **figure 2**.

**Figure 2:** Uniform and maximum local corrosion rates on the test coupons in the 5/30 V<sub>AC</sub>, 5 V<sub>AC</sub> and 30 V<sub>AC</sub> test series.

As seen in figure 2 the coupons exposed for varied a.c. voltages (5/30 V<sub>AC</sub>), both the uniform and maximum local corrosion rate, are higher than if the coupons are exposed to 5 V<sub>AC</sub> but lower than the 30 V<sub>AC</sub> test series. The coupon no 357 in the 5/30 V<sub>AC</sub> series has a high local corrosion rate compared to the coupons in the same series. An interesting observation is the fact that the measured off-potential (average of monthly measures) is quite positive and the protection is not satisfactory. **Figure 2** also shows that there seems to be a tendency of increasing local corrosion the higher the AC-voltage is.

As can be seen both in **figure 2** and **table 2** the corrosion rates vary widely between the test coupons in the test series. The uniform corrosion is higher in the 30 V<sub>AC</sub> test series. This

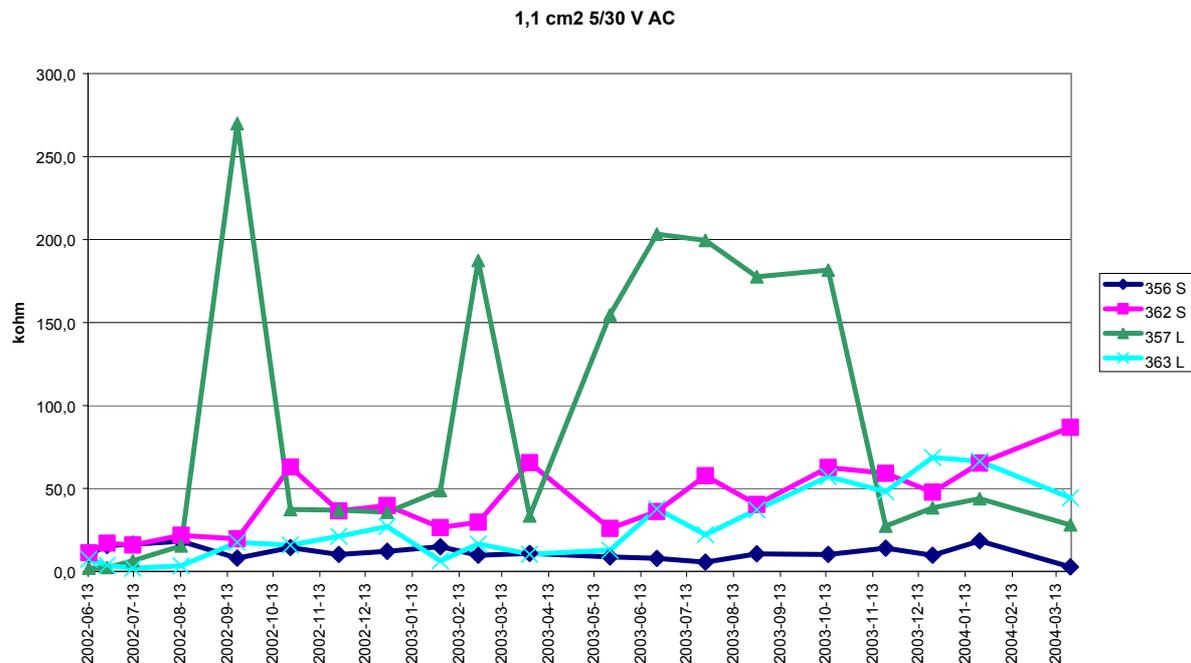
During this and earlier test series it was observed that the resistance between steel surface and earth increased over time and also varied in a large interval that not exclusively could be explained by soil humidity, see **Figure 3**. Generally the changes were larger for the coupons in clay (L).

**Figure 3:** The resistance between steel surface and earth for four coupons (1,1 cm<sup>2</sup>) in sand (S) and clay (L).

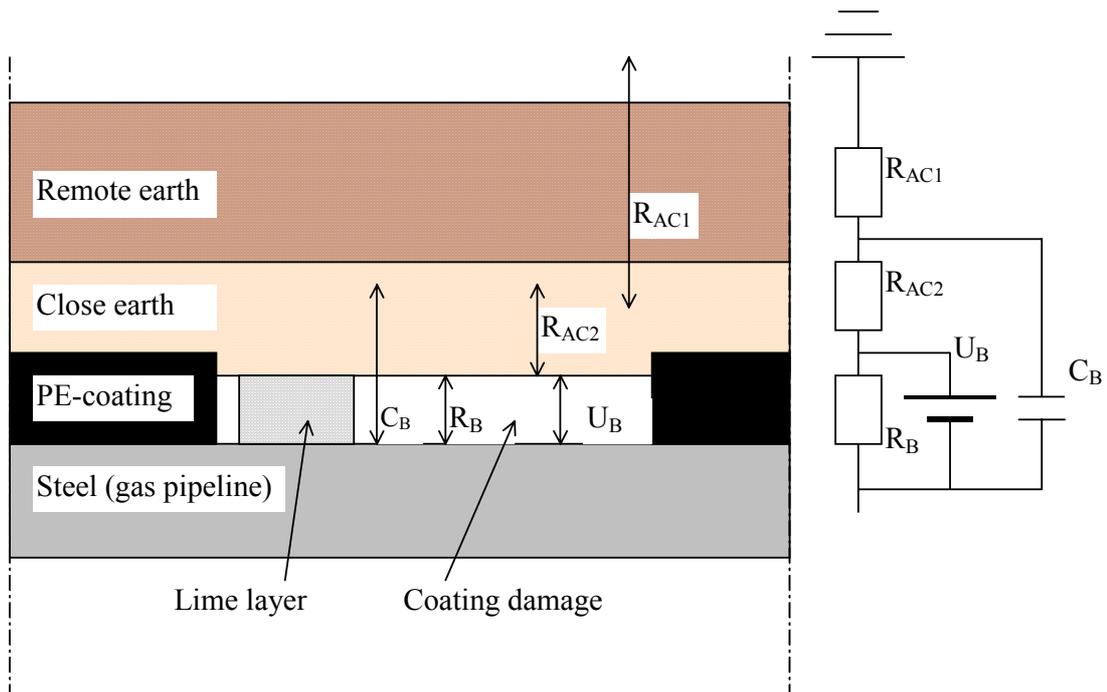
In an effort to understand the variations in resistivity as discussed above and the different factors that affect ac-corrosion, an electrical model has been developed. The cathodic protection current can cause a lime layer on the steel surface depending on the soil type. The layer works like a layer capacitor where the close earth is one of the plates and the steel is the other plate. **Figure 4** shows an outline over a coating damage of a PE-coated pipeline and the electrical parameters between the steel surface and the surrounding earth.

**Figure 4:** Physical and electrical description of a coating damage

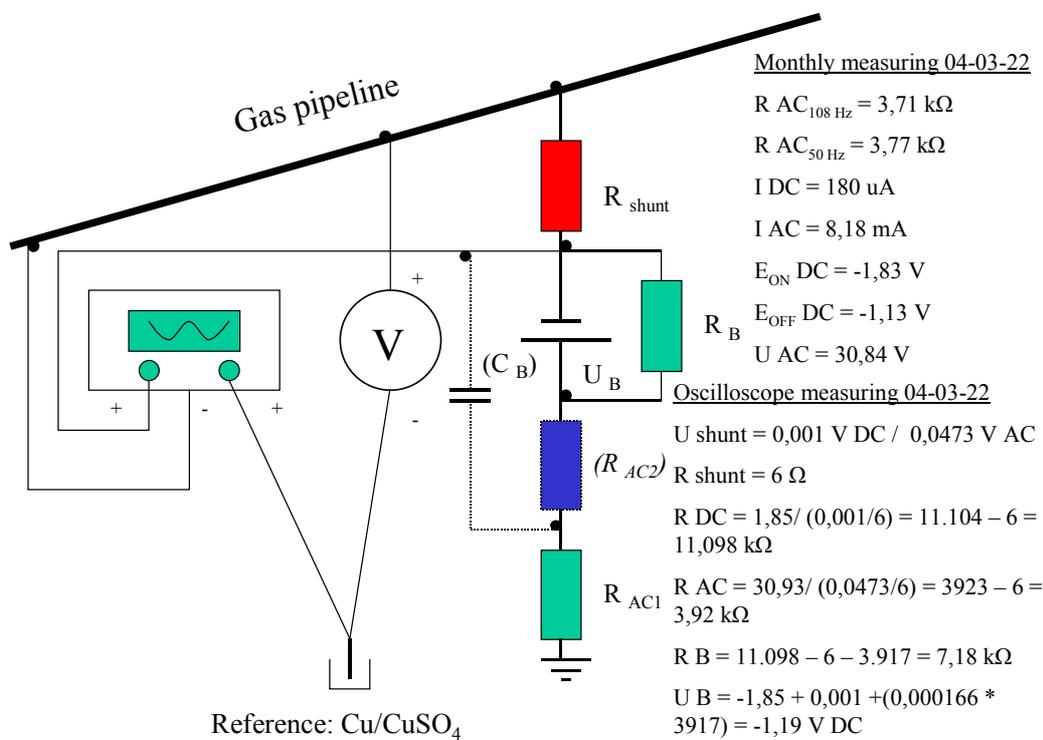
In **Figure 5** the Battery model is shown. The picture is completed with electrical parameters from one of the monthly measurements and oscilloscope data from the same time. In this case there was no phase angel between ac-current and voltage. Therefore there is no capacitor  $C_B$ .  $R_{AC}$  becomes a simple resistance for coupon 372 S. As can be seen in the figure, it is a good correspondence for  $E_{OFF}$ , which is also shown in the calculations.

# Modeltest 372 Sand (4,9 cm<sup>2</sup>)

**Figure 5:** The Battery model

The electrical model can briefly be described as a rechargeable battery, therefore the working name “Battery model” is used. The battery has different re- and discharge circuits. The steel areas at the coupons are possible to polarize to a dc-voltage potential, which is more negative than the natural corrosion potential (around  $-0,6 V_{DC}$ ) for a steel surface in soil. This can be compared with a bad rechargeable battery, which can increase battery voltage under charging. Furthermore, a discharge process takes place when the cathodic protection is turned off, which means “the charge current “ to the battery /free steel surface disappears. In the area around the steel which is in contact with soil, it is the electrolyte that gives the chemical and electrical course. There are several different parameters in soil that influence pH-value in the electrolyte. At the end of this test series a pH-value of approx. 10 was measured on the exposed steel surface.. The test result gives at hand that during seasons with low humidity in the ground cathodic protection is able to build up a protection of lime layer that also protect against high a.c. voltages for short periods.

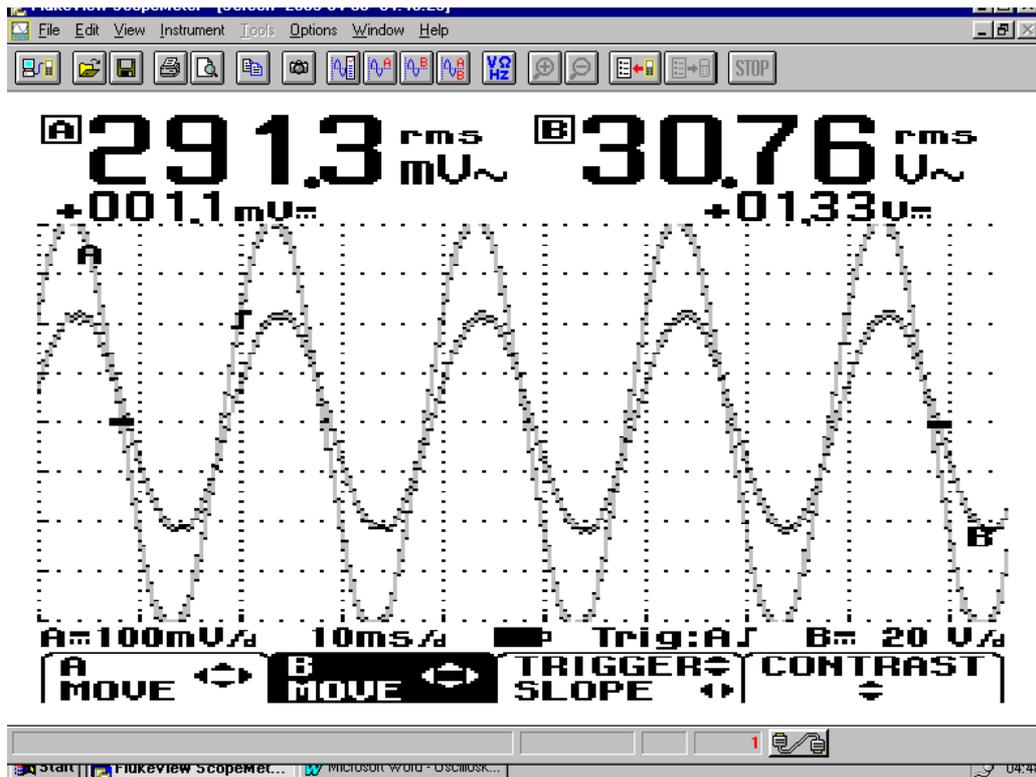
The layer capacitor causes a phase angle between the a.c. current and voltages. To determine the phase angle and thereby the size of the capacitor an oscilloscope was used. One of the coupons (no. 363) was recorded with the oscilloscope, see **Figure 6**. The phase angle was between 0.5 – 1.5 ms (9 – 27 degrees), which corresponds to some 1/10  $\mu\text{F}$ . An interesting observation is that this coupon has high local corrosion. At the time for measurement the resistance between the steel surface and the surrounding earth was high, namely 44.3 kohm.

**Figure 6:** The phase angle of coupon no. 363.
