Corrosion of vertical carbon steel at the ground water table region in soil – Laboratory investigation

**By: Göran Camitz & Tor-Gunnar Vinka, Swedish Corrosion and Metals Research Institute, Stockholm
Henrik Linder, SEMCON Sweden. Gothenburg**

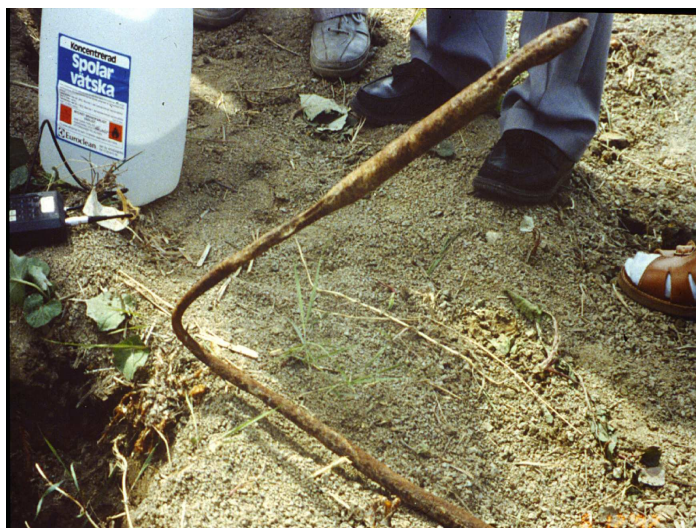
Figure 1. Ground anchor for high voltage power line tower heavily corroded where it passes through the groundwater region.

Carbon steel is frequently used in the ground as vertical load bearing construction members, e.g. as piles and sheet pilings beneath buildings and bridges and as ground anchors for the support wire of large power line towers and telecommunication towers. Most of these construction installations pass through the ground water table. During the years it has been discussed whether the steel section in the groundwater region could be exposed to enhanced and localised corrosion attacks. The background to this discussion is that the Swedish power companies have made observations of heavy localised corrosion attacks at some depth in the soil on ground anchors for power line towers. In some instances the corrosion has resulted in breaking of the solid steel anchor and a risk of the falling down of the tower with adjacent risk of electric power black-out in the society. See **figure 1**.

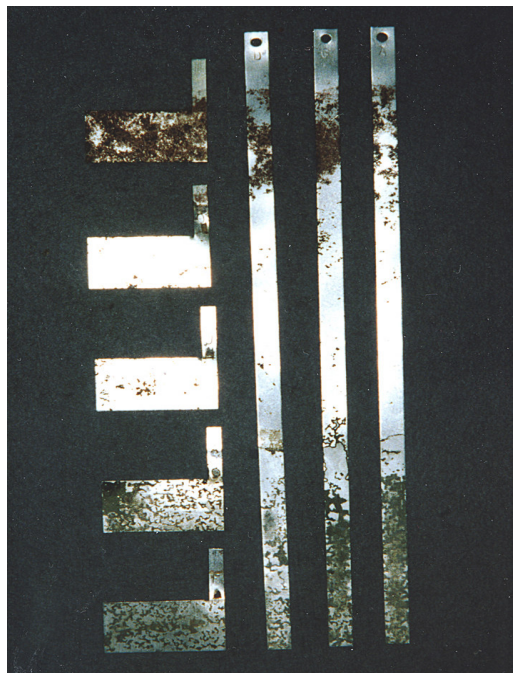
Figure 7. Corrosion appearance of test specimens before removal of rust. Upper coupon from upper test level etc.

The corrosion appearance of coupons and strips before cleaning from rust is shown in **figure 7**. Corrosion appearances of coupons after removal of rust are shown in **figure 8 – 10**.

The photos in figure 7 – 10 show that the most typical uniform corrosion attacks occurred in the fully water saturated sand (level 4 and 5). At level 2 and 3 local attacks were occurring, despite the cathodic protecting effect from the current flow from coupons at lower test levels. At the highest test level (lowest water content) the attack was of the uniform corrosion type, however some quite deep local attacks were also occurring at this level.

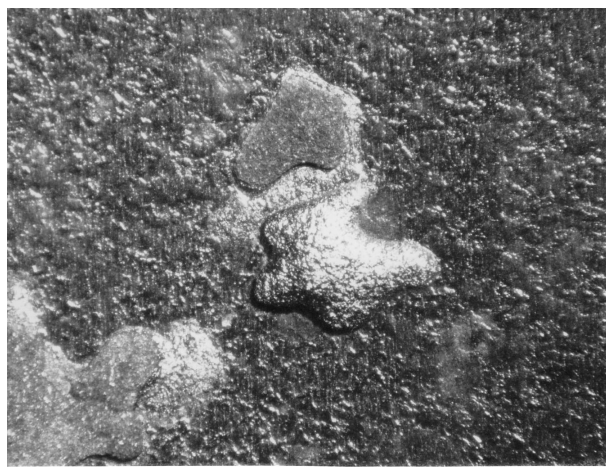
Figure 9. Appearance of corrosion on coupons from test level 2 and 3 after removal of rust. (x25)

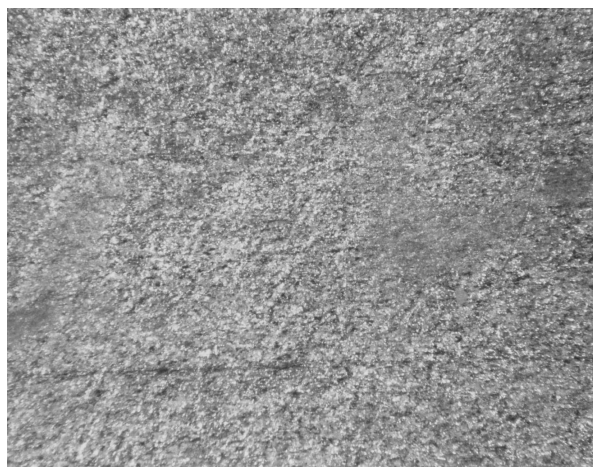
Figure 10. Appearance of corrosion on coupons from test level 4 and 5 after removal of rust. (x25)
