Corrosion damages in drinking water systems – examples out of the practice

Josef Klinger – DVGW-Technologiezentrum Wasser (TZW) Karlsruhe, Germany

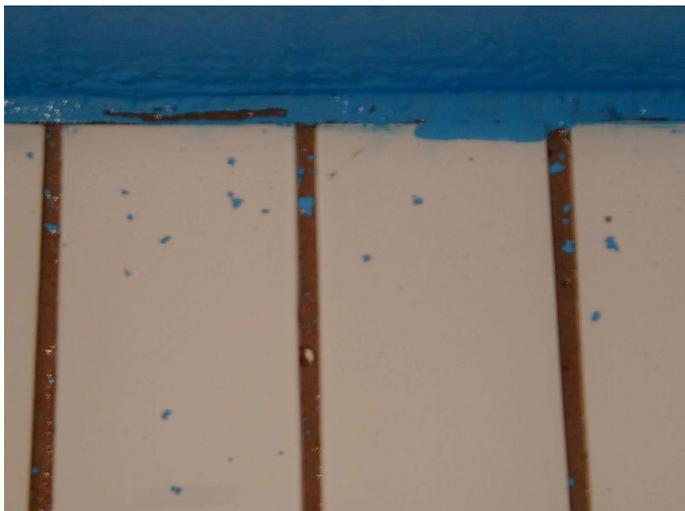
Figure 1: Flaking of a coating

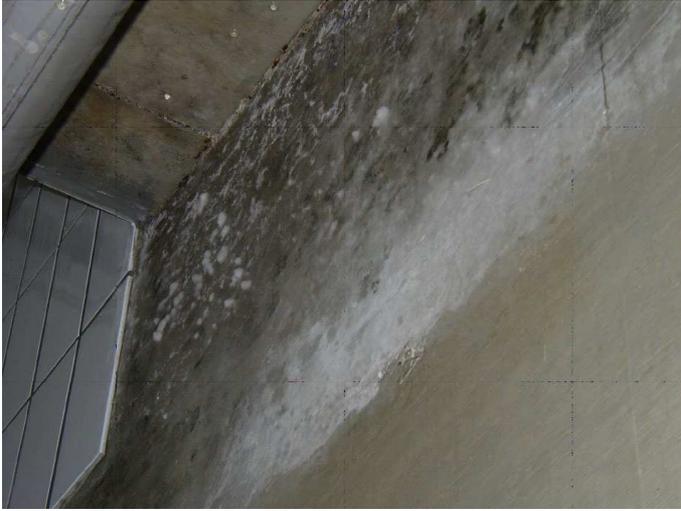
Figure 2: Fungus on a mortar surface

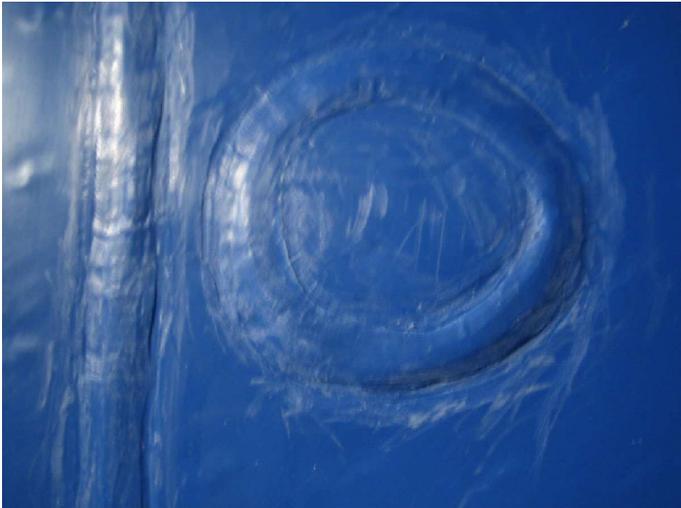
Figure 3: Weld seam of PE plates

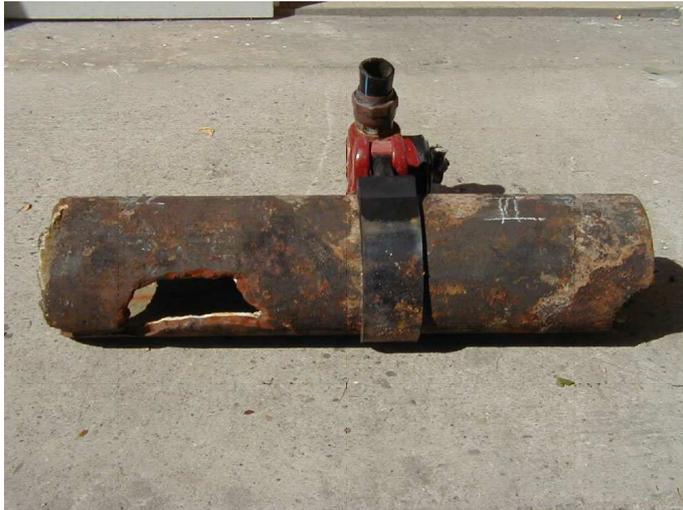
In the drinking water network old cast iron pipes are still in use. Corrosion damages of distribution network pipes can lead to succeeding damages especially in areas with a high building density. In such cases one reason for corrosion damages is the graphite corrosion (spongiosis) which can be characterised with figure 1 and 2.

Figure 4: Corrosion damage of an old cast iron pipe

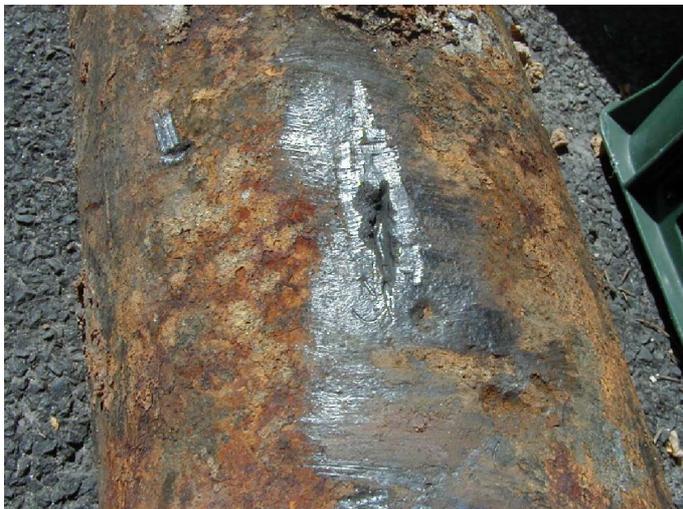
Figure 5: Graphite corrosion (spongiosis)

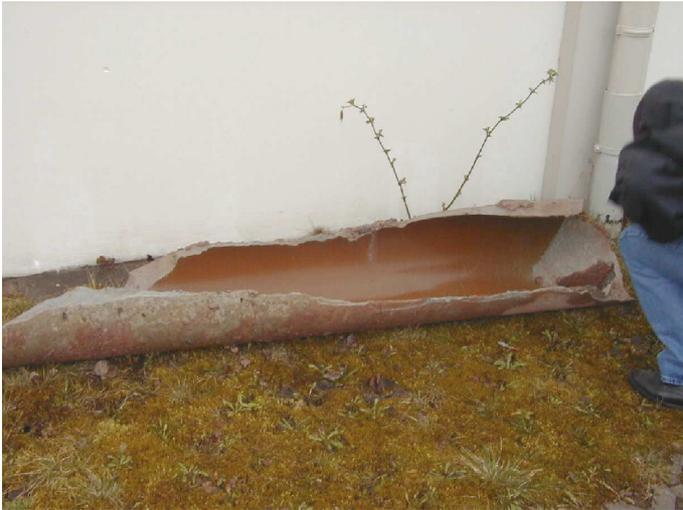
Moreover, in many regions asbestos cement pipes are still in use. Whereas, the oral intake of asbestos fibres can not be regarded as health risk one has to be careful at repair works especially at cutting actions. Corrosion damages can be caused by the water quality or by mechanical loads. In such cases the fracture appearance is as given in figure 6.

Figure 6: Corrosion damages of a cement asbestos pipe
