Stainless steels durability and biofilm formation in potable water: a comparative study with usual materials

ABSTRACT

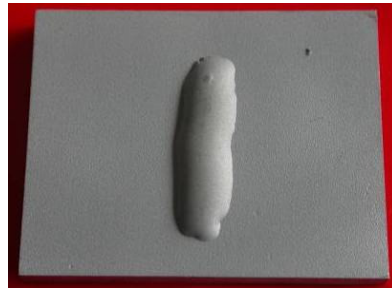
The dimensions of stainless steels coupons were $40 \times 50 \times 5-6$ mm. A bead of weld metal was deposited by automatic TIG welding process on coupons (Photography 1). Then coupons were sand-blasted and pickled in a hot hydrofluoric (HNO_3 / HF) bath in order to remove heat tints from welding.

a) Stainless steels coupons

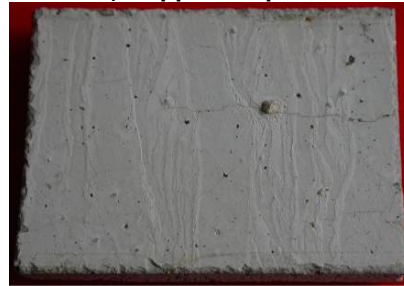
d) Cement coupons

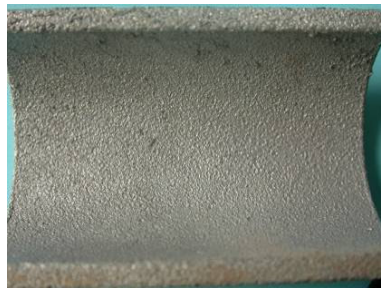
e) Galvanized steel coupons

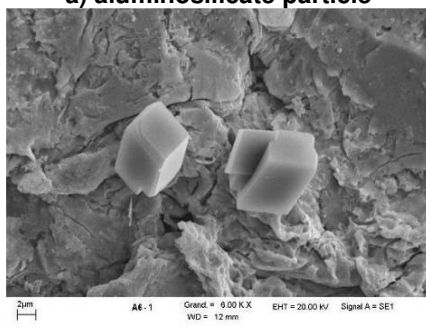
c) cubic calcium carbonate particles

SEM examination revealed the presence of particulate matter fouling of the surface such as: aluminosilicate (Photography 3a), iron hydroxide (Photography 3b) and cubic calcium carbonate particles (Photography 3c). From the third month, very few cubic calcium carbonates are still observed and more coarse flocculent (Photography 3d) is analyzed. It seems that deposit of calcium carbonate is not adherent.

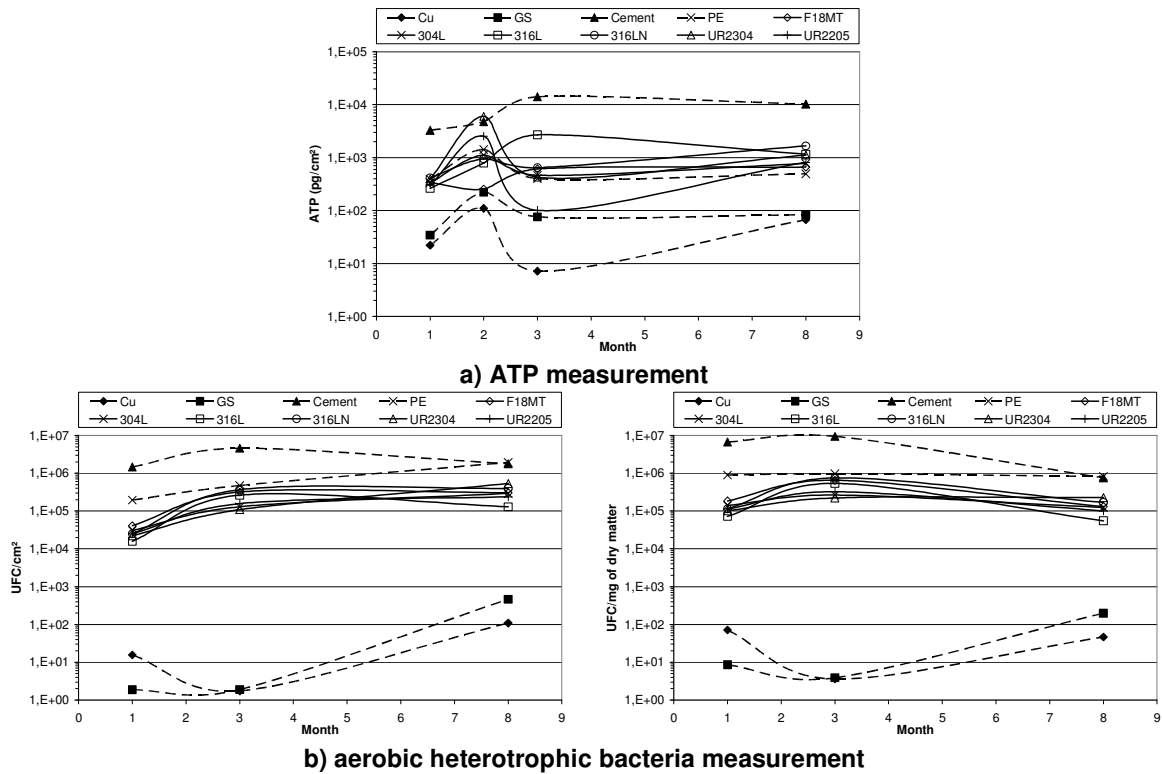
However, it seems that at the eighth month, aerobic heterotrophic bacteria have reached a stable value for cement and stainless steels (Figure 4b). For copper and galvanized steel, the contamination is still in an increasing phase at the eighth month. Indeed, the value of aerobic heterotrophic bacteria reported to the dry matter increases for copper and galvanized steel, whereas it decreases for the other materials. That could indicate a mineralization of the biofilm, i.e. secretion of bacteria or exogenous component trap.

Figure 4: Threshold of surface contamination: evolution of ATP and aerobic heterotrophic bacteria

As for fouling, ATP presents phases of increase and of decrease, which can be linked to the release of biofilm. This observation may be also linked to free potential evolution observed for stainless steels.
