Initial steps towards a framework to systematically deal with sulfide-induced corrosion problems in sewers

Abstract

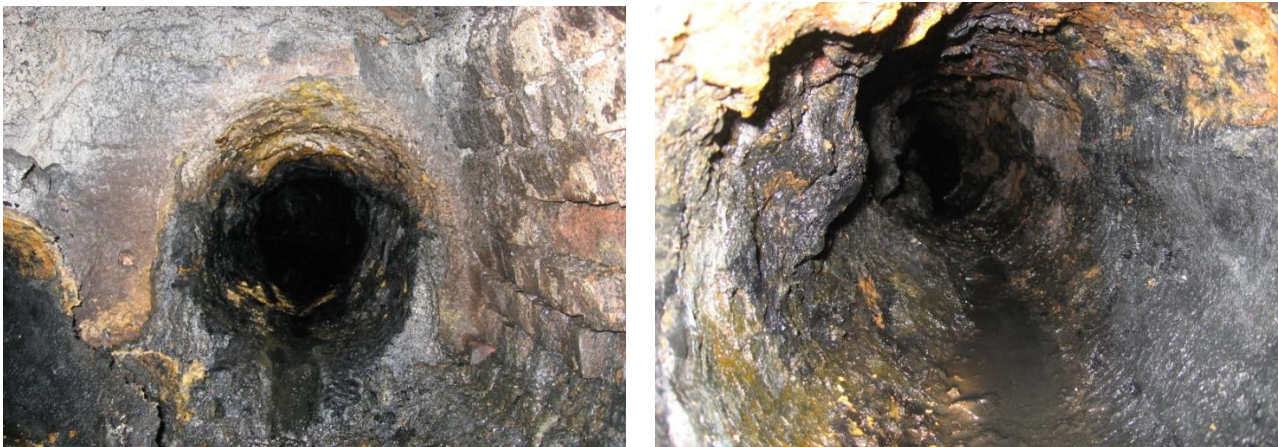
About 12% of the force mains operated by Aquafin are constructed in ductile iron, most of which are quite old and were inherited by Aquafin. When significant sulfide concentrations are obtained in these ductile cast iron pipes, the iron will react with hydrogen sulfide and insoluble iron sulfides (FeS) will be formed (metal corrosion). These FeS molecules will deposit in the pressure main and a thick black layer of sludge is deposited (two examples are depicted in Figure 2). As a consequence, also the mechanical strength of the pipe will decrease as iron is gradually leached out. The pipe becomes thinner and groundwater infiltrations may be expected.

Figure 2: Illustrating the effect of hydrogen sulfide in a cast iron pressure main in Flanders (Belgium).

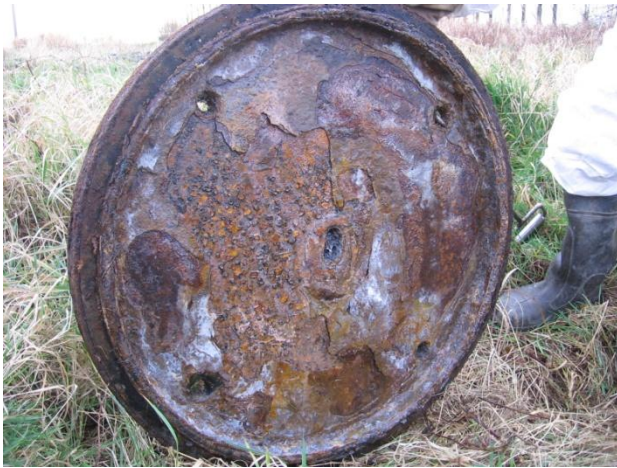
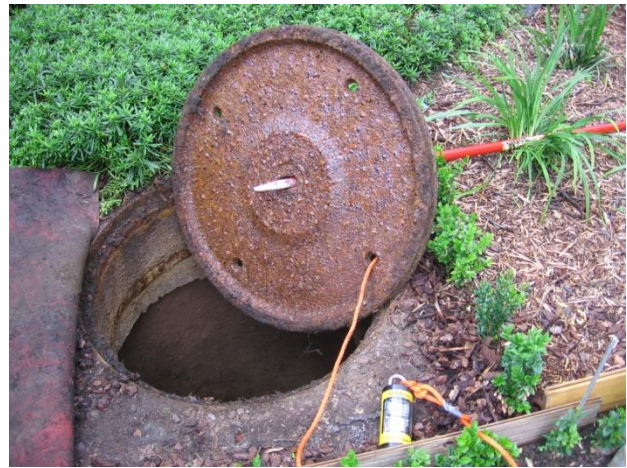
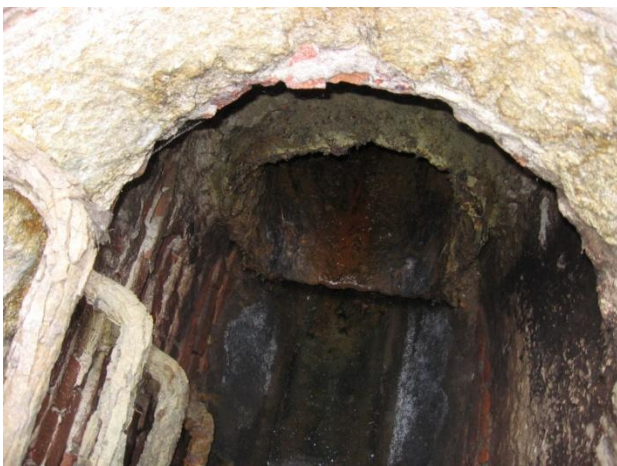
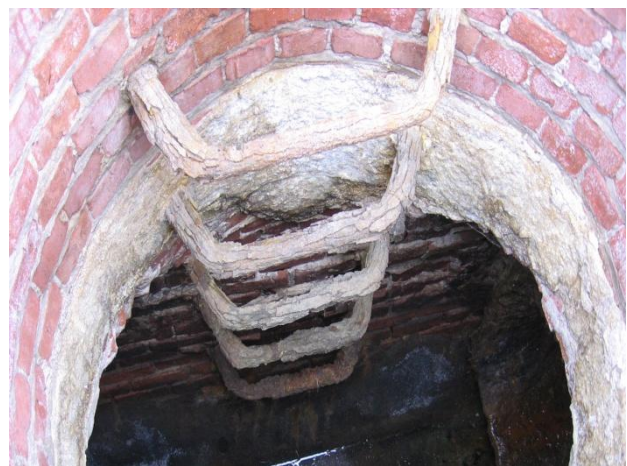
Inspection chambers or manholes are usually built in concrete and covered with a cast iron lid. The manhole in which the wastewater from a force main is discharged, as well as the manholes further downstream may also be exposed to significantly high concentrations of sulfide. Indeed, as this discharge is usually accompanied with a lot of turbulence, a significant fraction of the hydrogen sulfide gas present in the wastewater will be emitted to the sewer atmosphere. As it absorbs in condensate present on the iron lid and on the concrete walls of the manhole and the gravity sewer downstream, corrosion problems will arise (as illustrated in Figure 4).

Figure 4: Illustrating the effect of hydrogen sulfide on cast iron lids covering of manholes (a-b) and ladders (c-d).
