2-06

A new corrosion probe

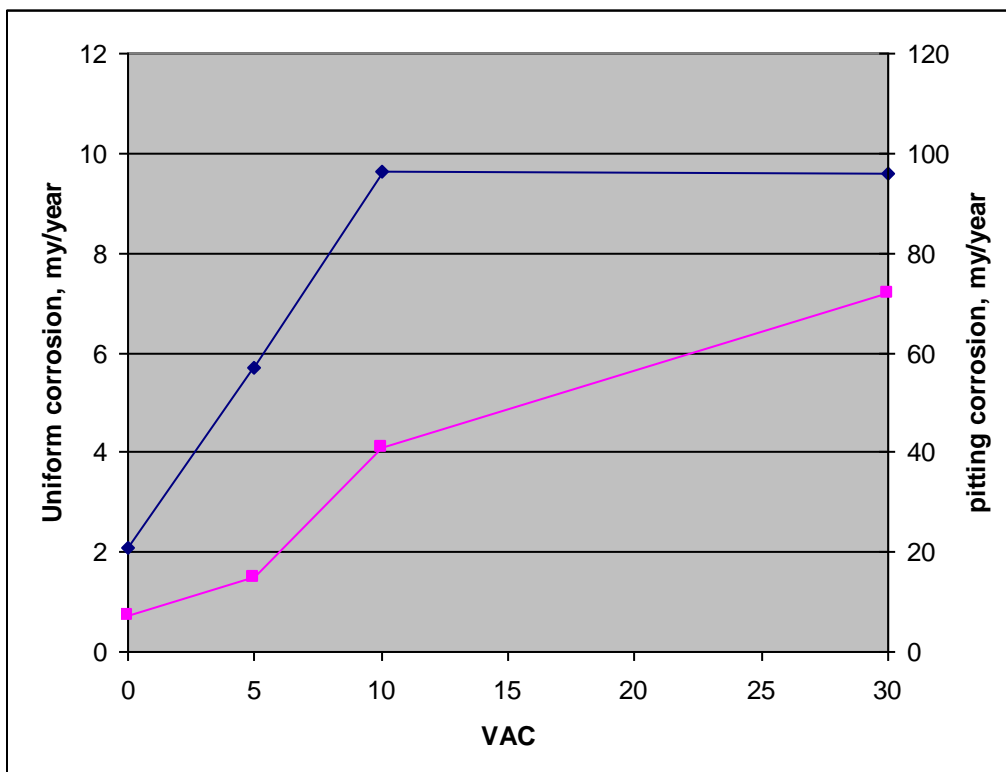
Figure 1. Uniform and pitting corrosion rates in clay with a CP level of -1100 mV and different AC voltages (uniform corrosion = blue line, pitting corrosion = red line).

The results are based on triplicate samples. As can be clearly seen, the maximum pitting corrosion rates are a factor 5 to 10 greater than the corrosion evaluated as uniform corrosion (mass loss). It is therefore of vital interest to monitor the local corrosion rate.

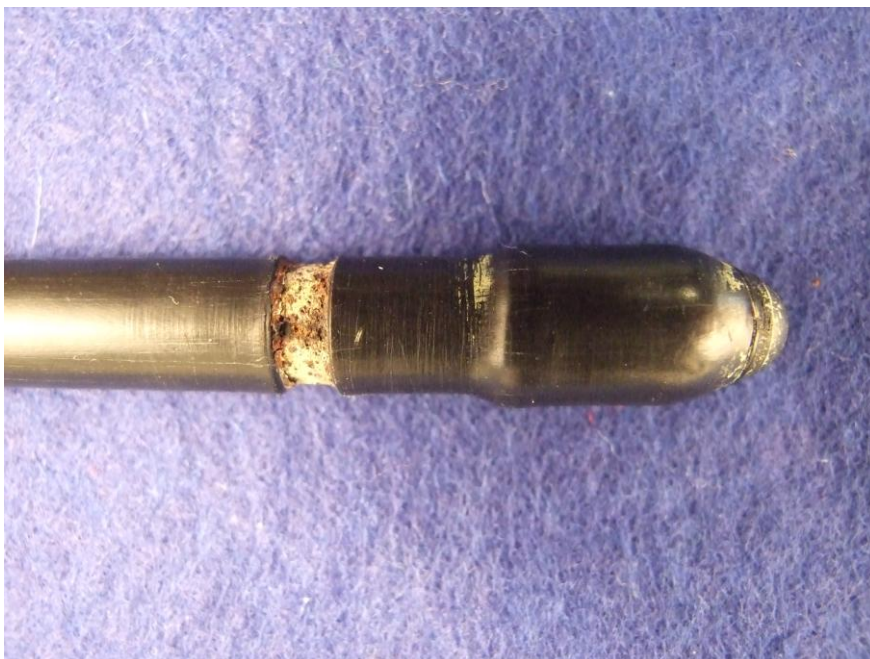
Figure 7. Test probe after exposure for 60 A/m^2 AC and cp from a zinc anode.

The probe was immersed in tap water and given CP from a large zinc anode. An AC current (60 A/m^2) was super imposed to the DC current. After 5 months the test was interrupted. The exposed surface before and after removal of coating and corrosion products are presented in figure 7 and 8.

As can be seen from figure 7, severe corrosion has taken place at the edge of the defect and the remaining surface is close to unaffected. High corrosion rates at edges have been reported earlier and been explained by higher DC current densities at edges (2).

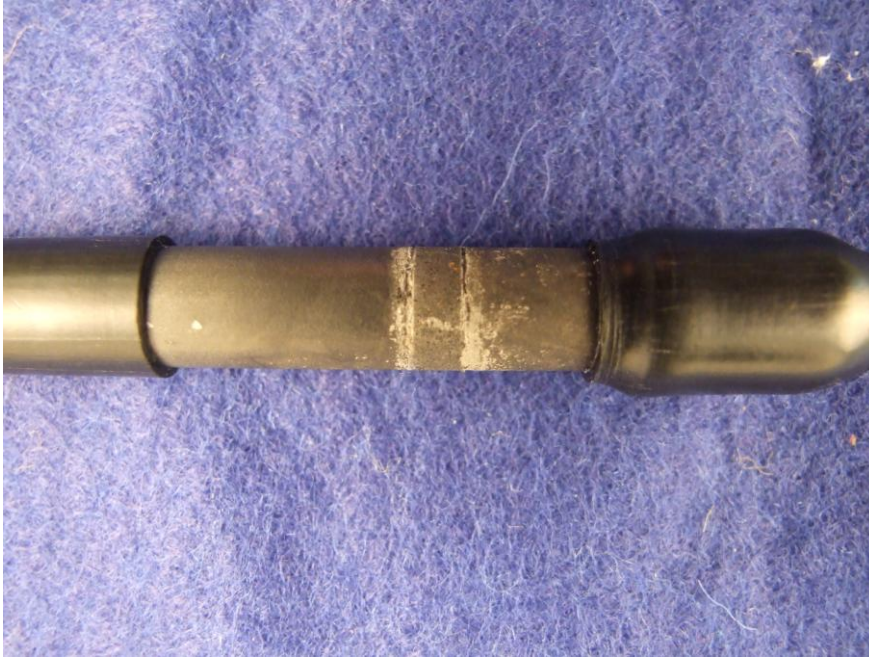
Figure 8. Test probe after removal of corrosion products.

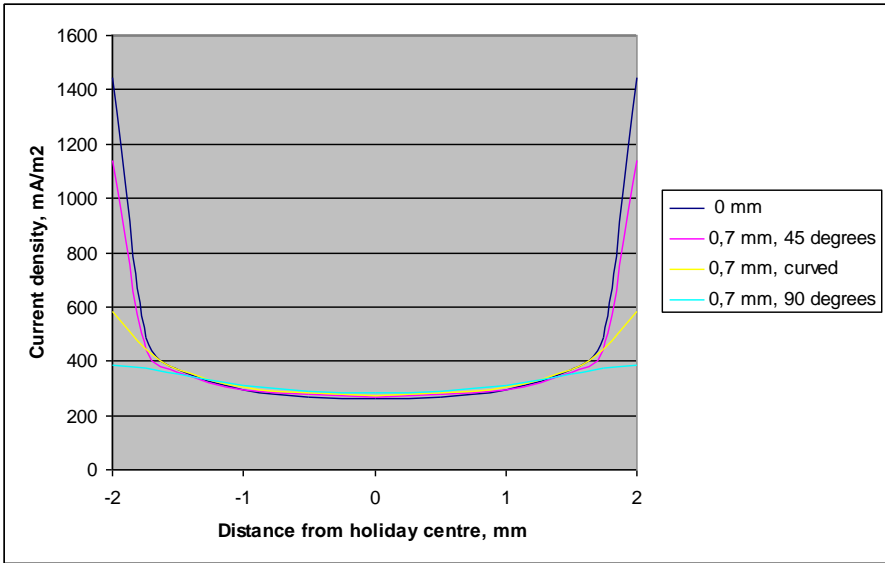
Figure 12. Calculated current distribution for a cylindric defect, 1 cm², with coating thickness of 0 mm as well as 0,7 mm and with different geometries.

In our exposure test, the coating thickness was 0,7 mm and the coating edge “90 degrees”. Figure 12 shows that the variation in current density between the defect centre and the edge is not big, 300 as compared to 400 mA/m². Even though the differences in corrosion attack is dramatic between the edge and the centre. This indicates that the DC current density is not the whole explanation. As can be seen in figure 16, the scale is cracked in the vicinity of the edge, probably due to internal

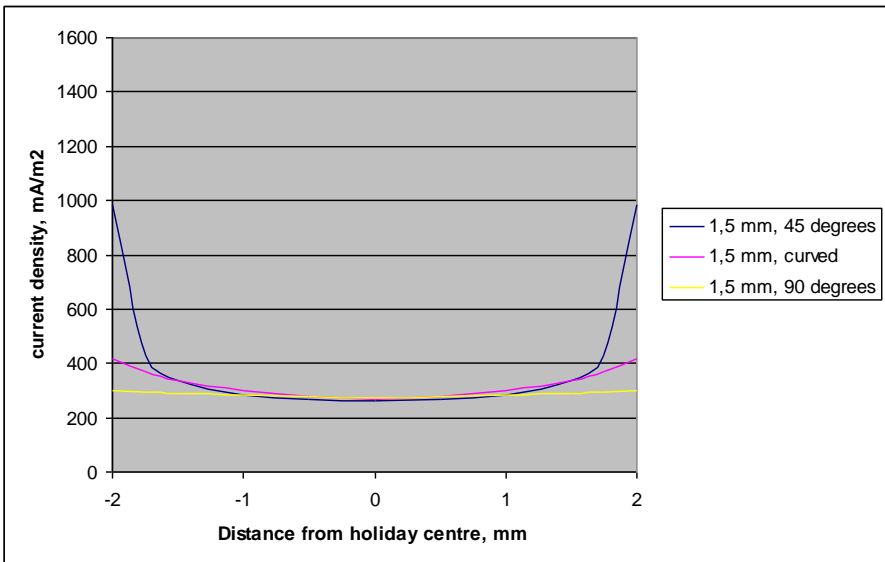
Figure 13. Calculated current distribution for a cylindric defect, 1 cm², with coating thickness of 1,5 mm and different geometries.

At a size of 1 cm² the spread resistance for a defect is 30 % lower for a cylindrical defect as compared to a circular defect. The calculations show bigger differences in current densities between the two type of defects but this is due to different models being used. For the circular defect we have used an isolated plane giving a half spherical field. In the cylindrical case the field is spherical. The variations in current density over the defects are however not influenced by this. The results are presented in figure 10 – 15.

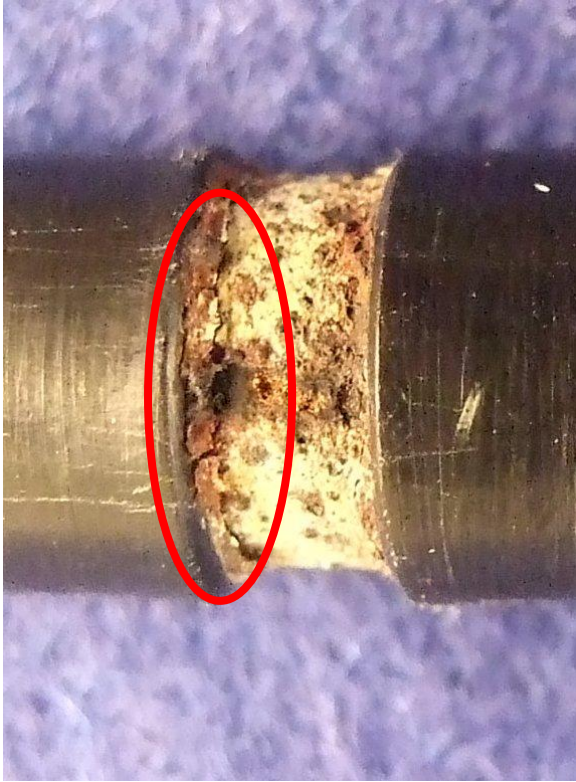
Figure 16. Cracks in the scale, in the area of severe corrosion.

stresses. This may cause more current to be transferred in a resistive and less capacitive way in this cracked area.
