**RENEWAL OF THE FREE-RUNNING SPRINGWATER PIPELINE BETWEEN  
GAICHEL AND KOERICH (G.-D. LUXEMBOURG)**

**EVALUATION OF THE CONDITION AND RENOVATION MEASURES**

**SYNDICAT DES EAUX DU SUD L-8386 KOERICH**

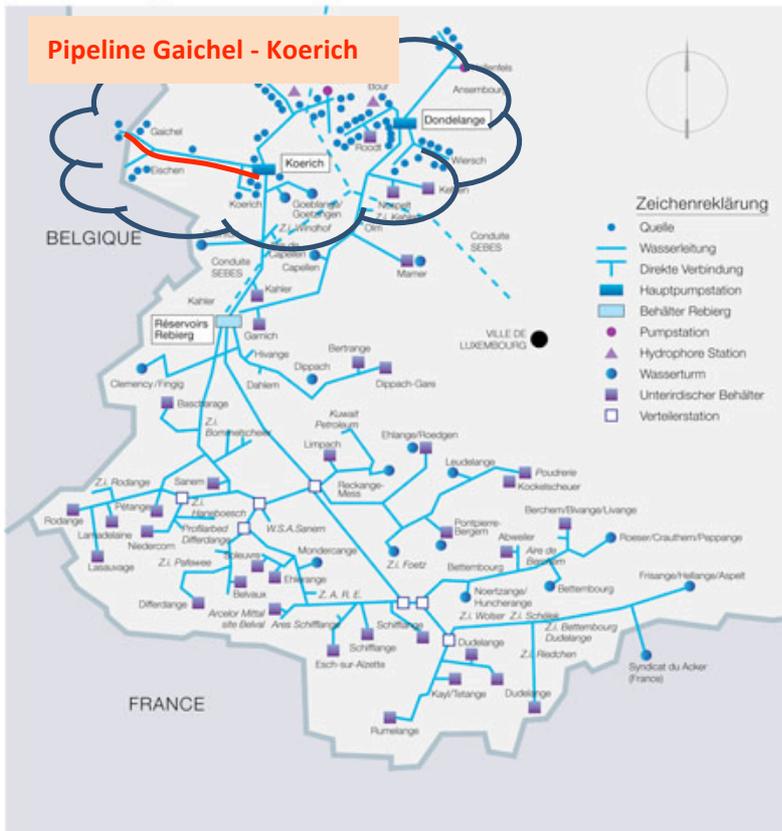
Catchment area and pipe network

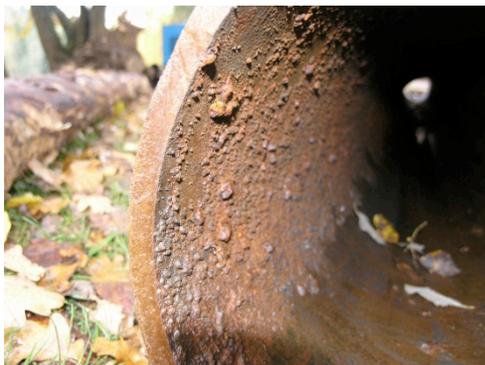
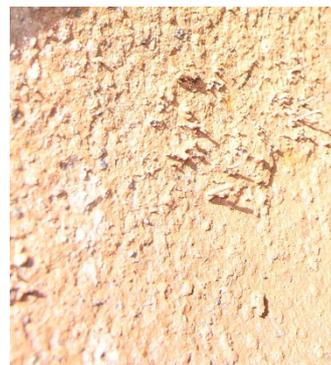
Furthermore, incrustations were found, caused by the deposition of iron.

**Incrustations of iron in the pipes**

In several places we identified cross-section constrictions which reduce the diameter of the pipeline by up to 30%.

On the basis of these findings, the inspected sections of the pipeline were flushed through with the jet washer in order to remove deposits and foreign bodies from the pipeline.

In order to prevent incrustations, the pipeline will in future be cleaned regularly. For this purpose, pipe cleaning boxes are now being incorporated at 500 m intervals to provide access to the pipeline for future cleaning operations.

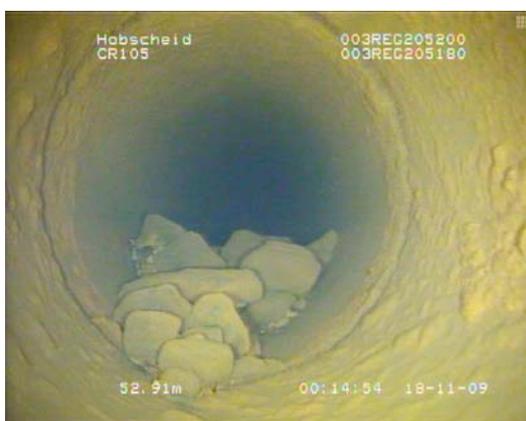
Foreign bodies, such as timber, stones and sand, were found inside the pipeline. These had most probably been there since it was constructed over 100 years ago and have since then impaired the network's performance.

**Stones**

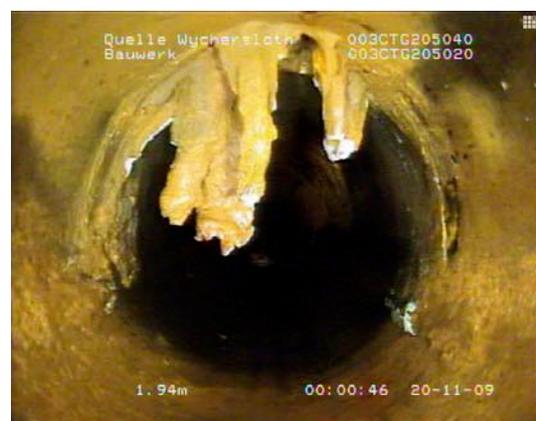
**Stalactites and leaky connections**

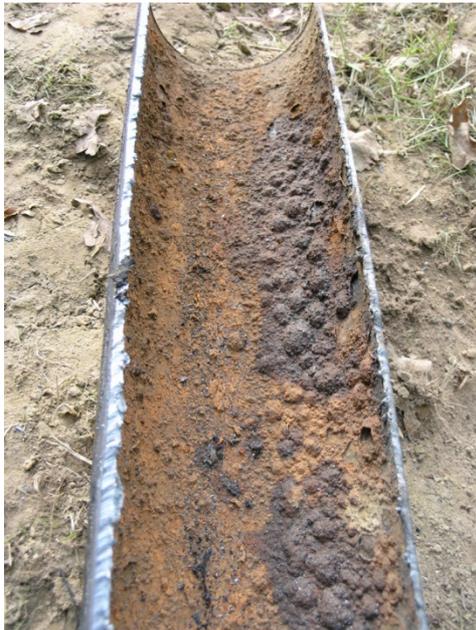
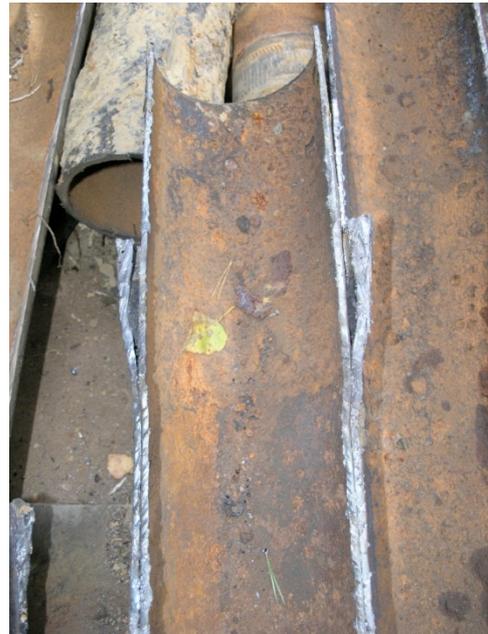
The camera inspection revealed that the Kindel source pipeline was a steel pipe with joints sealed with lead.

Both the cast iron pipelines between Gaichel and Koerich and this steel pipeline were coated externally with bitumen to inhibit the corrosion process.

### **Steel pipeline Gaichel DN 150 – connections sealed with lead**

During the inspection, lead deposits were also found at various places in the pipeline. Evidently the lead had flowed into the pipeline during the sealing operation.

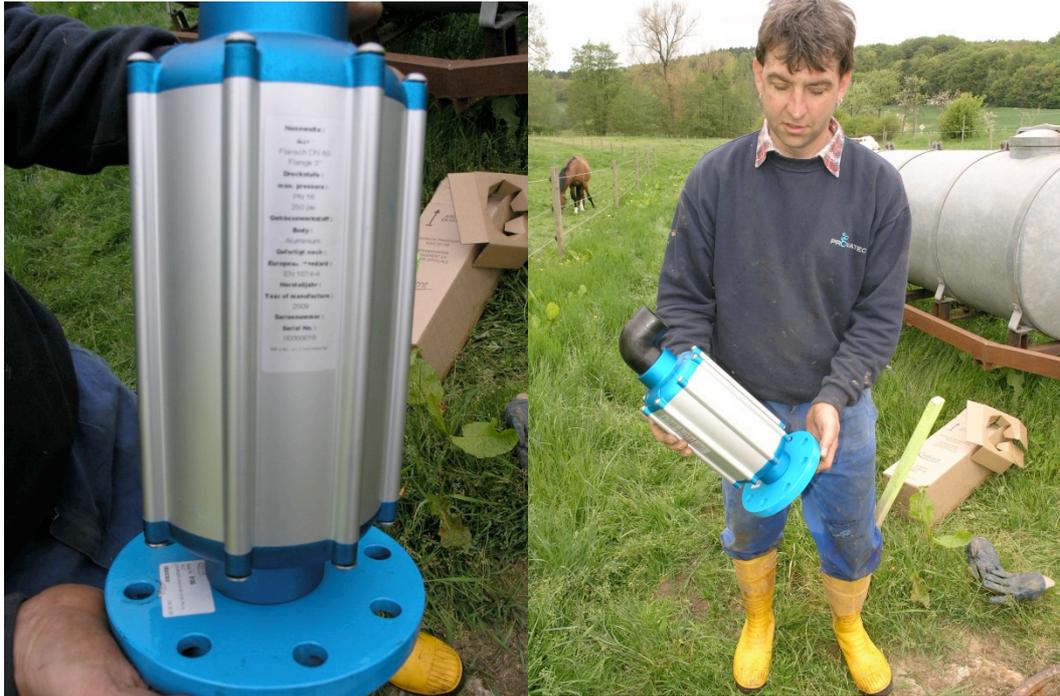
The topographical survey of the pipeline showed that various high points in the old pipeline were not equipped with ventilation devices. Ventilators had to be installed at these high points, and at other points old ventilators had to be replaced with new ones.

Since the headwater pipeline is only exposed to very low operating pressures, ventilation fittings specifically designed for drinking water pipelines with very low operating pressures were chosen. The advantage of these is that they are suitable for low-pressures operating from 0.1 bar.

**Ventilation devices**

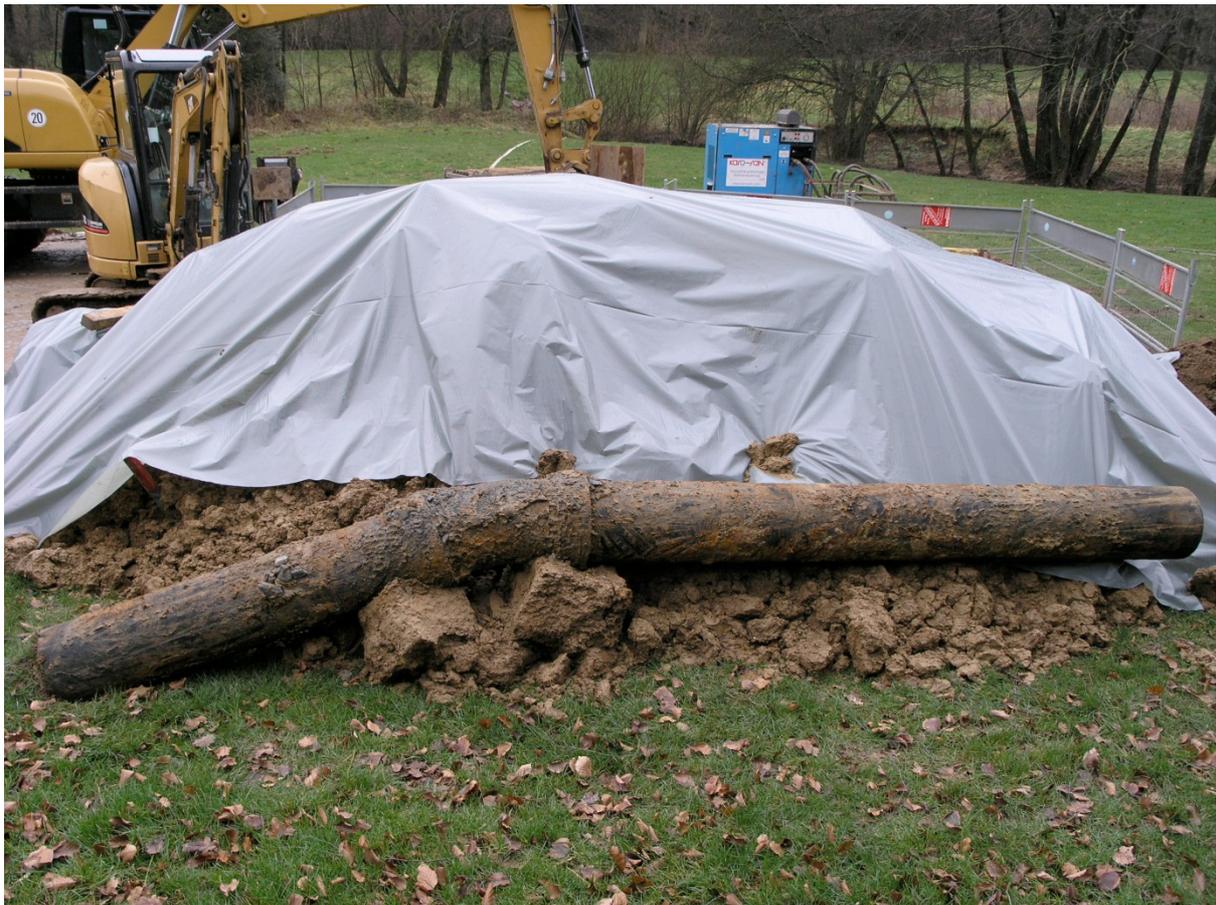
The bends in the pipeline were detected during the camera inspection and subsequently measured topographically. They are the pass-through points, and define the places where machine pits or pipe-laying trenches need to be dug.

### Bend in the pipeline

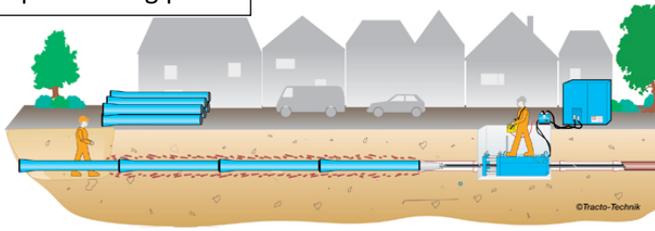
Pipe entering pit

With this method, the new pipeline is drawn through the old one, in the process of which the old pipeline is split open using a bursting head and pushed into the ground. To prevent any fragments of the old grey cast iron pipeline nicking the new pipeline, we used pipes made of ductile cast iron with a reinforced cement mortar shell in a longitudinally force-locked design.

Since the couplings are exposed to particular mechanical strains and stresses, they are protected with sheet metal cones to prevent, for example, any nicks caused by old fragments. Protective rubber sleeves are also inserted between the couplings and the sheet metal cones.

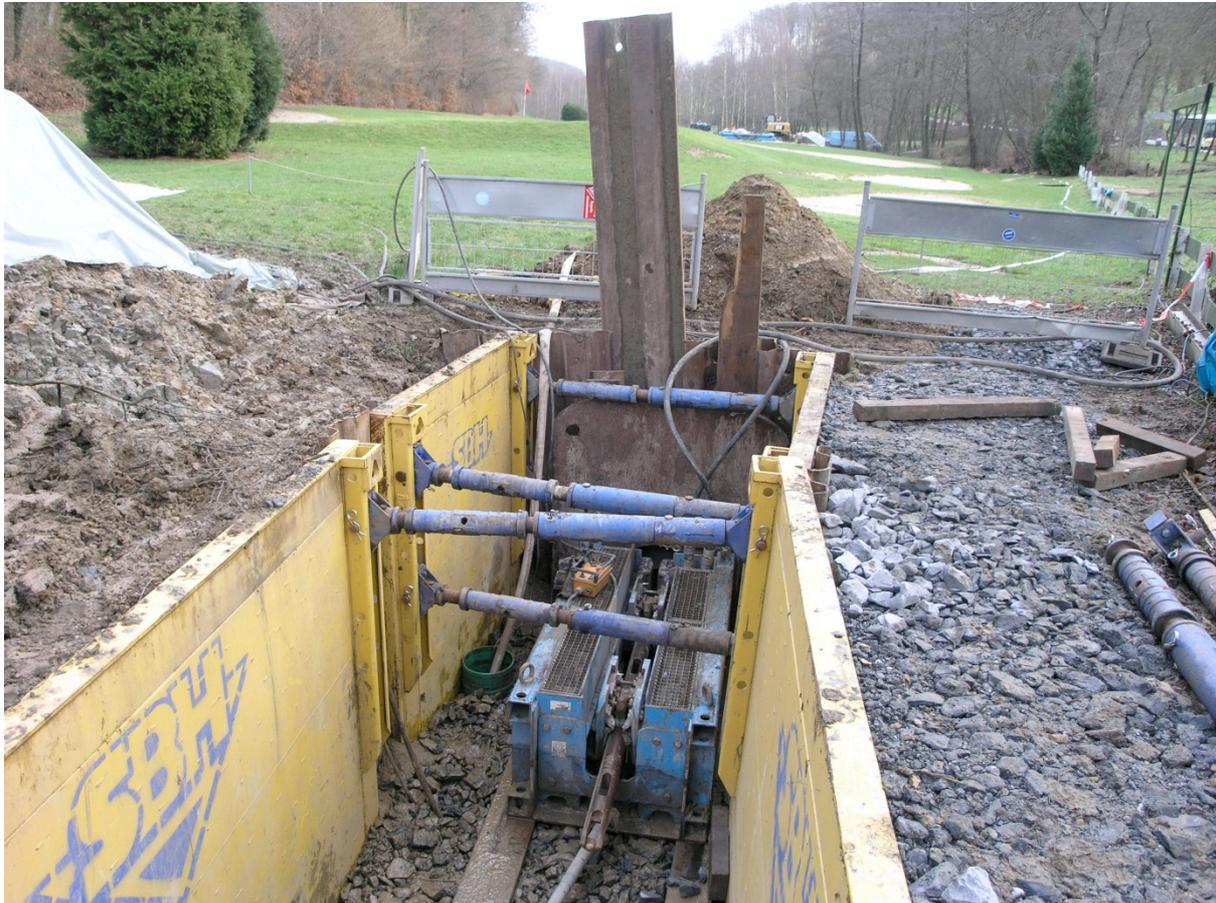
When introducing the pipe, the traction forces are measured continuously to ensure that the maximum permissible traction forces are never exceeded.

**Berst-lining traction unit**

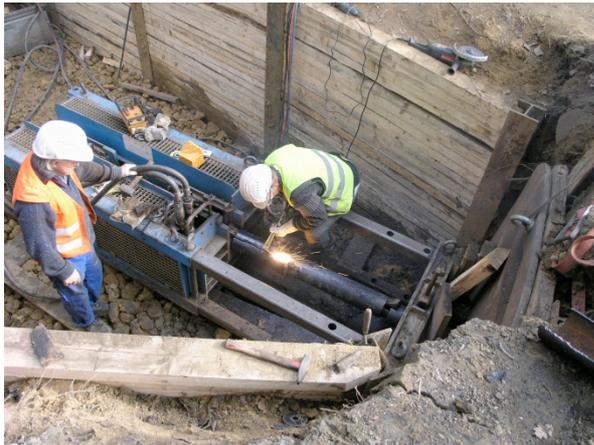
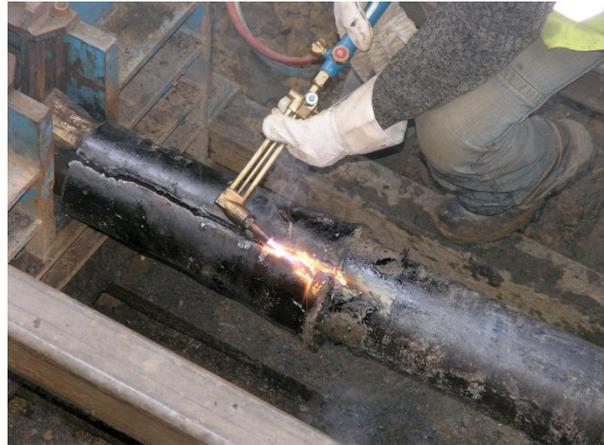
When the Kindel springwater pipeline was laid, the traction force of the traction unit, coupled with the fact that the skin friction of the piping located in the ground was too low, meant that the piping was removed completely by the traction unit.

During the laying process, the old Kindel line therefore had to be flame cut into two half-shells.

**Flame work on the old pipeline**

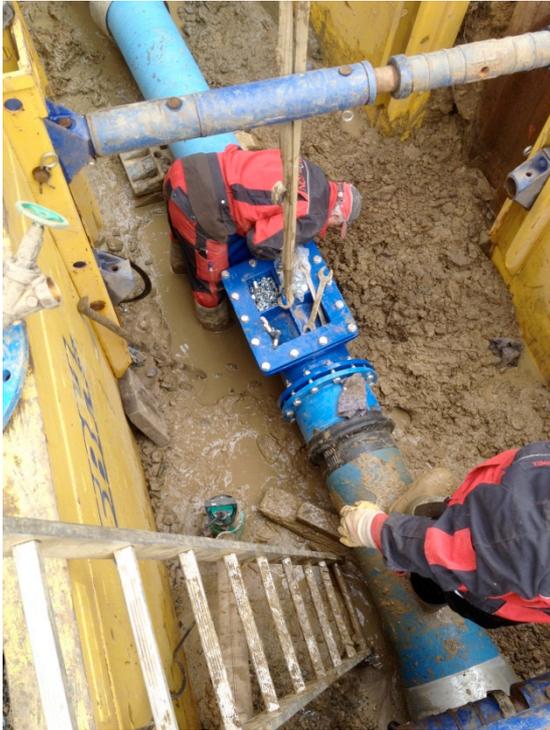
For the renovation of the existing pipeline the burst lining method will continue to be used, although in a modified form. In order to enable longer lengths to be laid at a time, a special technique will be employed by means of which individual sections of pipeline can be pulled in and burst simultaneously.
