"Sustainable corrosion protection of cast iron pipes by cement mortar lining considering the existing water quality"

By Stephan HOBOM, Duktus Rohrsysteme Wetzlar GmbH, Germany

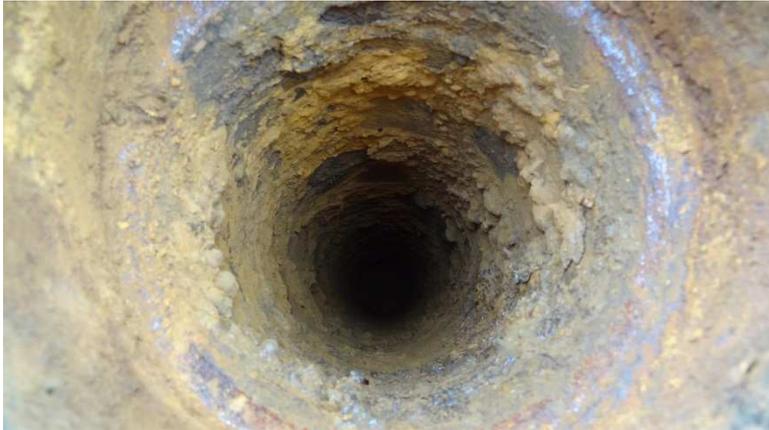
It was not until about 100 years ago that people began to coat cast iron pipes. What they used to do this was tar and later bitumen. These first attempts at a form of passive corrosion protection were, however, not very effective. Deposits of iron or manganese, some solid, still used to keep forming, especially inside drinking water pipes. These incrustations led to significant hydraulic losses and even to the complete blocking of the pipe. Any abrupt increase in flow speed, as can happen for example when a water pipe bursts, could and can lead to the familiar brownish 'rusty water'. Under certain operating conditions and with certain qualities of water it is moreover not possible for protective layers to form, as a result of which corrosion can occur. Picture 2 shows the inside of a grey cast iron pipe from c. 1930 with slight incrustations. No corrosion damage can be seen. This pipe was in use for around 80 years.

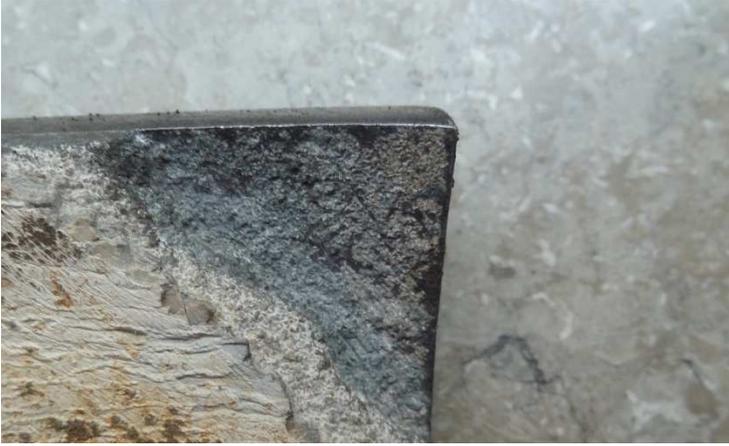
Picture 4

This assessment is reinforced by a visual examination of the cast iron pipe surface underneath the cement mortar lining. Even after 39 years of use no signs of any corrosion at all could be identified (see picture 4).
