Considerations on the Risk of Hydrogen Embrittlement of Pipeline Steel due to Cathodic Overprotection

Hanns-Georg Schöneich, Open Grid Europe GmbH, Essen, Germany

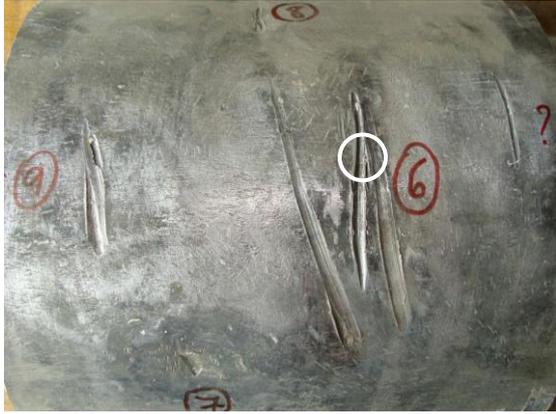
Fig.3: Gouges in the pipe wall of a cathodically protected pipeline

The following provides some details on a case history of a buried pipeline (constructed in 1967 / MOP 66bar). The pipe wall (10.75” O.D. (ND 250) x 5.56mm API 5L X 52) was heavily damaged by a trench cutting machine causing gouges. Cathodic protection on potential was -2.86V (fluctuating due to stray current interference). The pipeline was operated at 38 - 41%(55-60bar) SMYS with some pressure fluctuations. From the operation of the pipeline it may be estimated that crack propagation ran over 18 years. Fig. 3 to 6 show the gouges in the pipe wall and results from metallographic investigations:

- Depth of gouges is between 0.21 and 0.92mm and longest circumferential length was 135mm
- Crack length is app. 0.6mm; the boundaries along the crack path are sharp and complementary with no evidence of corrosion.
- Vickers hardness is app. 350 in the altered and hardened material, compared to HV180 of the non altered material. It should be noted that the propagation of the crack does not exceed the transition from the hardened to the non altered material.

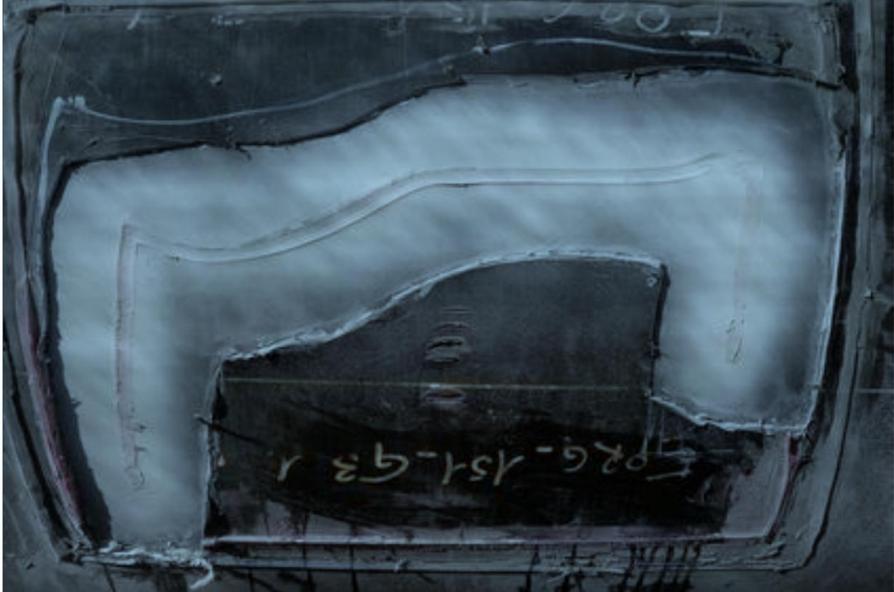
; strain rate: $10^{-8}/\text{s}$
Pipe damages:	Gouge and combination of gouge in a dent - produced by a simulated excavator (35 ton) 15 damages in total The following fig. 10 shows a typical gouge in a dent
Fig. 10: Typical gouge in a dent, produced by a simulated excavator; the picture shows the gouge after the test (coating partially removed due to MP-testing)
