## **Rehabilitation and reconstruction of large water reservoirs in the Grand-Duchy of Luxembourg.**

Dipl Ing. Tom LEVY  
Syndicat des Eaux du Sud (SES) – Koerich (G.D. Luxembourg)

### **Summary**

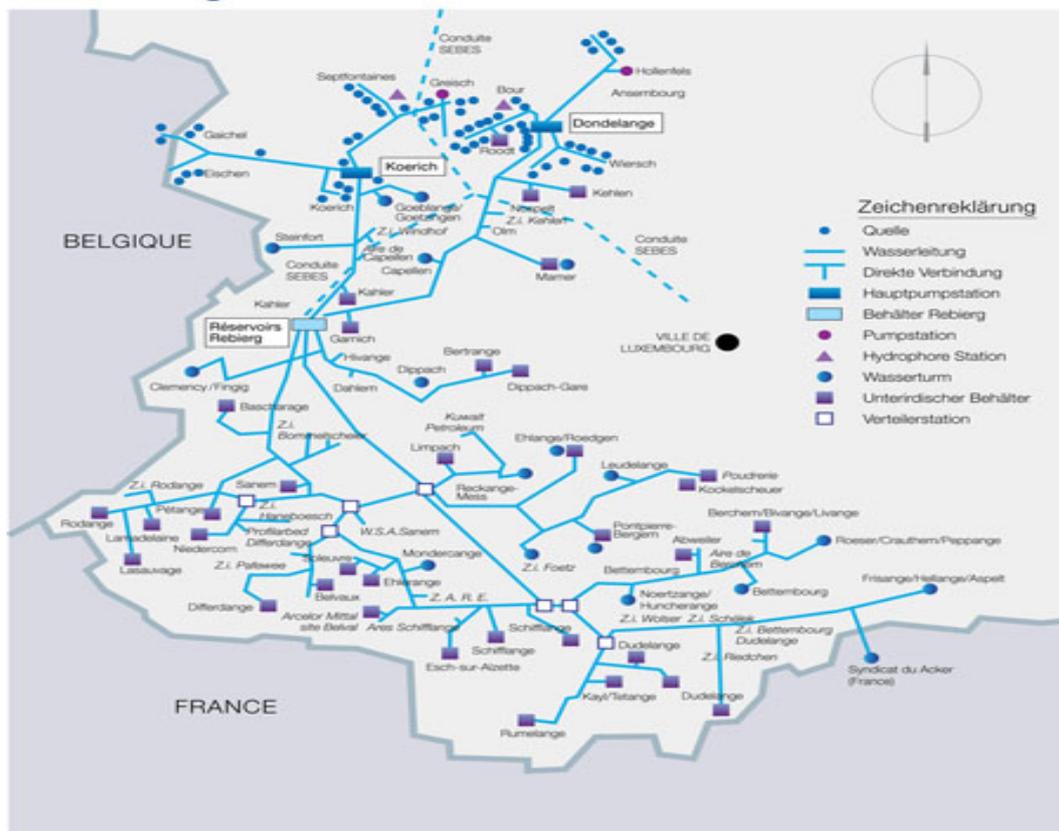
Sixty-five spring catchments in all, which draw their water from the Luxembourg Sandstone geological formation, supply spring water to the two pumping stations in Koerich and Dondelingen, from where it is pumped to the main reservoir on the "Rebierg", the highest point in the area supplied by the SES.

Catchment area and pipe network

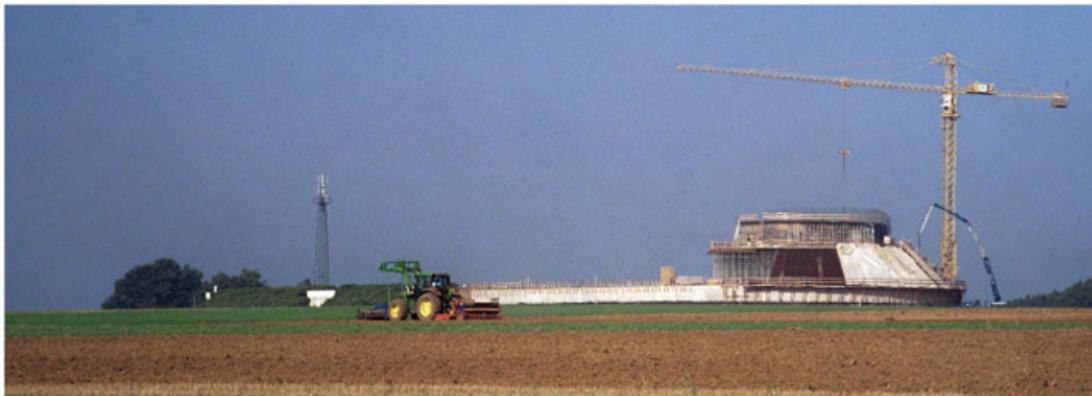
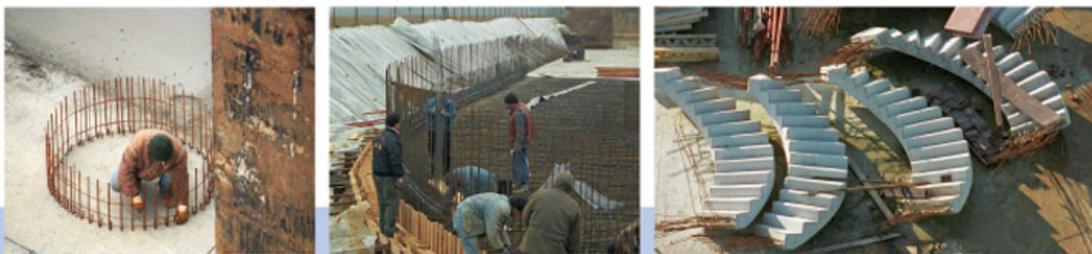
### RebiERG reservoir construction

The shape of the new reservoir, especially of the water tower, was very ambitious, in order to get the best integration in the natural surrounding. Insufficient on-site work planning by the contractor as well as bad weather conditions (heavy rainfall during concrete installation) lead to a very poor concrete quality of the outer walls of the reservoir. Also the formwork was not able to resist to the pressure of the concrete and resulted in an irregular surface.

The first proposition was to demolish the whole structure and start reconstruction! Instead of this it was decided to improve the surfaces by covering them with shotcrete. Nonetheless the first test filling showed numerous leaks that could not be accepted.

Even after injection of the numerous cracks many leaks remained, and, after a second injection of the remaining cracks, it was decided to cover the whole interior walls of the reservoirs with an impermeable membrane.

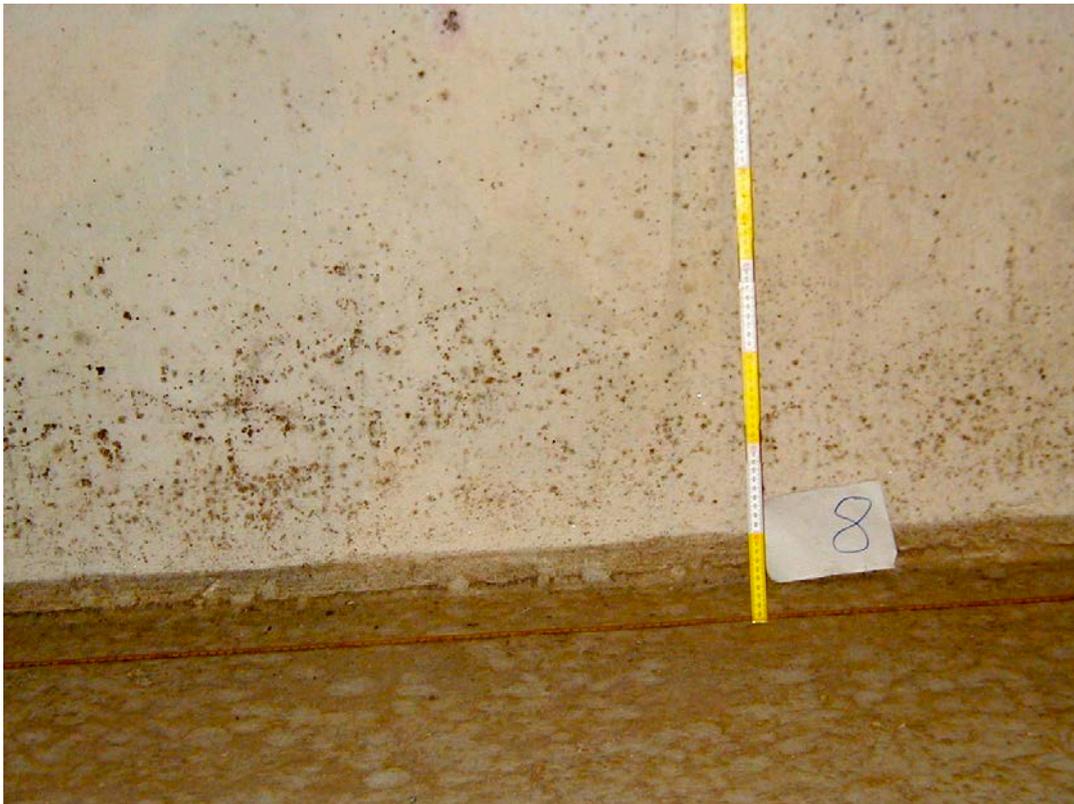
Unfortunately soon numerous blisters appeared, especially on the soil of the reservoir. On the affected surfaces the membrane was removed by sandblasting, and replaced by another cement membrane including a synthetic resin. Unfortunately another, much more severe problem appeared, just days before the tanks should be filled with water and go at last into operation. In fact the membranes had started developing mycoses ("Aspergillus"), especially on the bottom of the walls. A new expert concluded that this was due to insufficient mixture of the membrane material before application.

### **Mycoses on the internal coating**

This then lead to parts with elevated organic materials, that could not be embedded into the hydraulic matrix, resulting in the formation of mycoses.

In order not to endanger the health of consumers the whole of the recently applied coating had to be removed again with dry sand blasting. Removal by sand blasting is preferred versus hydraulic demolition as it results in a smoother concrete surface, thus reducing the quantity of materials to be applied afterwards. Also we avoided in this way introducing additional mycoses into the walls and problems with treating the contaminated water.

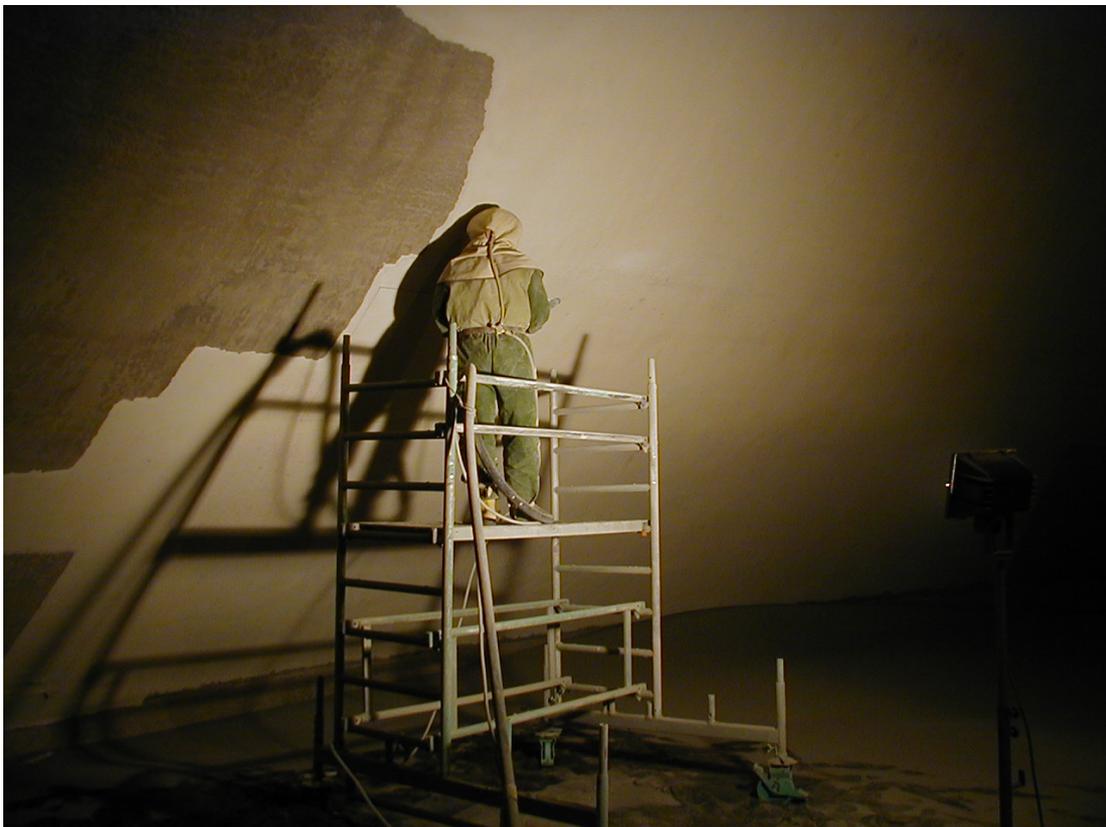
### **Removal of waterproof membrane by sandblasting**

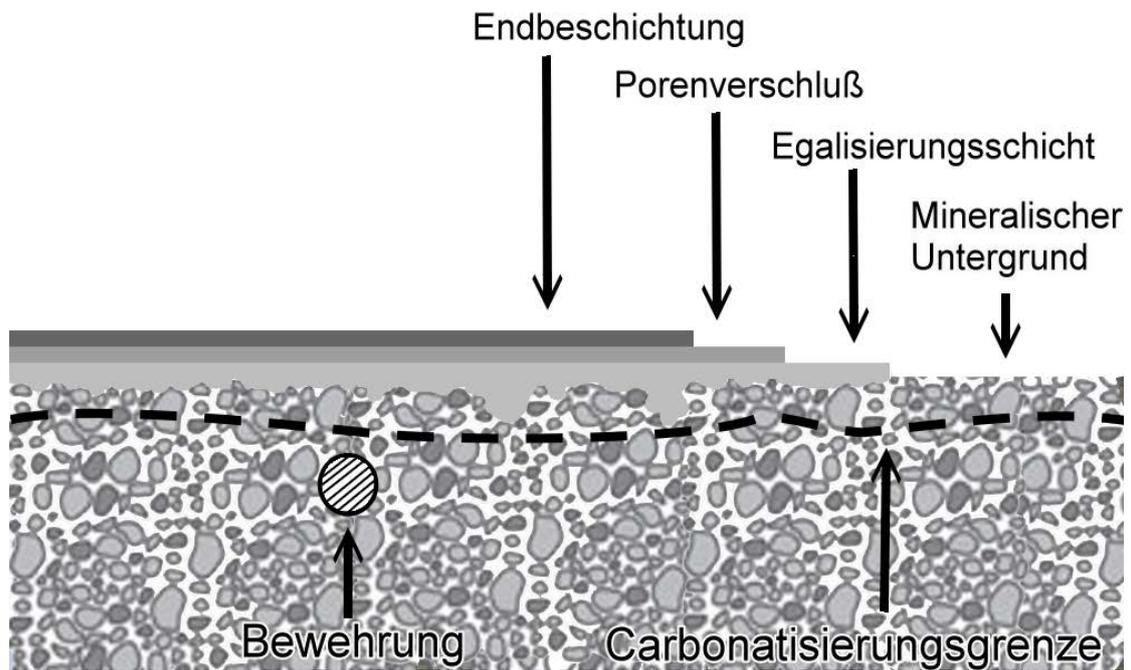
As conventional solvents are rarely used, problems arising from solvent retention are eliminated. The resulting higher viscosity of the coatings requires application by hot spraying or the use of heaters. By a double manual application the concrete and sandblasted surface is leveled and pores are closed before the top coat is applied by hot spraying. The resulting surface is smooth, non-porous and chemically inert, so that the cleaning costs are minimal and no substances can penetrate. Also the thin layers of the epoxy resin coatings avoid important additional static loads. The principle is the hermetic seal of the substrate, so that the concrete is beyond the influence of water and other substances.

**Basic structure of the epoxy coating system**

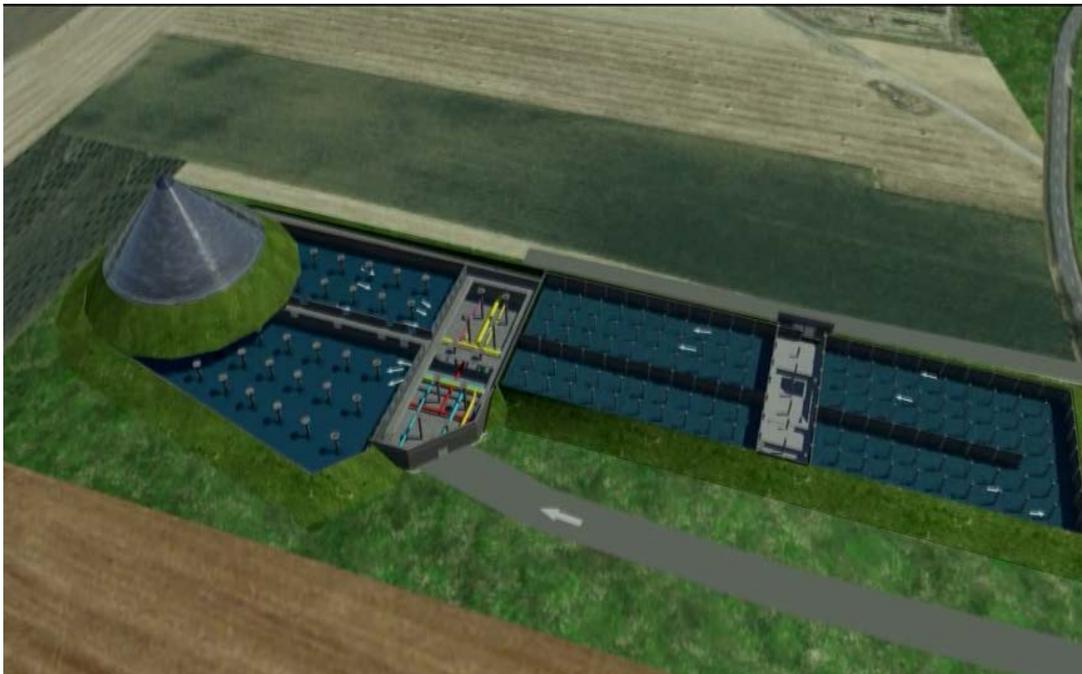
**Water flow in the new (left) and old (right) reservoirs**

Also some internal structural modifications had to be accomplished. Thus the two tanks of the old reservoir were connected by canals, so that water flow coming in would be separated equally between the new and the old reservoir.

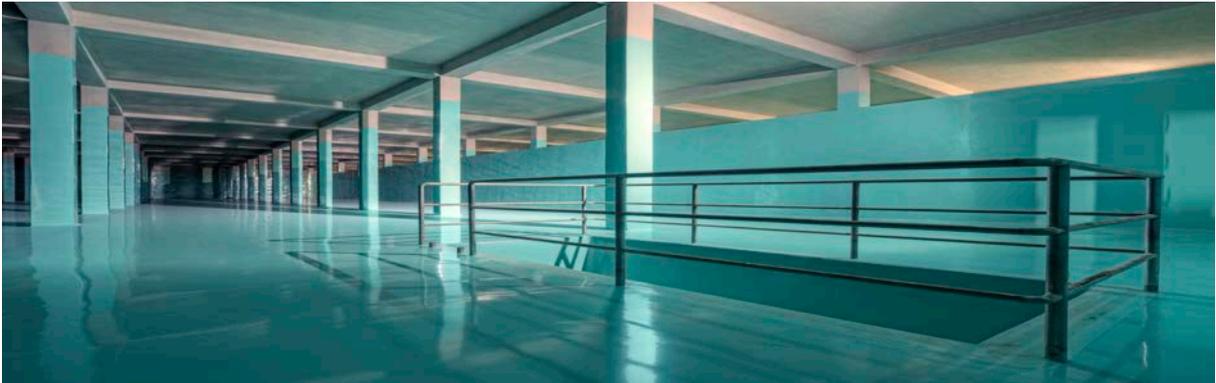
As this reservoir was in operation since 1966, first plans proposed demolition and reconstruction. Finally it was decided to proceed to rehabilitation of the existing building. First the exterior bituminous sealing had to be replaced, as it presented numerous leaks. At the same time the aeration tubes over the water surface were removed and a central aeration and filtration unit was installed

The cement cover of the interior walls had lost strength, and it was decided to remove it by sand blasting and replace it with the same epoxy coating that was used in the new reservoir. Rehabilitation works had been finished in 2014.
