CEOCOR – Stratford May 2018

## POLYMERIC MESH BACKED COATING INTERACTION WITH CATHODIC PROTECTION

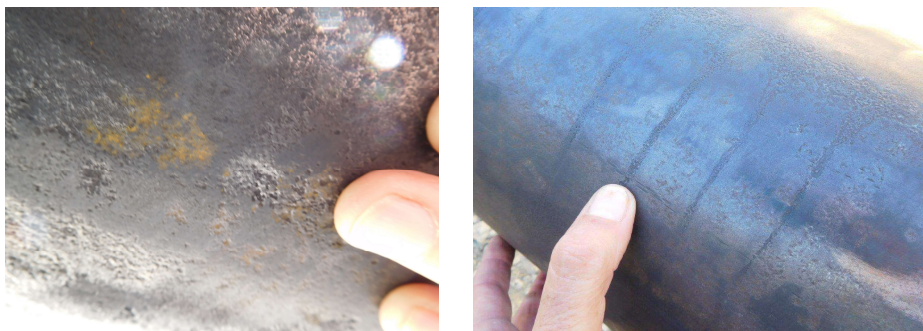
**External Corrosion mainly due to Cathodic Protection Current Shielding**

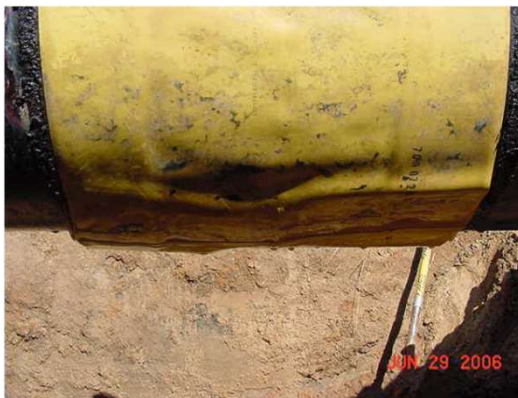
**USA 2006: 10-inch Pipeline**  
Shrink sleeve applied in 1997 and resulting corrosion found in 2006. Shrink sleeve shielded the CP. Pipe potentials met all NACE criteria

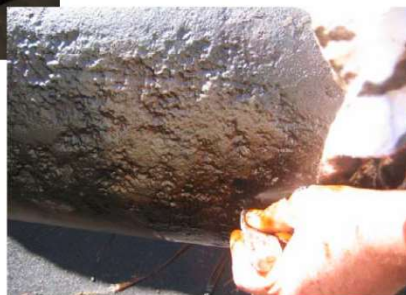
**EDINBURG 2007: TOTAL 16-inch in Syria**  
*Pipeline operated in Syria for about 12 years has revealed severe external corrosion at many girth welds areas coated with HSS (hot-melt adhesive type).*

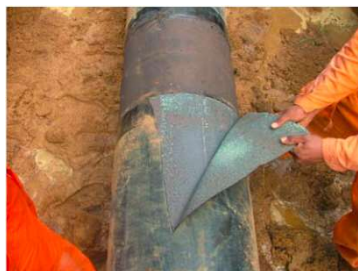
France: pipeline with a 3LPP coating has suffered complete loss of adhesion without any corrosion.

**Gaz de France & Total: Study of the "CP shielding effect" under disbonded coatings.**  
*no detrimental consequence on corrosion with 3-layer Polyolefin (3LPO) systems because the gap remains very low, in opposition to the case of other coatings such as coal tar or asphalt enamels, tapes or heat-shrinkable sleeves (HSS).*

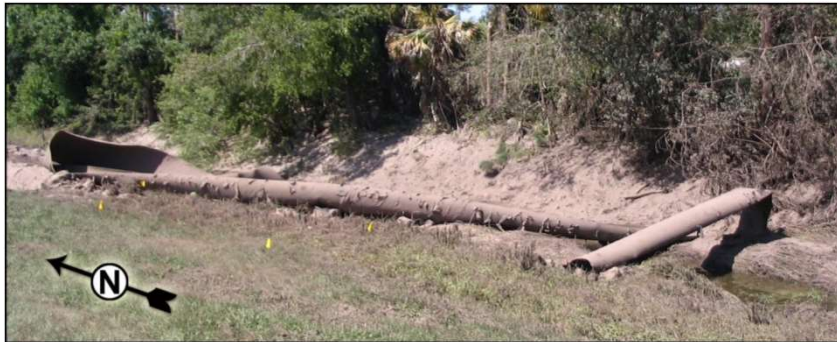
**MAY 2009: Rupture 18-inch Pipeline**  
**Florida Gas Transmission Company**

## Case Study MAY 2009: Rupture 18-inch Pipeline Florida Gas Transmission Company

SCC (Stress Corrosion Cracking) occurs with mechanically failed coating in the absence of adequate cathodic protection (Shielding)

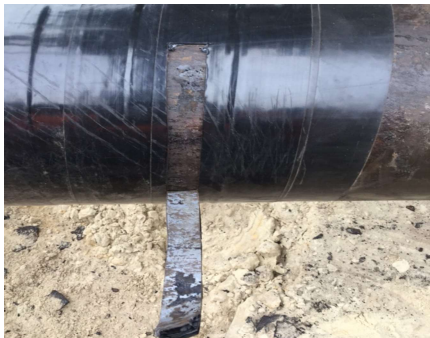
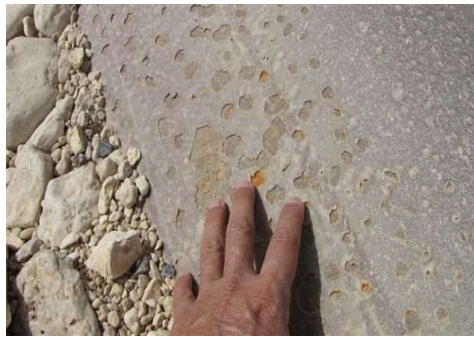
**FAILURE MODE is the most important factor that influences shielding behavior**

Surface preparation is critical for some coating systems  
ISO21809-3: Soluble Salt:  $\leq 20\text{mg/m}^2$  (Chapter 9.1.2.2)

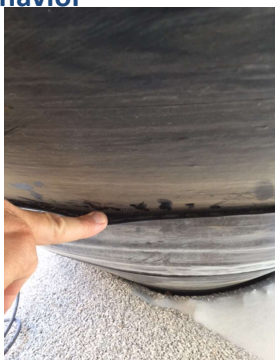
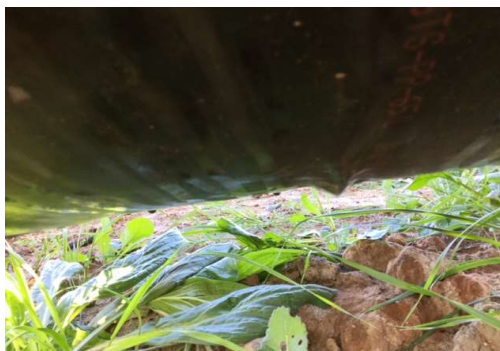
**FAILURE MODE is the most important factor that influences shielding behavior**

**ISO15589-1 Chapter 7.5.1:** *Field joints and fittings coated on site are applied under more demanding conditions and can be a weak point in the general corrosion protection system if not selected and applied correctly.*

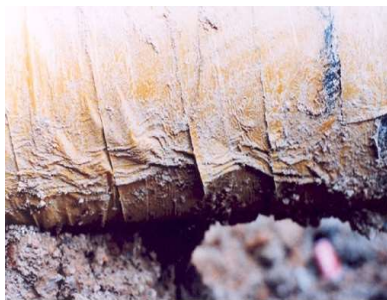
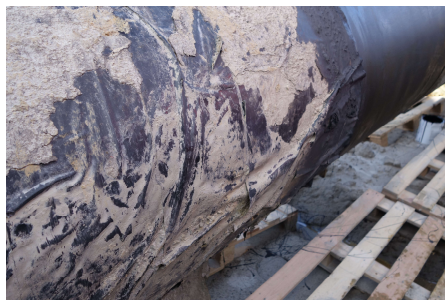
**Poor Soil stress resistance**

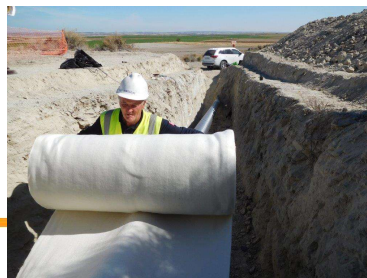
***Soil Stress:*** PP Mesh applied with very high tension + Optional SP-6 (allows CP current flow)

***Rock Shield*** if necessary (allows CP current flow)

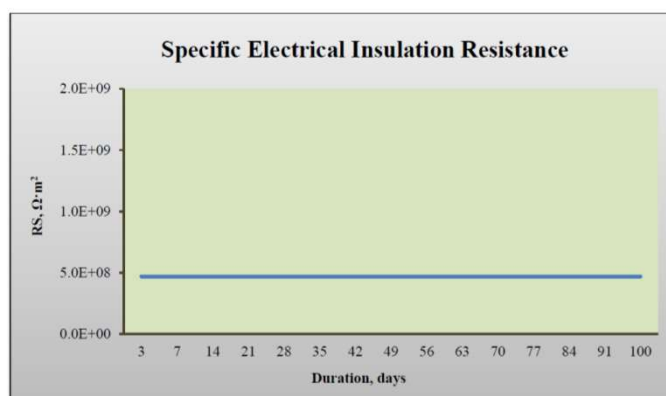
Figure 1. The Plot of the Specific Electrical Insulation Resistance of the RD-6 Polymeric Tape Coating  
verse Time for Immersion in 0.1 mol/L NaCl Solution at 23±2°C

$$R_{S100} = 4,7 \times 10^8 \Omega.m^2$$

$$R_{S100}/R_{S70} = 1$$
