CORROSION AT ISOLATING JOINTS DUE TO CATHODIC PROTECTION

**Dr David Buxton
PhD, MICorr
Principal Engineer**

**Intertek Production & Integrity Assurance,
Manchester Technology Centre,
Units 12-15, Longwood Road,
Manchester
M17 1PZ**

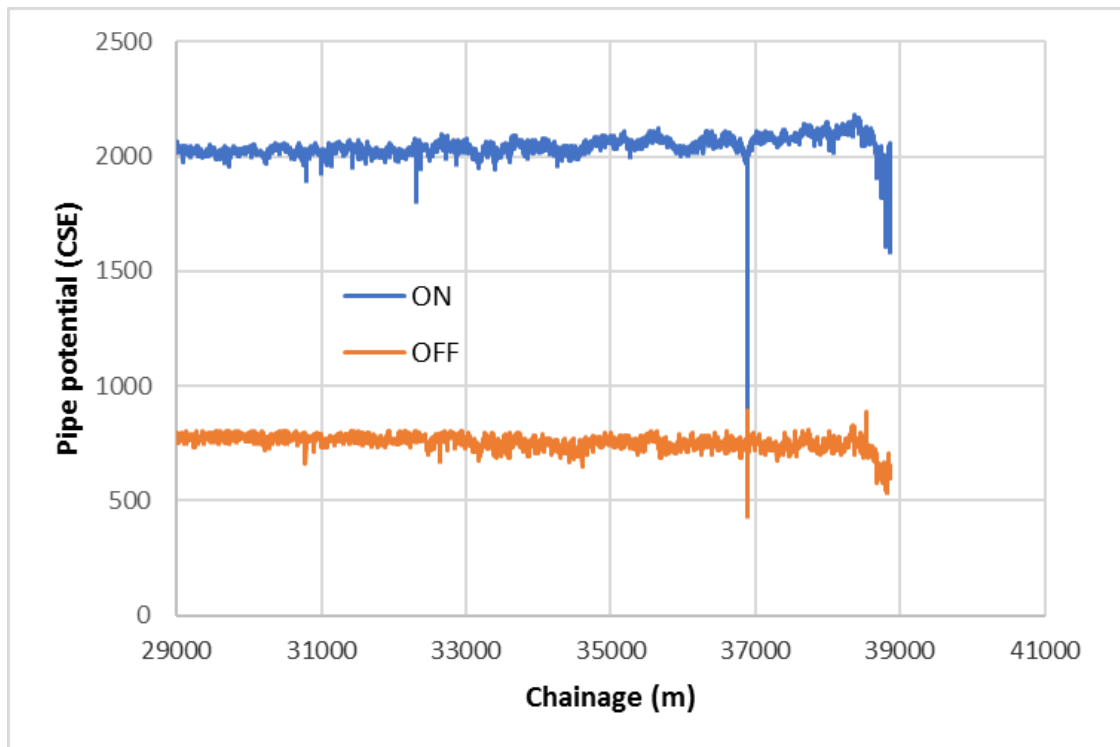
An indication from data collected during commissioning as to whether an IJ or IF is not fully effective, is a reduction in the level of protection and corresponding change in the recorded pipe to soil potential values. See example data in Figure 4 which shows close interval potential survey (CIPS) data measured using a copper sulfate electrode (CSE) connected to the positive terminal. If the IJ/IF was fully tested prior to installation and found to be satisfactory and a change in potential values is seen approaching the isolation at 39 000 m, it could indicate current drain and the possibility of internal corrosion.

Figure 4 Close interval potential data (NB data collected by others)

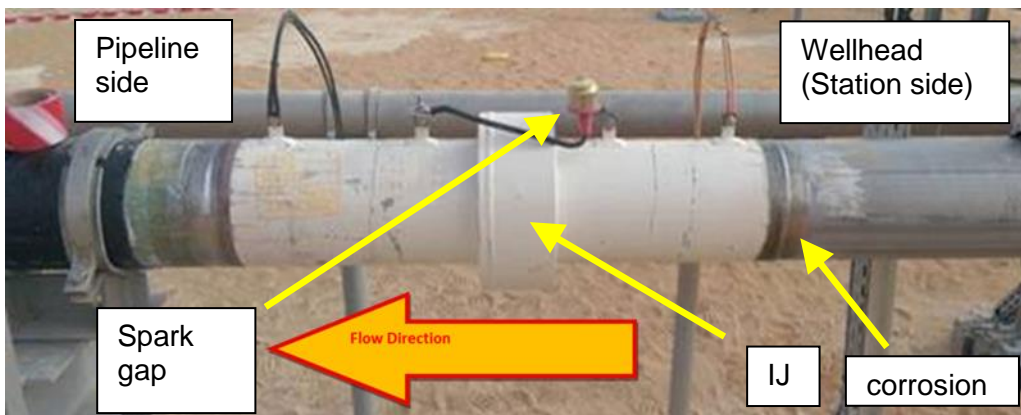
Figure 6. Failure at export line

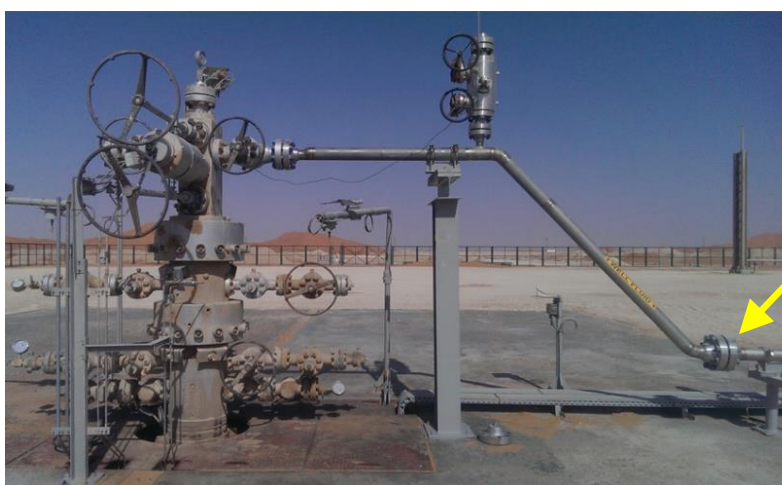
Corrosion damage was also observed at IFs located at the wellhead (Figure 7). Cathodic protection was applied to the well casing via a vertical anode groundbed. The IF was installed close to the well head and was intended to restrict the CP to the wellhead and avoid current drain to the station electrical earthing system. The extent of the corrosion damage at the wellhead IF is shown in Figure 8.

Insulating flange

Figure 7 Typical well head arrangement with IF

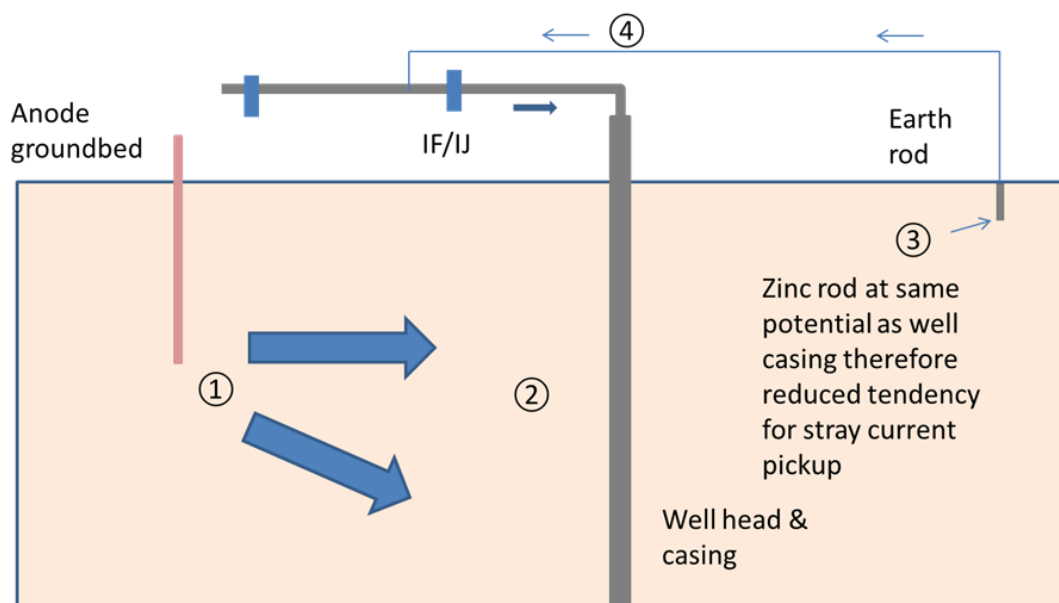
- ① Current is injected into the ground from the anodes
- ② The majority of the current goes directly to the well
- ③ A small amount of current goes to the earth rods
- ④ The current passes through cables, earth straps and pipes , via the IF to the well

Figure 11. Minimising stray current at the wellhead IF by earth system modifications

In Table 3 modifications to the earth system are suggested as methods to mitigate the stray current corrosion, including relocation of the copper rod and a change from copper to zinc. The reason for the relocation is to increase separation distance between anode groundbed and thus make the rods a less attractive path for current. The change of material is suggested because copper has a noble potential and if placed in a voltage field where stray current can pick-up onto the surface, the current density will be high in comparison to zinc coated rods. As for CP design, if zinc electrodes or coated rods are used instead of copper the effective CP drain is reduced (see EN 14505, section 6.7 [2]). It is noted that the relocation and change to zinc may only reduce the current flow through the bond and not offer a complete solution.
