CEOCOR

Paper 2021-04

Assessment of isolation between a metallic casing and a pipeline by means of remote monitoring and coupon

*by I.Magnifico (AUTOMA S.r.l., Ancona, Italy)
A.Bonetti (Cathodic Protection Co, Grantham, United Kingdom)
R.Gutiérrez (EXOLUM, Madrid, Spain)*

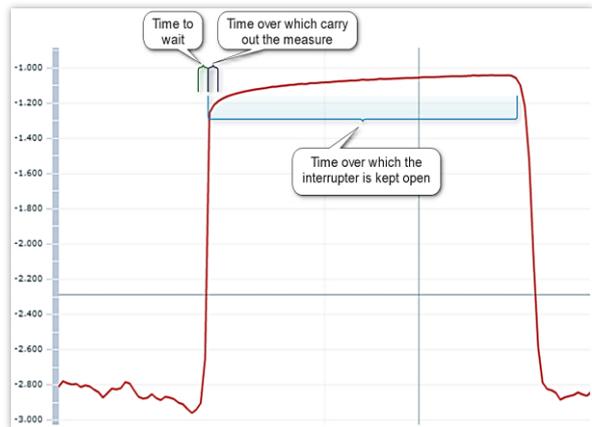
Fig.6: timing setup of the measurements

The continuous instant off measurement on coupon has been performed as shown in Fig.6:

Instant off timing setup	Time to wait	1 ms
	Time over which carry out the measure:	20 ms
	Time the interrupter is kept open:	22 ms
Total coupon ON/OFF timing	Total time coupon OFF during 1s:	22 ms
	Total time coupon ON during 1s:	978 ms
Measure frequencies	Eoff (Coupon instant-off potential)	1 s
	Eon.dc: (Pipe On potential)	1 s
	mIon: (Coupon polarization current)	1 s

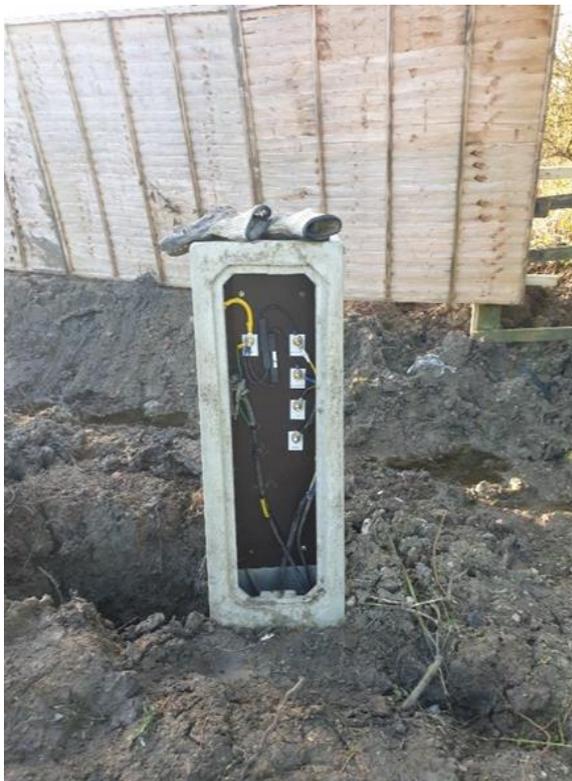
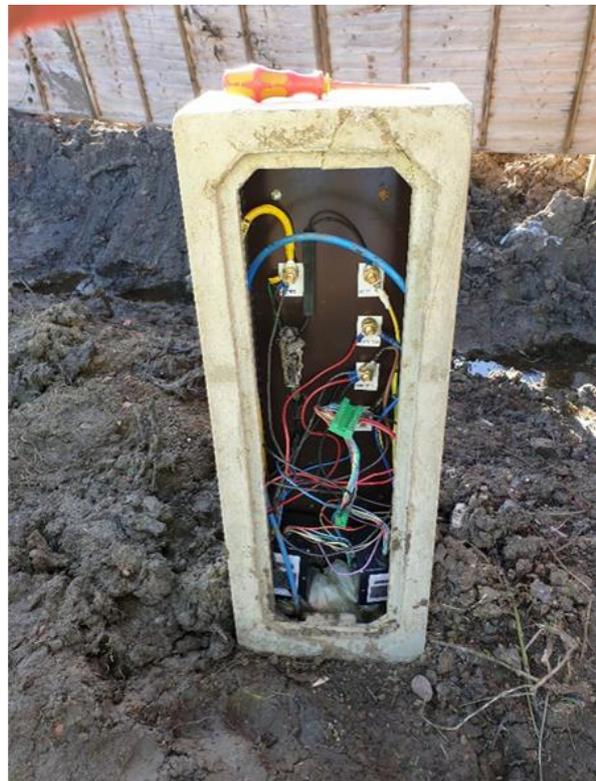
Fig.7: test site before and after test preparation

In the pictures in Fig.7, a view of the test post before and after the installation of the materials required by the test is shown:
