**CEOCOR 2007
MALAGA (SPAIN) 8 - 10 May 2007**

Paper A06

a.c. corrosion – Some results of the activities

L. Di Biase – R. Cigna – O. Fumei - ISPRONA S.r.L

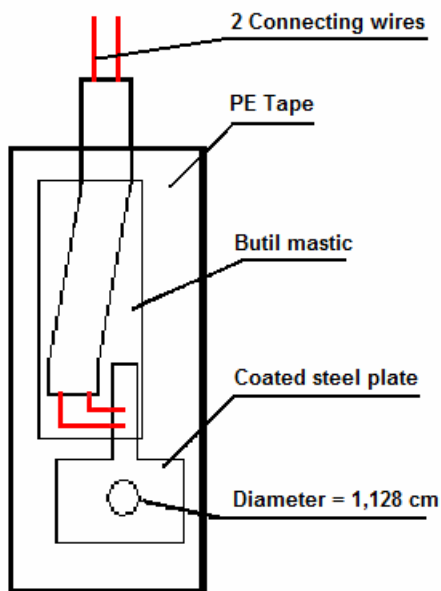
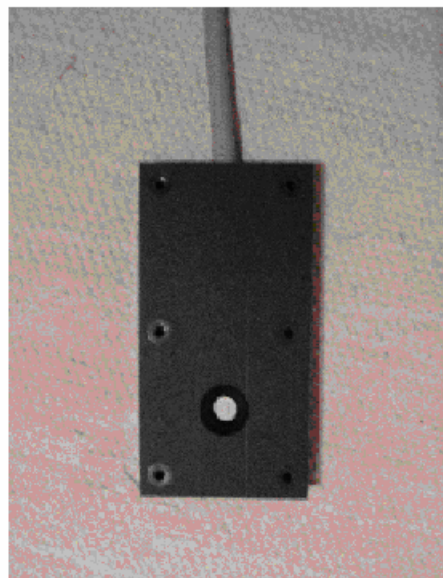
a.c. Corrosion Coupon

The old a.c. Corrosion Coupons have been replaced with new ones.

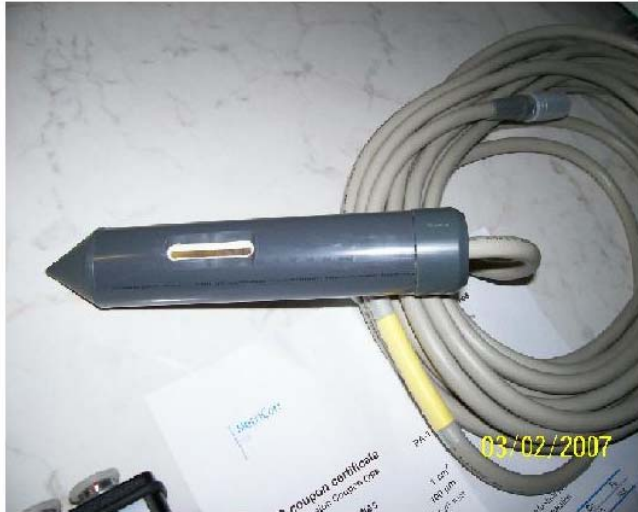
ER Coupon

Besides the a.c. Corrosion Coupons n. 1 and 2 placed in the Section 3, n. 2 ER Coupons have been installed very near to these.

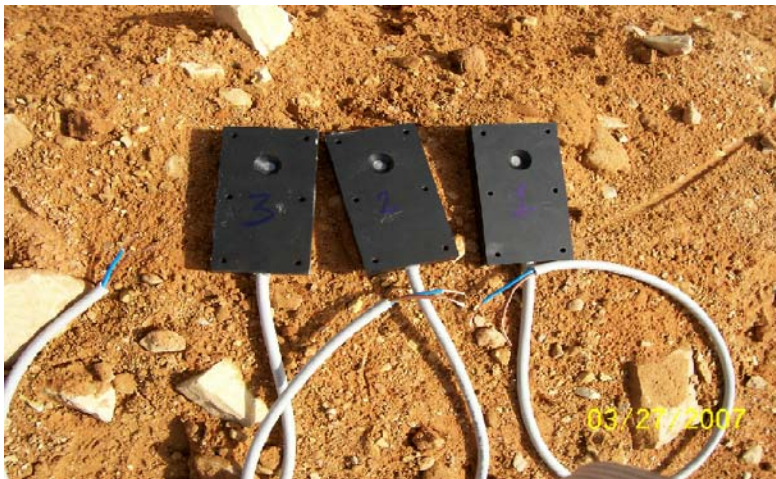
Three new a.c. Corrosion Coupons

In the Section 4, coated with bitumen, which includes two sacrificial magnesium anodes, and 1 coating fault (n.11) to simulate d.c. interferences, a new set of three a.c. Corrosion Coupons has also been installed. These three new a.c. Corrosion Coupons are within a certain number of existing "natural" coating faults which have already been detected and localised during the Commissioning phases.
