Stainless steel: Two case studies of corrosion.
Importance of choosing the components
with which they are in contact and cleanliness of manufacturing
on the behaviour of installations

P LEROY*, F VUILLAUME**

Abstract:

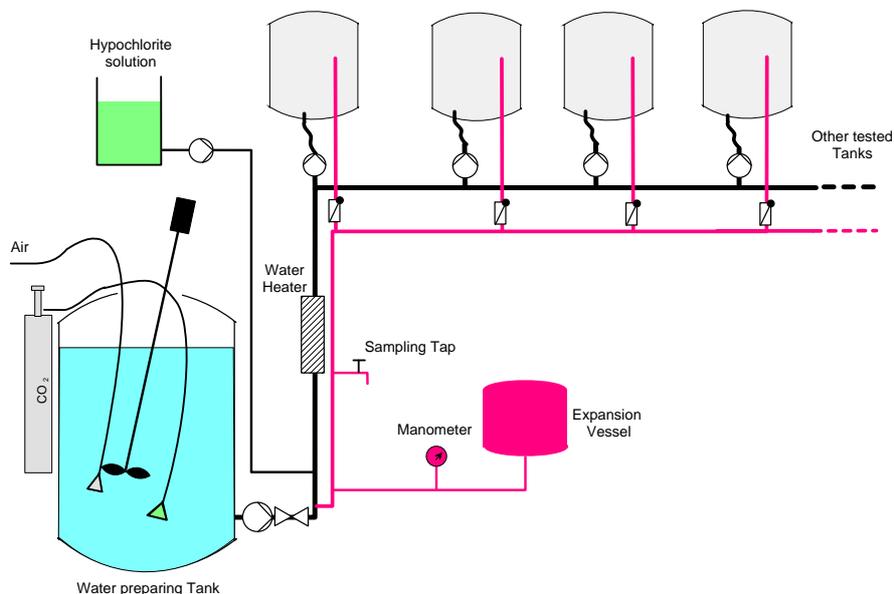
Fig. 2.4: Schema of the test rig

The test rig aims to compare the corrosion resistance of water tanks made of different stainless steel grades or of the same grade but for which the manufacturing process has changed. It allows to perform the tests with various compositions of water. This water is prepared from the tap water to which are added specific quantities of salts in order to obtain the desired mineral composition. This test rig was built according to the scheme given in Figure 2.4 and can test up to 8 tanks simultaneously.
