Failures of insulating joints and spark gaps on the Hellenic Gas Pipeline System - a case study

Hellenic Gas Transmission System Operator (DESFA) S.A.

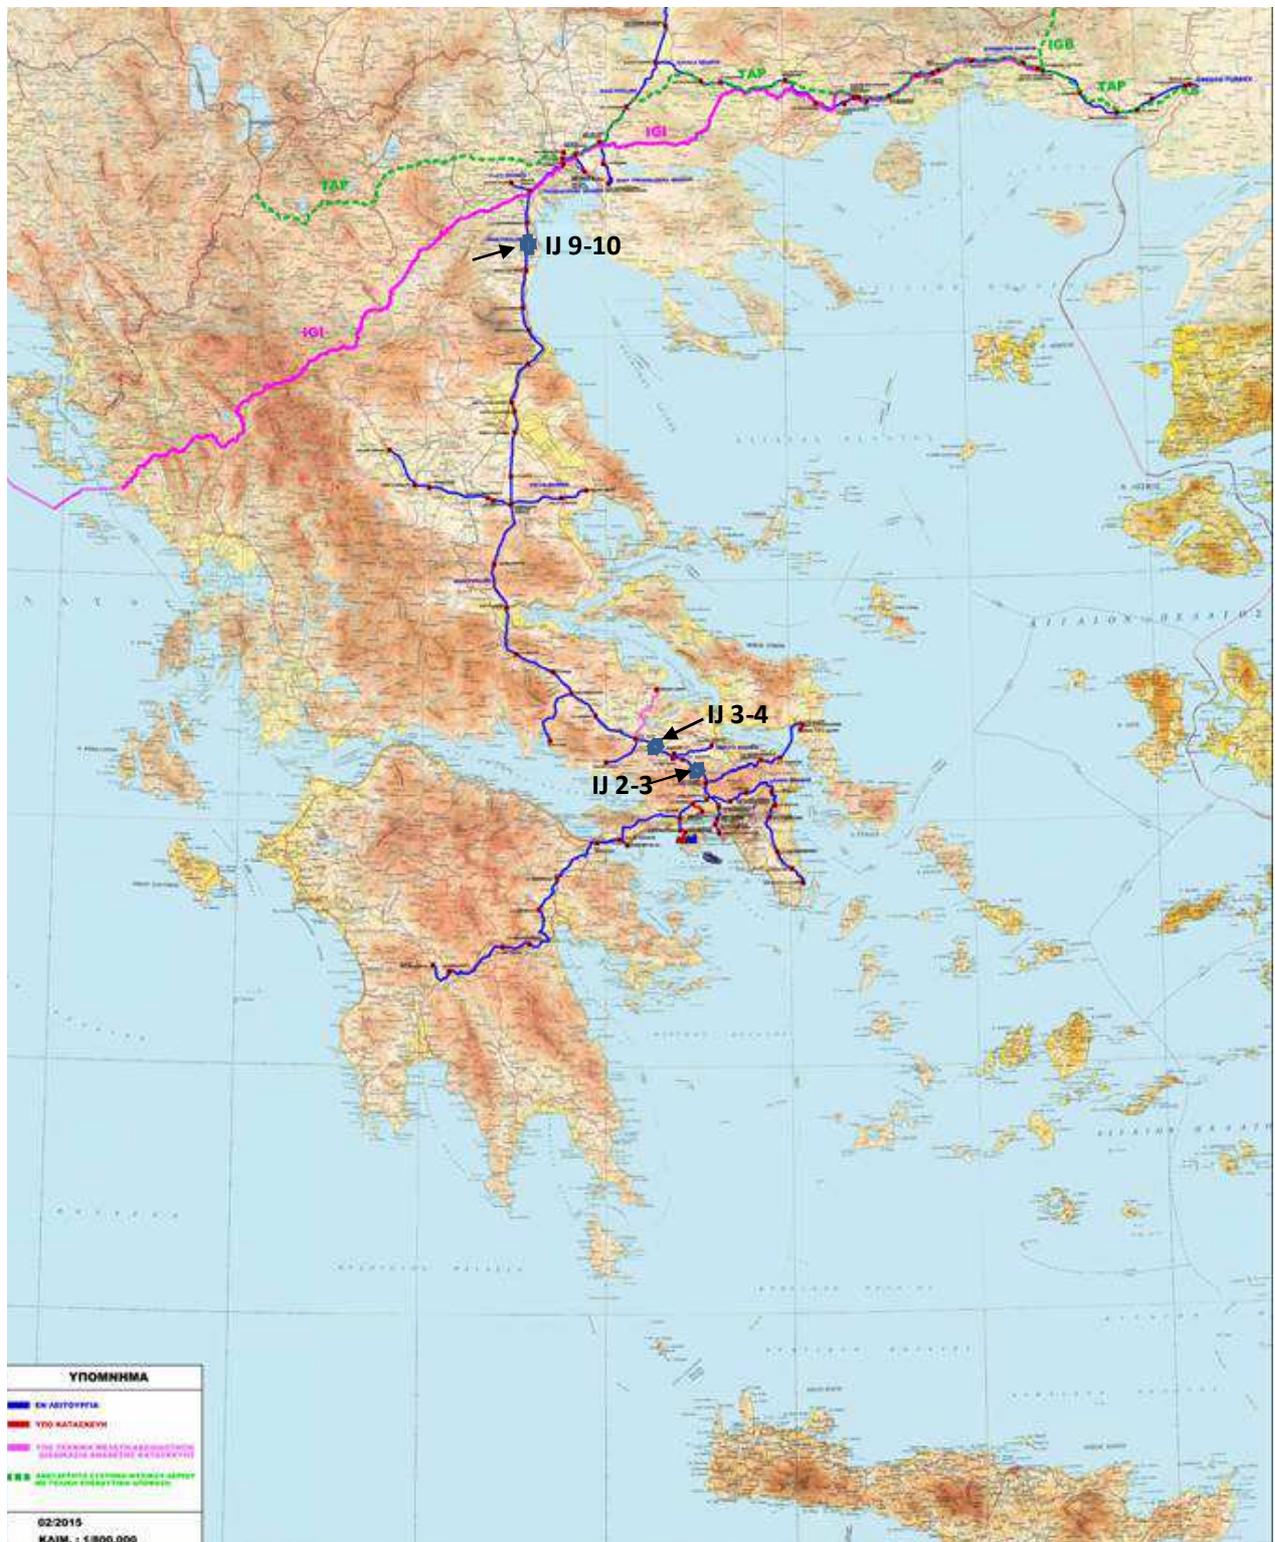
Figure 1 : Existing NGTS of Greece (the sites of IJ/ISGS in question are indicated by arrows)

The main gas line of NGTS of Greece extends from the Greek-Bulgarian borders to the west of Athens area. The pipeline had been installed between 1992 and 1995 (construction period). The burial depth range varies between 1 to 2 m. The factory coating is 3LPE with HSS at girth welds. The pipeline diameter is 30'' with wall thickness ranging between 9,5 to 15,6mm. The CP system consists of 12 CP areas separated by monolithic IJs (Fig. 1). Each CP area is normally protected by means of one Rectifier. The numbering of CP areas increases from south to north. In this work, we focus on the IJs of the main line that are in sequential order (i.e. between areas 1-2, 2-3, 3-4, etc.) other than the IJs separating the main line from branch lines or earthed structures. The rectifiers are remotely monitored and their switching is controlled through a GSM wireless transmission system since 2006-2007. More details on CP and earthing system can be sought in the bibliography [3-5]. It is noted that the described incidents in the following sections of this paper, belong to this main gas line.
