**CEOCOR 2007
MALAGA (SPAIN) 8 - 10 May, 2007**

Paper A06

a.c. corrosion – Some results of the activities

L. Di Biase – R. Cigna – O. Fumei - ISPRONA S.r.L

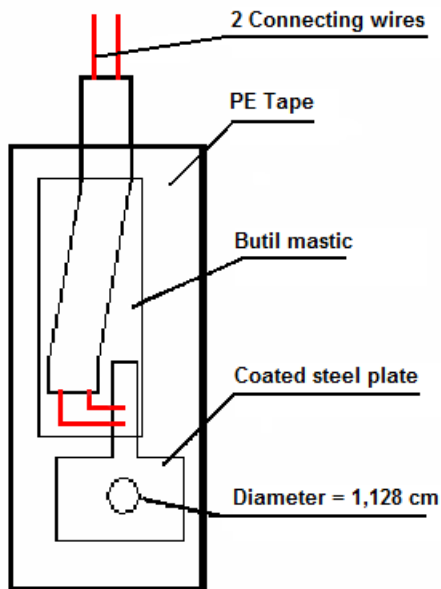
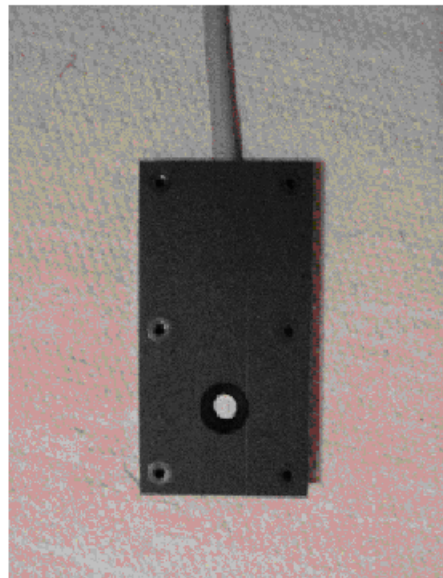
a.c. Corrosion Coupon

The old a.c. Corrosion Coupons have been replaced with new ones.

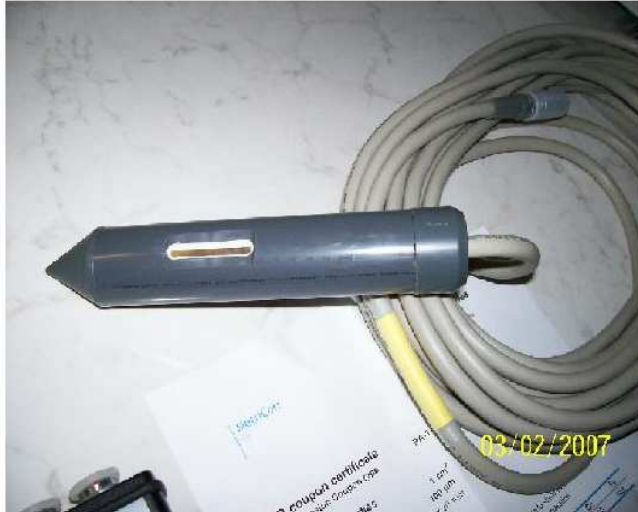
ER Coupon

Besides the a.c. Corrosion Coupons n. 1 and 2 placed in the Section 3, n. 2 ER Coupons have been installed very near to these.

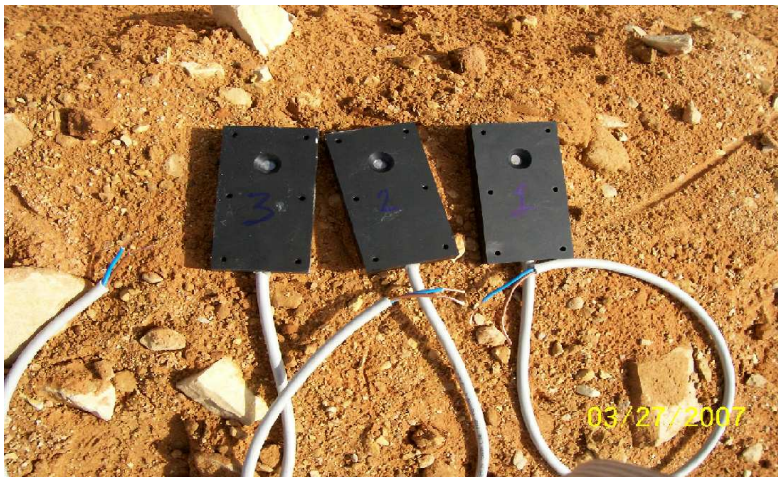
Three new a.c. Corrosion Coupons

In the Section 4, coated with bitumen, which includes two sacrificial magnesium anodes, and 1 coating fault (n.11) to simulate d.c. interferences, a new set of three a.c. Corrosion Coupons has also been installed. These three new a.c. Corrosion Coupons are within a certain number of existing "natural" coating faults which have already been detected and localised during the Commissioning phases.
