CORROSION RESISTANCE OF COPPER IN SWEDISH SOILS

Göran Camitz and Tor-Gunnar Vinka

Swedish Corrosion Institute, Kräftriket, Building 23A, SE-104 05 STOCKHOLM, Sweden

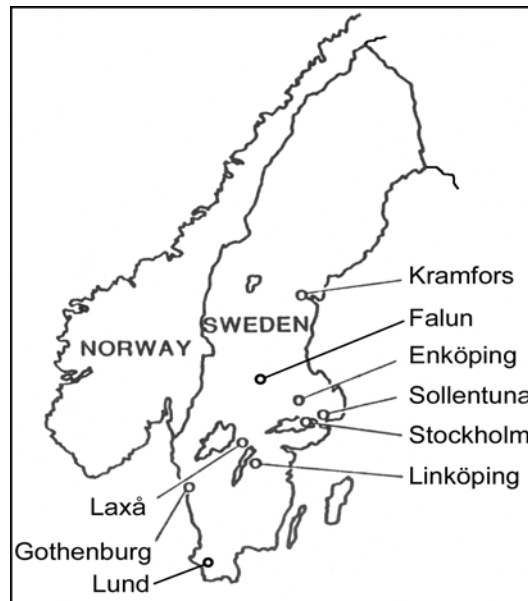
Figure 1. Location of the test sites in soil.

Nine test sites in soil have been established in different parts of Sweden. See **figure 1**. All test sites were established in flat terrain, which means that there are no strong ground water movements. The soil at the test sites is given in table 1.

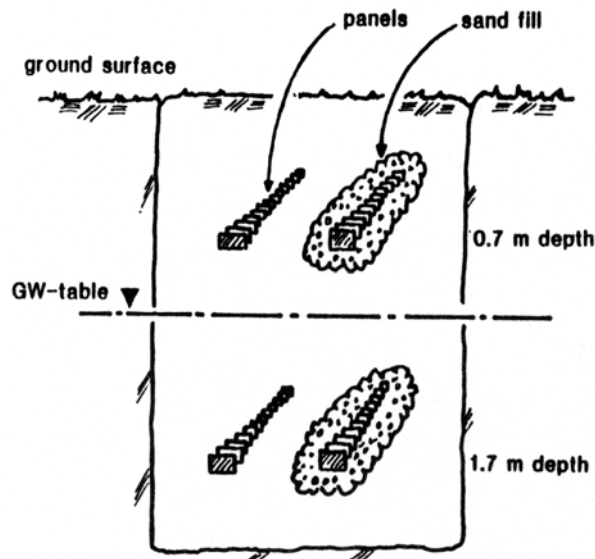
Figure 2. Position of the test panels in the trenches at the soil test sites no.1-7.

The test panels have been buried in trenches at the test sites - one trench for each planned withdrawal of samples. At test site nr.1 – 7 there are in total five test trenches at each test site. In each trench there is an upper test level at a depth of about 0,7 m and a lower one at about 1,7 m. See **figure 2**. When the trenches were refilled, an attempt was made to return as far as possible the excavated soil according to its original stratification. The groundwater table fluctuates with the season of the year between these two levels. During the period from late autumn with frequent rainfall to early spring after the snowmelting the groundwater table is high at test sites with clay soil. The upper test level may then be covered with groundwater and thus the soil at the upper level periodically is water saturated.

The test panels are exposed standing in a vertical position in a row in the original soil above and below the groundwater table. Furthermore, a set of panels above and a set below the groundwater table have been entirely embedded in a sand-fill. When the specimens were buried at the test site nr. 3 the upper and the lower rows of test panels were placed rather deeply (1,2 m and 2,2 m respectively) by mistake, so that the groundwater table stands at or above the upper row of panels during long periods of the year.

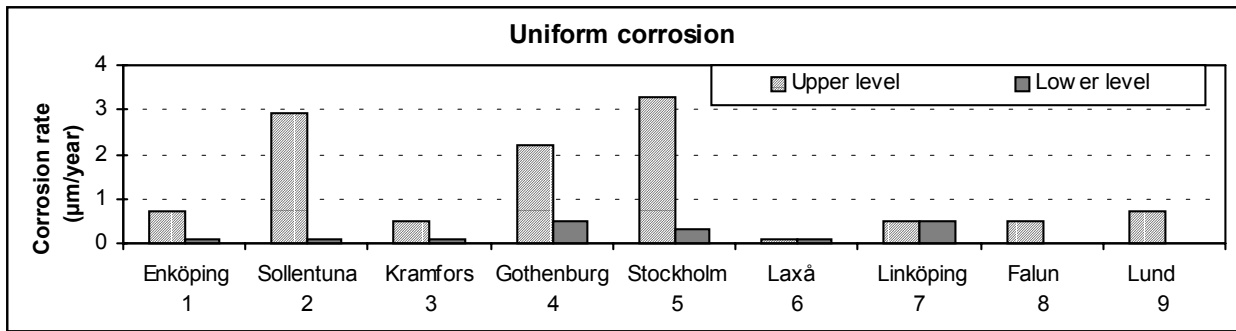
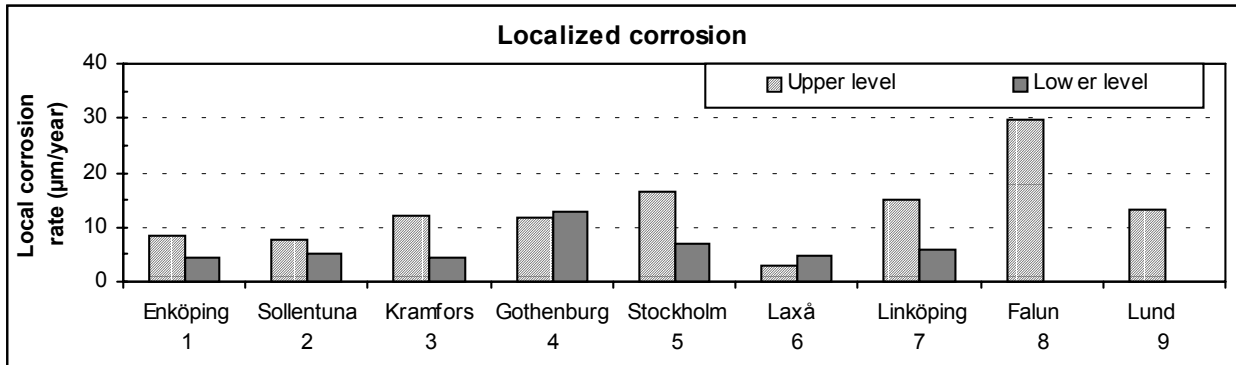
The corrosion rate (uniform and localized corrosion) of the test panels after the latest withdrawal of specimens, which were buried in original soil, is shown in **figure 3**. The corrosion rate (uniform and localized corrosion) of the test panels after the latest withdrawal of specimens, which were buried in sand fill at test sites 1-6, is shown in **figure 4**. The exposure period is seven years for panels from test sites 1, 2, 4, 5, 6 and 7 and five years for panels from test sites 3, 8 and 9. The corrosion rate is presented as uniform corrosion, and as localized corrosion. The corrosion rates are given as mean value for triplicate test panels (three test panels having been exposed near each other at the same position in the trench). The corrosion rates are based on evaluation of 48 single test panels. The corrosion rate (uniform and localized corrosion) for each single test panel at each of the three withdrawals has, as already mentioned, been reported earlier for test sites 1 – 7 (1) and for test sites 8-9 (2).

Figure 3. Corrosion rate (uniform and localized corrosion) of the test panels after the latest withdrawal of specimens, which had been buried directly in original soil. At test sites 1-7 test panels had been buried at an upper and at an lower test level. At test sites 8-9 test panels had been buried only at one test level.

From figure 3 it appears that the uniform corrosion was low and that it varies between $<0,1$ and $3,3 \mu\text{m}/\text{year}$. Only nine of all 48 test panels showed a uniform corrosion higher than $0,5 \mu\text{m}/\text{year}$. Also the localized corrosion was quite low and it varies between ca 1 and $30 \mu\text{m}/\text{year}$. Only twelve of all 48 test panels showed a localized corrosion higher than $10 \mu\text{m}/\text{year}$.

An attempt has been made to distinguish a relationship between the corrosion rate and the chemical composition of the soil. It is found from figure 3 that the highest uniform corrosion (mean value of triplicate specimens) appeared on test panels exposed in the original soil at the upper test level at the test sites no. 2 (2,9 $\mu\text{m}/\text{year}$), nr. 4 (2,2 $\mu\text{m}/\text{year}$) and no. 5 (3,3 $\mu\text{m}/\text{year}$). At the remainder sites and panel positions the average penetration was 0,7 $\mu\text{m}/\text{year}$ or less, with the exception of the test site no. 2, upper test level in sandfill, where the corrosion rate was 1,4 $\mu\text{m}/\text{year}$.

The highest localized corrosion also appeared on test panels exposed in original soil at the upper test level, at the test sites no. 3 (12,0 $\mu\text{m}/\text{year}$), no. 4 (11,7 $\mu\text{m}/\text{year}$), no. 5 (16,5 $\mu\text{m}/\text{year}$) and no. 7 (15,0 $\mu\text{m}/\text{year}$). At the lower test level at these test sites the local corrosion rate was ca 10 $\mu\text{m}/\text{year}$ or less, with the exception of test site no. 4 where it was 12,7 $\mu\text{m}/\text{year}$. Further, high localized corrosion appeared at test sites no. 8 (29,7 $\mu\text{m}/\text{year}$) and no.9 (13,3 $\mu\text{m}/\text{year}$).

As already mentioned increased localized corrosion appeared in the sand soil at the upper test level at test site no.7 and in the till soils at test sites no.8 and 9, **figure 3**. The sand and the till soils are the most aerated soils in the test program. The reason to the increased localized corrosion might be that the sand was unevenly packed towards the copper surface during the burial resulting in the formation of micro-aeration cells. Till is per se a non-uniform type of soil. Such corrosion cells can be quite effective in aerated soils since the oxygen transportation to the cathodic areas is effective in loose soils. Increased localized corrosion was found also on carbon steel and aluminium in this test position, given the cause of micro-aeration cells (11, 12, 13).

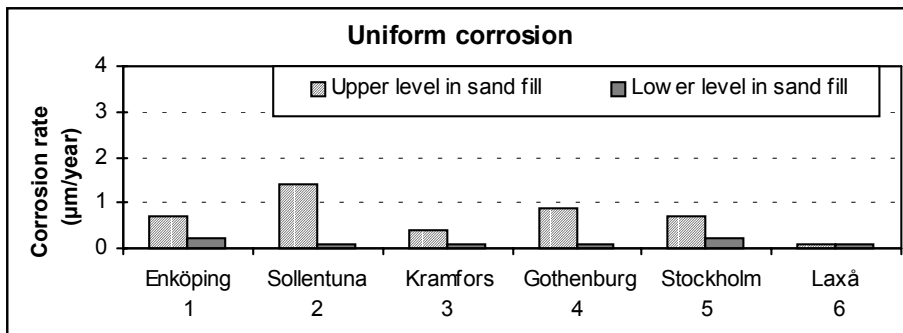
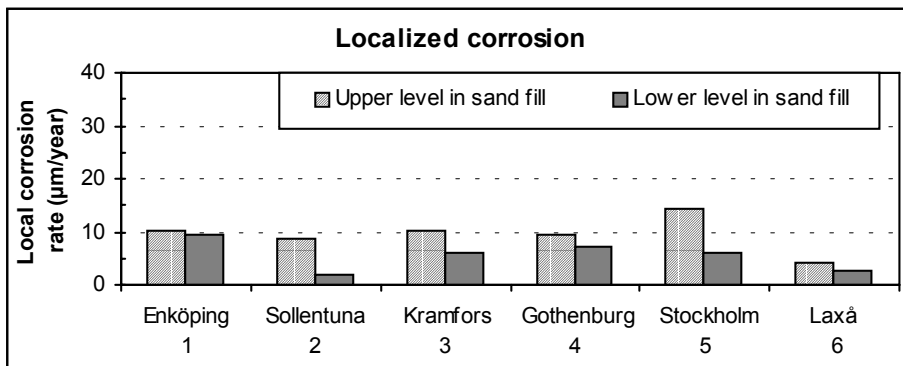
Figure 4. Corrosion rate (uniform and localized corrosion) of the test panels after the latest withdrawal of specimens, which had been buried in sand fill at test sites 1-6. The test panels had been buried at an upper and at an lower test level.

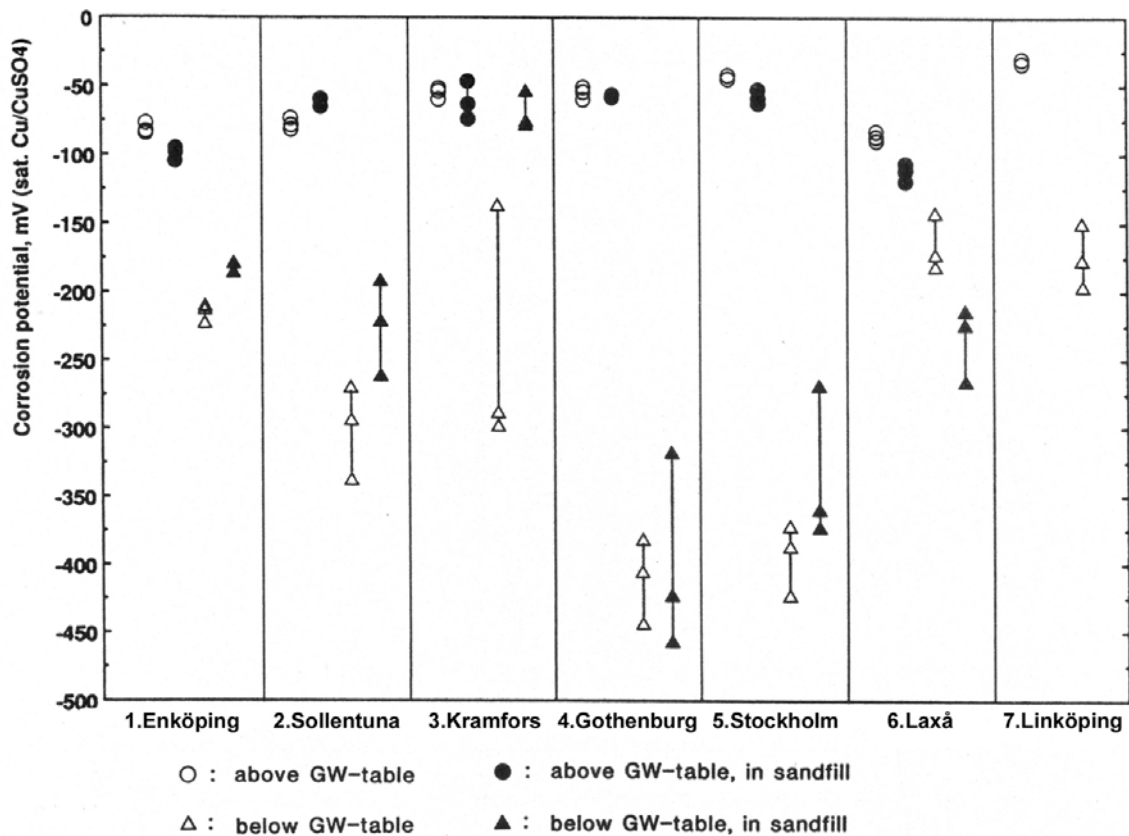
The corrosion potential of each separate panel at test sites 1-7, measured when the panels were taken in after three years' exposure, is shown in **figure 5**. During the measurement, the reference electrode (saturated Cu/CuSO_4) was placed in the soil close to the test panel. Metal contact was achieved by carefully uncovering and cleaning a corner of the test panel. Thereafter the test lead was connected to the panel with a crocodile clip.

Figure 5. Free corrosion potential of copper test panels after ca. 3 years exposure in soil.
