## ***PIPELINE INTEGRITY: STUDY, ANALYSIS, AND PROPOSAL TO SOLVE A REAL CASE***

### **Abstract**

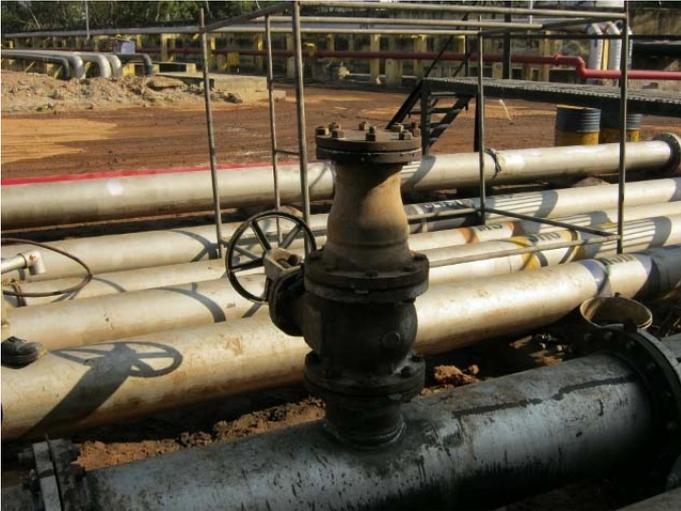
The SmartBall® is typically launched and received from a pipeline at existing pig traps. Since this particular pipeline for inspection is “non-piggable”, then a minor modification to either install an insertion spool (Fig. 3) or alternatively provide a 4” hot tap (Fig. 4) will be required as per photos below.

Fig. 3 – Short insertion spool

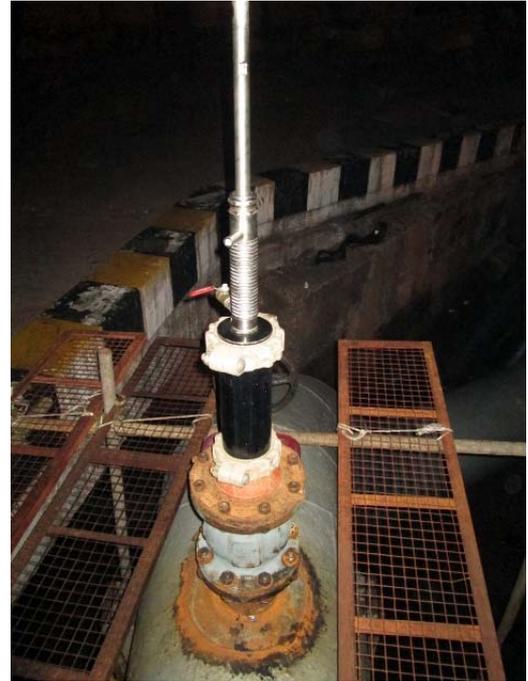
Fig. 4 – Hot-tapped insertion
