# **The effect of variation of ac-interference over time on the corrosion of cathodically protected pipelines**

## **Summary**

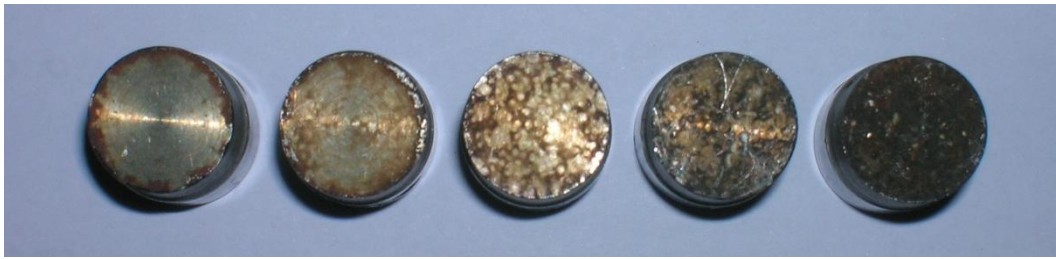
Fig. 3: Coupons of type 2 (after removing the surrounding polymer) after 3 months test in the series of 14 V avg a.c. voltage in soil solution with 17  $\Omega\text{m}$ . The coupons correspond from left to right to the series 1 to 5.

In Fig. 3 the coupons of type 2 are shown after 3 months test in the series of 14 V avg a.c. voltage in soil solution with 17  $\Omega\text{m}$ . The results are typical for all investigations shown in Table 2. Although all coupons exhibit identical average a.c. voltage, clearly a difference in the amount of rust layer formation is observed. Microscopic analysis shows that no corrosion has taken place in the central area of the coupons. Even the traces from machining the coupons are still visible in all cases. Although no serious a.c. corrosion has taken place, the amount of rust layer formation appears to be related to the higher maximum a.c. voltage applied. According to the proposed mechanism of a.c. corrosion, extremely high a.c. current densities can be passed through the metal surface without causing corrosion, if the charge can be consumed by oxidation and reduction of the rust layer formed on the metal surface. Hence, higher a.c. current densities require thicker rust layers, which indeed is experimentally concluded in all cases from the increasing blackening of the samples. The amount of anodic charge that can be consumed by the rust layer was determined at the end of the test by coulometric oxidation. The results are shown in Fig. 4. Additionally the amount of charge flowing during an anodic half wave is displayed.
